**CULTURAL RESOURCE ASSESSMENT SURVEY
ADDENDUM UPDATE**

**PREFERRED STORMWATER MANAGEMENT FACILITY (SMF) &
FLOODPLAIN COMPENSATION (FPC) SITES
AND
HISTORIC RESOURCES SURVEY UPDATE (HRSU)**

**US 301 (SR 41) from Fowler Avenue to SR 56
Hillsborough & Pasco Counties, Florida**

**ETDM Number: 14194
WPI Segment Number: 255796-1**

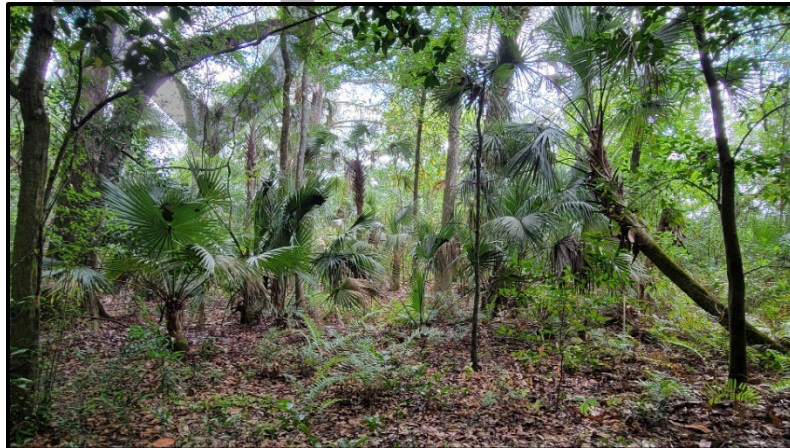
Photo 11. Site 8HI15394, facing east.

It is located on the moderately well-drained Tavares-Millhopper complex, 0-5% slopes, at an approximate elevation of 40-45 ft amsl just above swampland; the site is overgrown with mixed hardwoods that transition to palm and cypress towards the west. The general stratigraphy of the site consists of 0-30 cm of gray sand followed by 30-70 cm of light brown sand, clay 70-100 cm.

The site was discovered while conducting systematic shovel testing at 25 m and judgmental subsurface testing. The testing intervals were decreased to 12.5 m intervals to bound the site. There were two positive and 10 negative shovel tests. The site extends 10 m east/west by 25 m north/south.

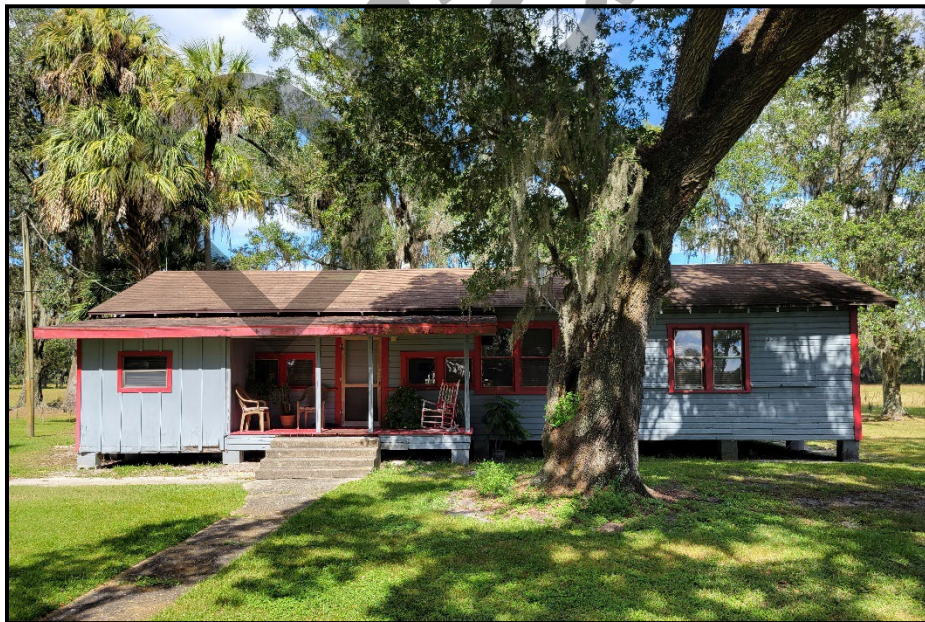
Photo 12. Road Camp No. 8502 - Building 1 (8HI15171), looking north-northeast.

Despite the demolition of the majority of the buildings associated with State Road Department Camp No. 8502, the overall setting of the camp remains rural in nature and has not been significantly developed with the exception of approximately five non-historic agricultural buildings. The two remaining buildings – the ca. 1934 Frame Vernacular style building (8HI15171) and mess hall (8HI15172) – serve as contributing resources within the State Road Department Camp No. 8502 (8HI15170) building complex resource group. These contributing resources are the only known examples of early road camps remaining in the region and have received few non-historic alterations. As such, the buildings and overall resource group are significant examples of early twentieth century penal practices in the State of Florida which brought negative attention to the state for decades, eventually leading the modernization of facilities in the state. Although simple in appearance, the buildings are examples of the rudimentary construction methods utilized to house the convicts and shed light on the living conditions experienced as prisoners served their sentences at the camp. As a result, State Road Department Camp No. 8502 (8HI15170) appears eligible for listing in the NRHP under Criteria A and C in the areas of Law, Politics/Government, and Architecture as an example of a prison road camp commonly used throughout the state in early- to mid-twentieth century Florida.

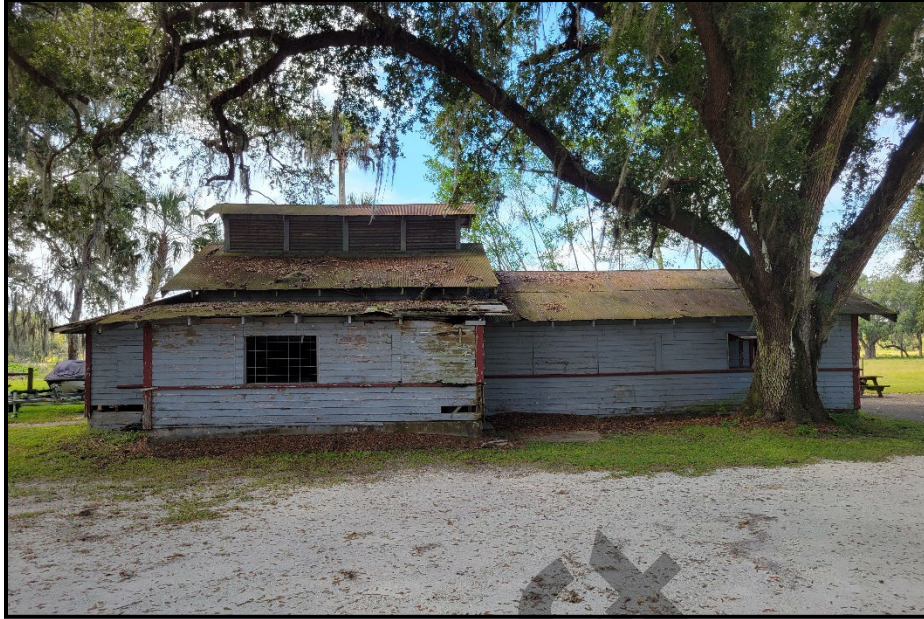
Photo 13. Road Camp No. 8502 - Mess Hall (8HI15172), looking northwest.

8HI15171 and 8HI15172: The Frame Vernacular style buildings at 17040 N US 301 were constructed in ca. 1934. Road Camp No. 8502 - Building 1 (8HI15171) was likely used as living quarters (**Photo 12**), while Road Camp No. 8502 - Mess Hall (8HI15172) served as a mess hall for convicts and authority at State Road Department Camp No. 8502 (**Photo 13**). The resources are considered contributing resources within the State Road Department Camp No. 8502 (8HI15170) building complex resource group. Despite the demolition of the majority of the buildings associated with State Road Department Camp No. 8502, the ca. 1934 Frame Vernacular style buildings (8HI15171 and 8HI15172) serve as contributing resources within the State Road Department Camp No. 8502 (8HI15170) building complex resource group. These resources are the only known examples of early road camp architecture remaining in the region. The Road Camp No. 8502 - Building 1 (8HI15171) has received multiple alterations, including the enclosure of the original ventilation openings and the installation of windows, as well as a historic shed roof addition; however, the addition was completed while the building was utilized by the road camp. The Road Camp No. 8502 - Mess Hall (8HI15172) is largely intact and has been minimally altered since its use as a mess hall.

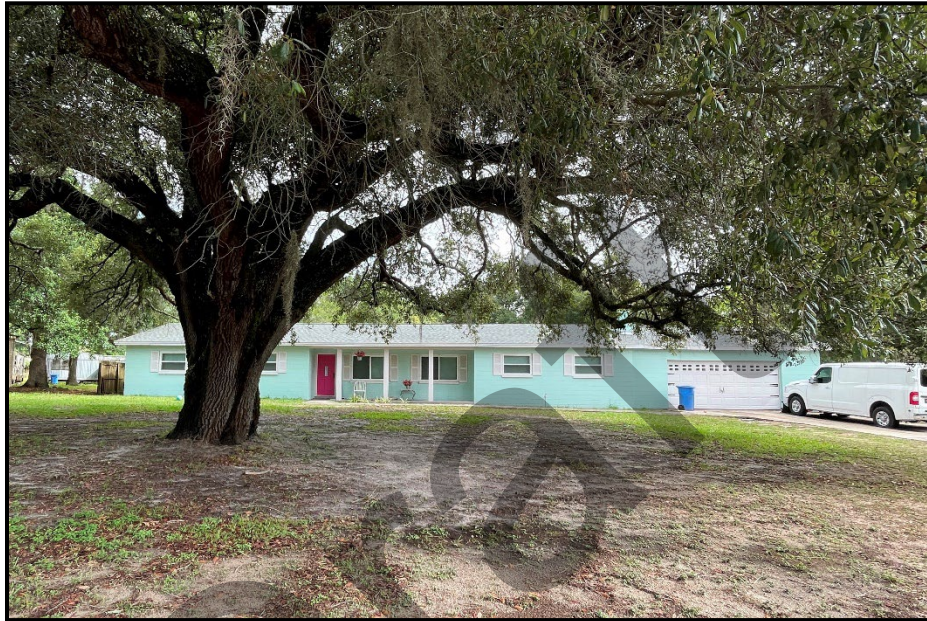
Photo 14. Masonry Vernacular style building (8HI15452) located at 9812 Rockhill Road, looking north.

Masonry Vernacular: A total of five (5) historic resources (8HI15450, 8HI15452, 8HI15453, 8HI15454, 8HI15458) within the APE are of the Masonry Vernacular style (**Photos 14 and 15**). The construction dates range from ca. 1968 to ca. 1973. The majority of these resources were constructed as single-family residences; however, two are utilized for commercial purposes (8HI15454 and 8HI15458). Masonry Vernacular style buildings reflect the local customs, environment, and building materials, and do not rely on academic architectural vocabulary for their design and ornament. Within the APE, the resources generally have a continuous concrete block foundation and concrete block walls that have been painted. The windows are typically metal or vinyl single-hung sash or sliding units. Roof types commonly consist of hip or gable roofs, clad with composition shingles or ribbed sheet metal. Most display replacement windows and roofs, fenestration changes, and additions.

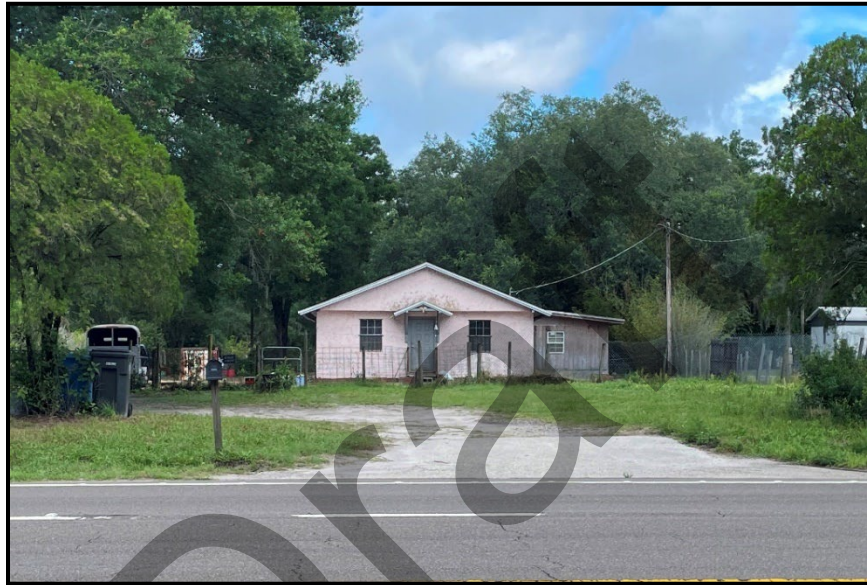
Photo 16. Frame Vernacular style building (8HI15456) located at 14016 N US 301, looking northwest.

Frame Vernacular: Two (2) historic resources (8HI15456 and 8HI15457) within the APE are of the Frame Vernacular style and were constructed in ca. 1974 and 1972, respectively (**Photo 16**). Frame Vernacular style buildings are simple structures built with available local materials and boasting little ornamentation (McAlester 2013). They are often built by developers, contractors, master carpenters, or the building's occupants. These buildings are decidedly practical structures. Within the APE, this building type has obscured foundations with wood frame structural systems. Roof types include gable roofs with shed roof segments covered in composition shingle, composition roll, or 3V crimp sheet metal. The exteriors of the buildings are clad in various siding, including stucco, vinyl, and plywood. The windows include vinyl single-hung sash units. Exterior ornamentation is minimal and includes basic features such as overhanging eaves with boxed rafter tails and trim around the windows. The resources display alterations and additions, such as replacement roofing, siding, and windows.

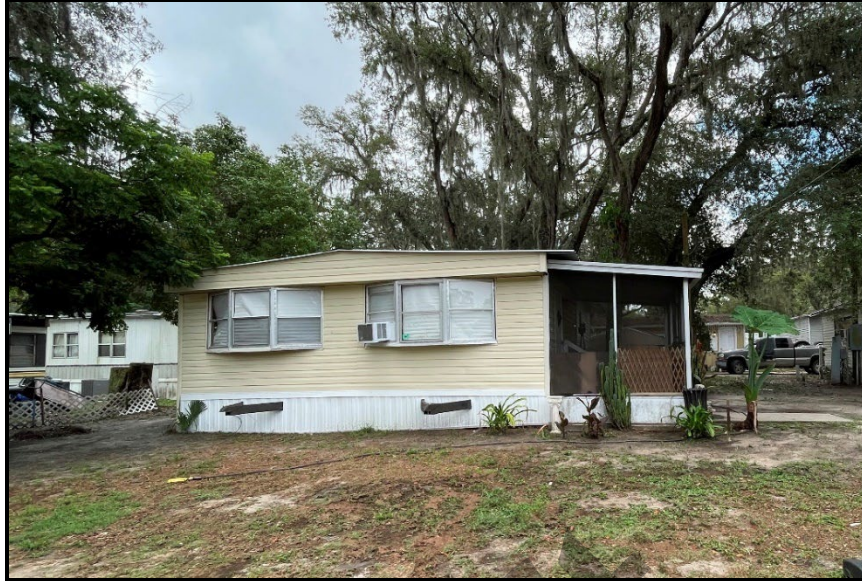
Photo 17. Mobile home with no style (8HI15455) located at 12073 Emory Oak Loop, looking east.

No Style: Two (2) historic resources within the project APE are mobile homes with no style (8HI15451 and 8HI15455) and were constructed in ca. 1970 and 1969, respectively (**Photo 17**). The mobile homes within the APE include both single-wide and double-wide designs with pier foundations surrounded by metal skirting. Metal single-hung sash and awning windows are most common, and exterior ornamentation is minimal with metal siding. These manufactured buildings have no style and are simply built in a factory with a steel chassis to allow for the ability to be moved. One of the two mobile homes (8HI15455) is a representative and contributing resource to the Green Oaks Mobile Home Park (8HI15448).

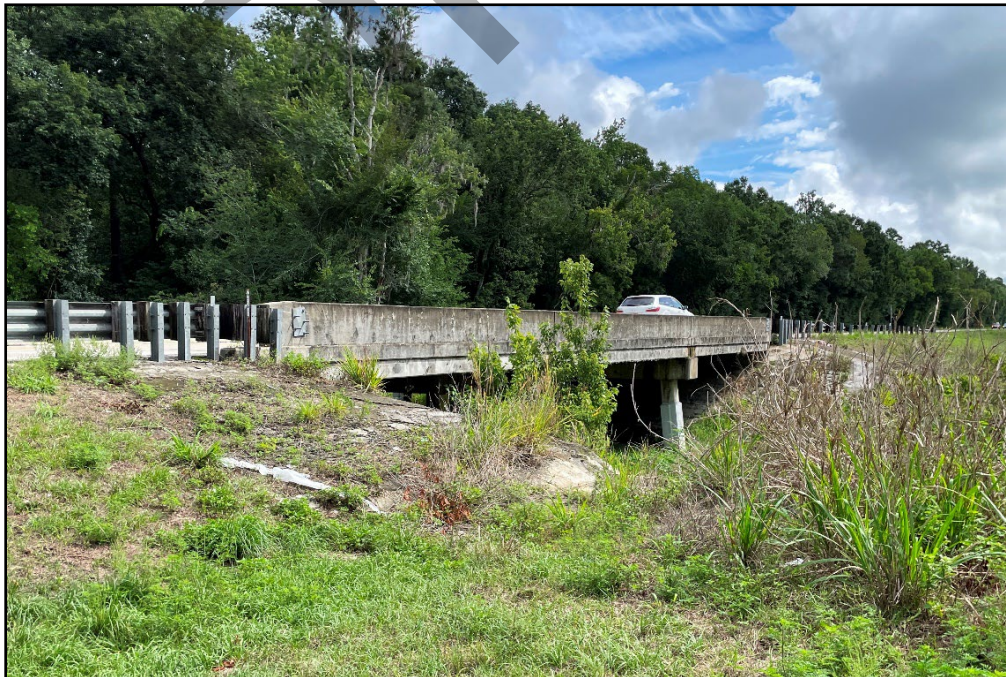
Photo 18. US 301 over Flint Creek (FDOT 100951) (8HI15445), looking north.

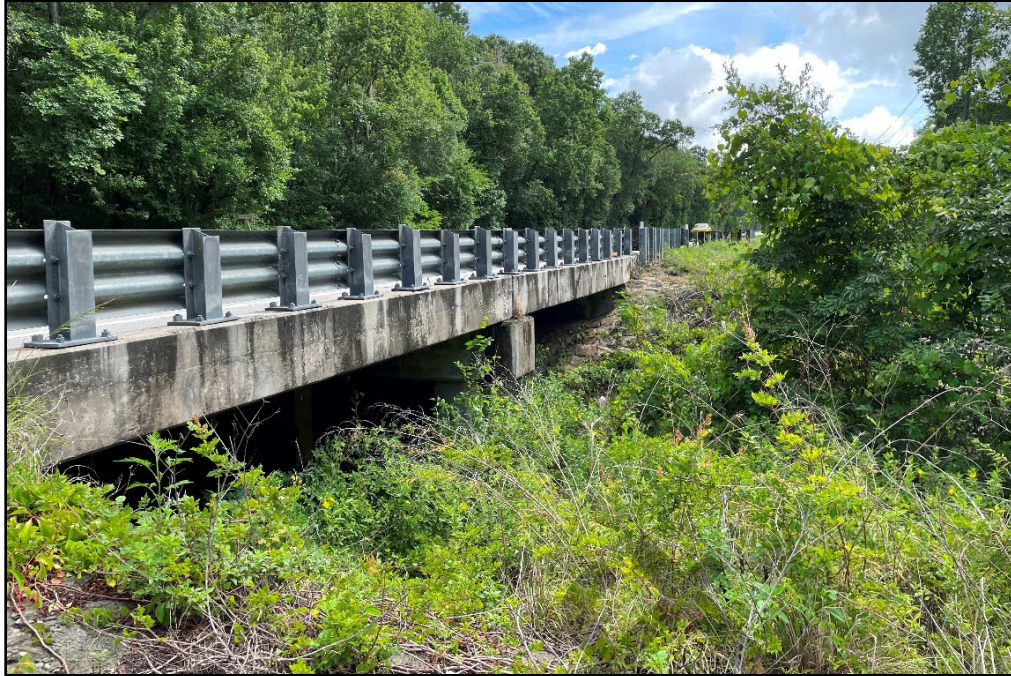
Photo 19. Photo 20. US 301 over Flint Creek relief (FDOT 100052) (8HI15446), looking northeast.

Bridges: Three bridges (8HI15445, 8HI15446, 8HI15447) are located within the APE. These include the US 301 over Flint Creek (FDOT No. 100951/8HI15445) bridge, the US 301 over Flint Creek Relief (FDOT No. 100052/8HI15446) bridge, and the US 301 over Hollowman's Branch (FDOT No. 100053/8HI15447) bridge. The three resources are concrete slab bridges that were constructed in ca. 1972. The overall lengths of the bridges range from approximately 50-ft long (two spans) to 96-ft long (three spans) and all three bridges are 40-ft wide with roadway widths of approximately 24-ft. The superstructure of each bridge consists concrete slabs supported by concrete bent substructures with sloped concrete bag abutments. The bents have 4-5 squared piers each. Two bridges (8HI15445 and 8HI15447) are lined with solid concrete parapets (**Photo 18**), and one is lined with metal guardrails (8HI15446) (**Photo 19**). The bridges are typical examples of a common Post-1945 concrete slab bridge found throughout Florida. This type of bridge was constructed as part of the massive expansion of the State's road system in the decades following the end of World War II (Parsons Brinckerhoff 2005). The bridges within the APE do not possess any notable engineering features or design elements that would differentiate them from dozens of similar examples built throughout Florida during the same time period. Background research did not reveal any historic associations with significant persons and/or events. Thus, due to the commonality of design and lack of significant attributes or association, 8HI15445, 8HI15446, and 8HI15447 do not appear eligible for listing in the NRHP, either individually or as part of a historic district.

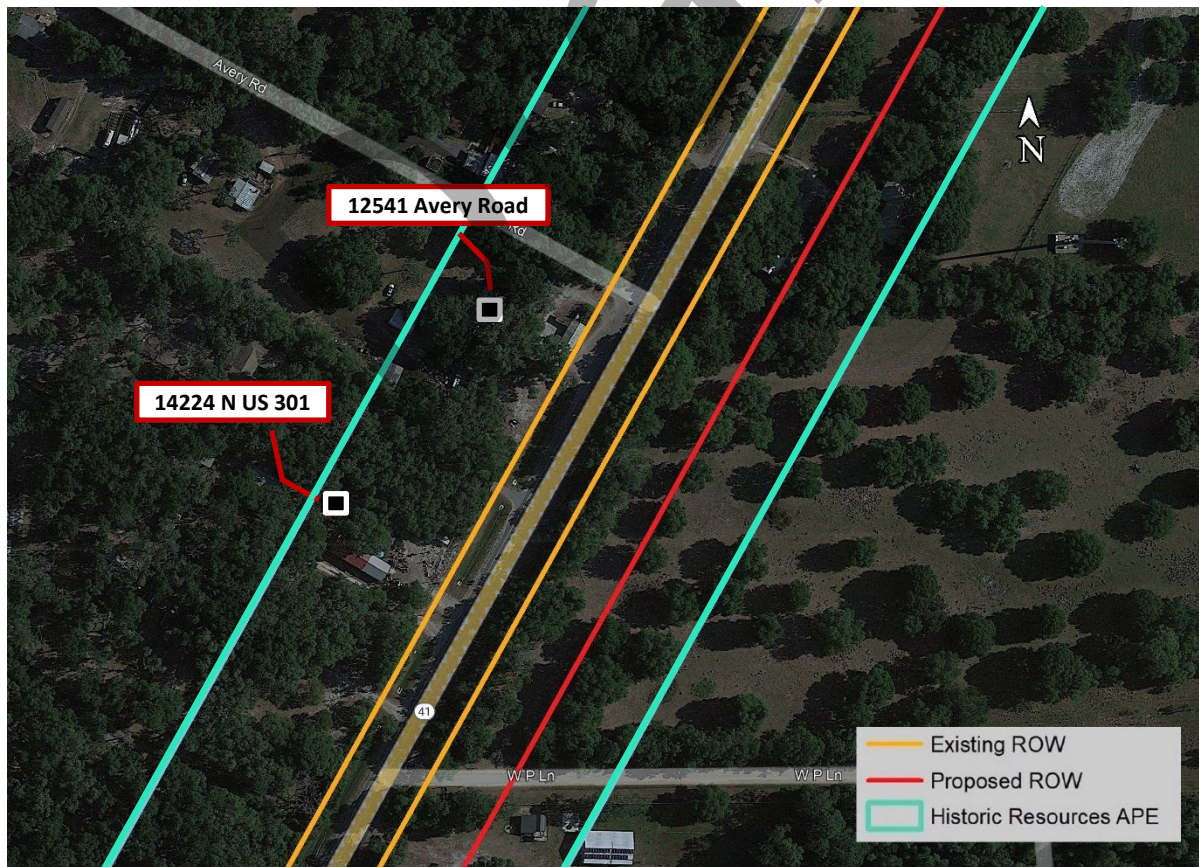
Figure 19. Location of two inaccessible ca. 1973 historic resources.

In addition to the 17 historic resources identified within the APE, the Hillsborough County property appraiser identified two historic resources that could not be evaluated or recorded during the field survey due to lack of accessibility and/or obstructed views from the ROW (**Figure 19**). These are two ca. 1973 buildings located at 14224 N US 301 and 12541 Avery Road. The building at 14224 N US 301 is on a residential lot that is set back from the roadway, lined with fencing, and obscured by vegetation and non-historic outbuildings. The building at 12541 Avery Road is surrounded by adjacent buildings, a fence, and heavily overgrown vegetation. Based on available information, these resources are probably typical examples of vernacular style buildings; however, because the resources are not visible or accessible from the ROW, the status and condition of the resources are unknown. Per the project Roadway Plans, no ROW acquisition is proposed in this area of US 301. The buildings are a considerable distance from the proposed improvements, 110-ft to 170-ft respectively, and are hidden by existing vegetation on the parcels.

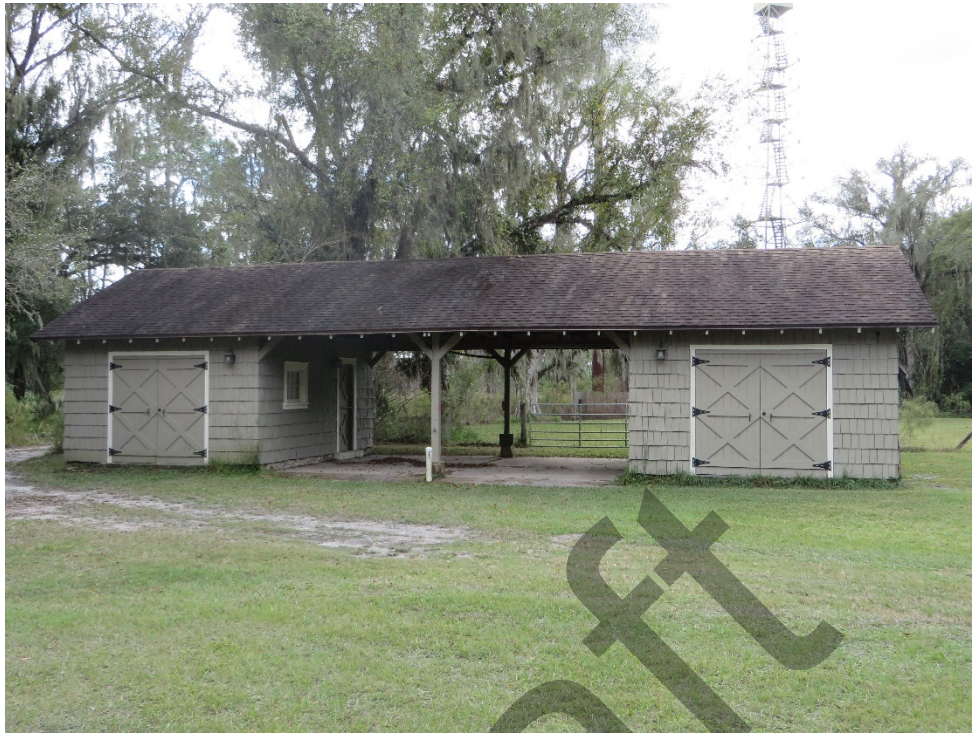
Photo 2. Maintenance Shed 1 (8HI03891), facing south.

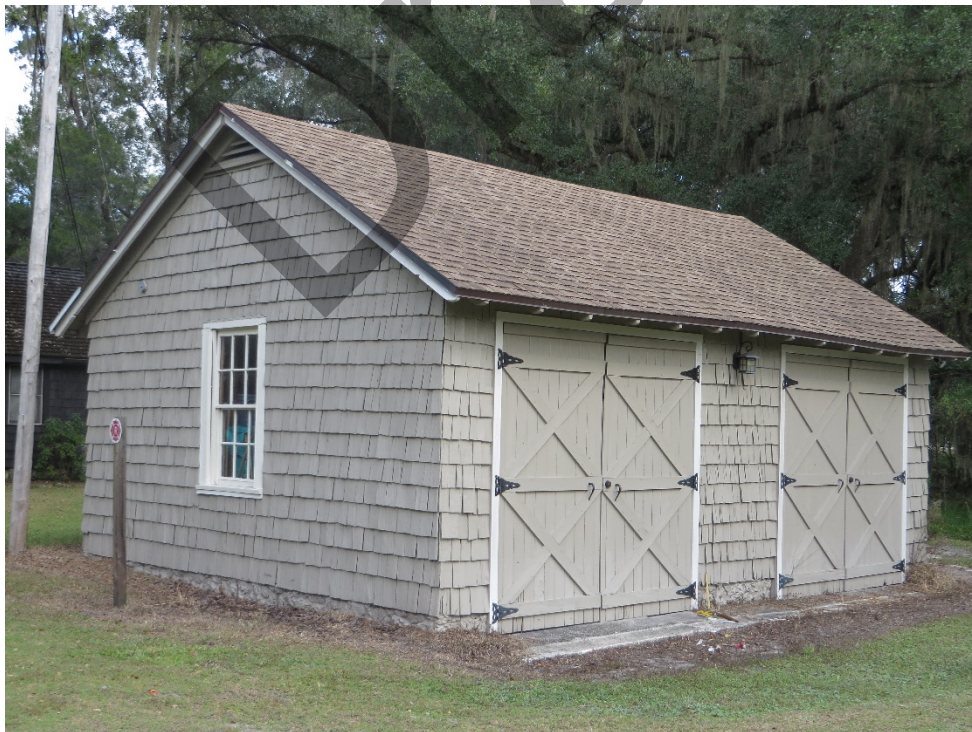
Photo 3. Maintenance Shed 2 (8HI03892), facing east.

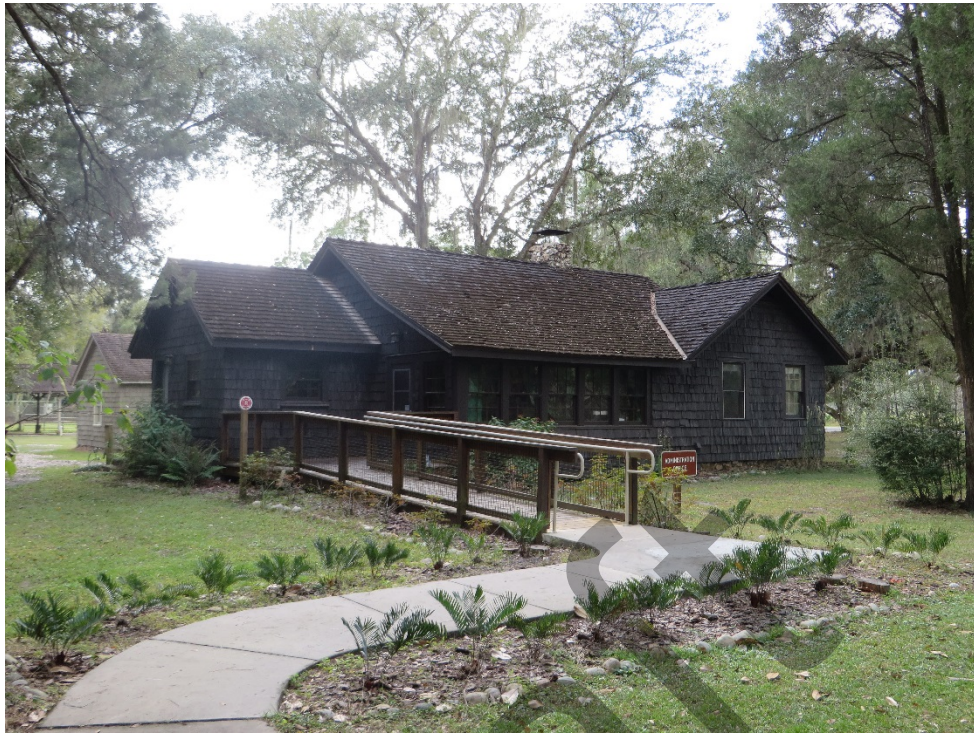
Photo 4. Ranger's Residence (8HI03893), facing east.

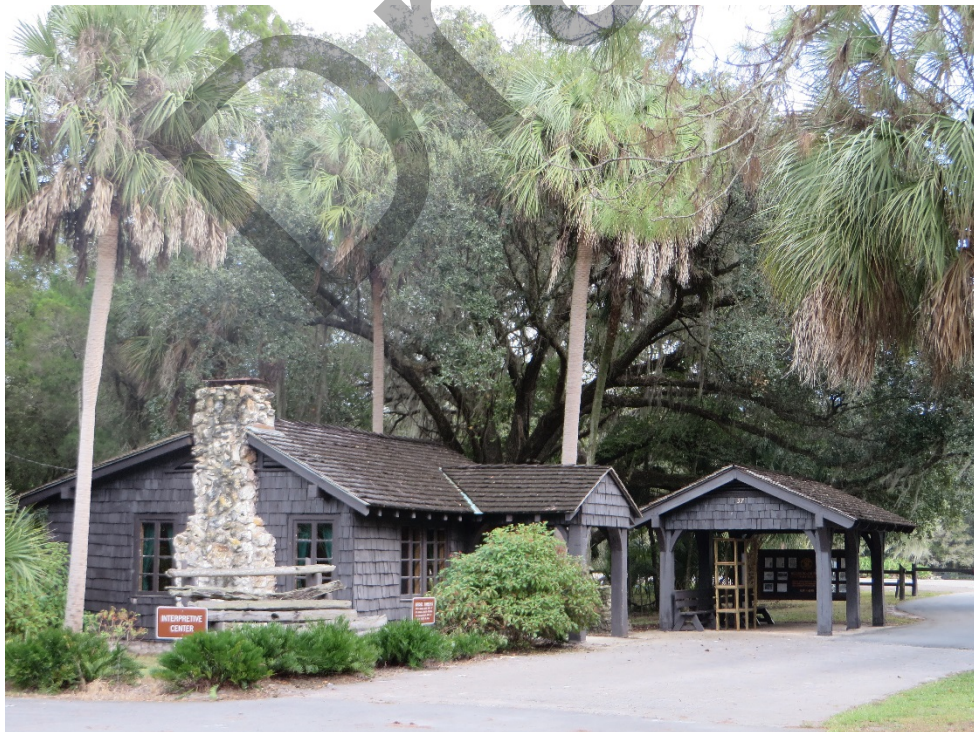
Photo Error! No text of specified style in document.. Interpretive Center (8HI03894), facing northeast.

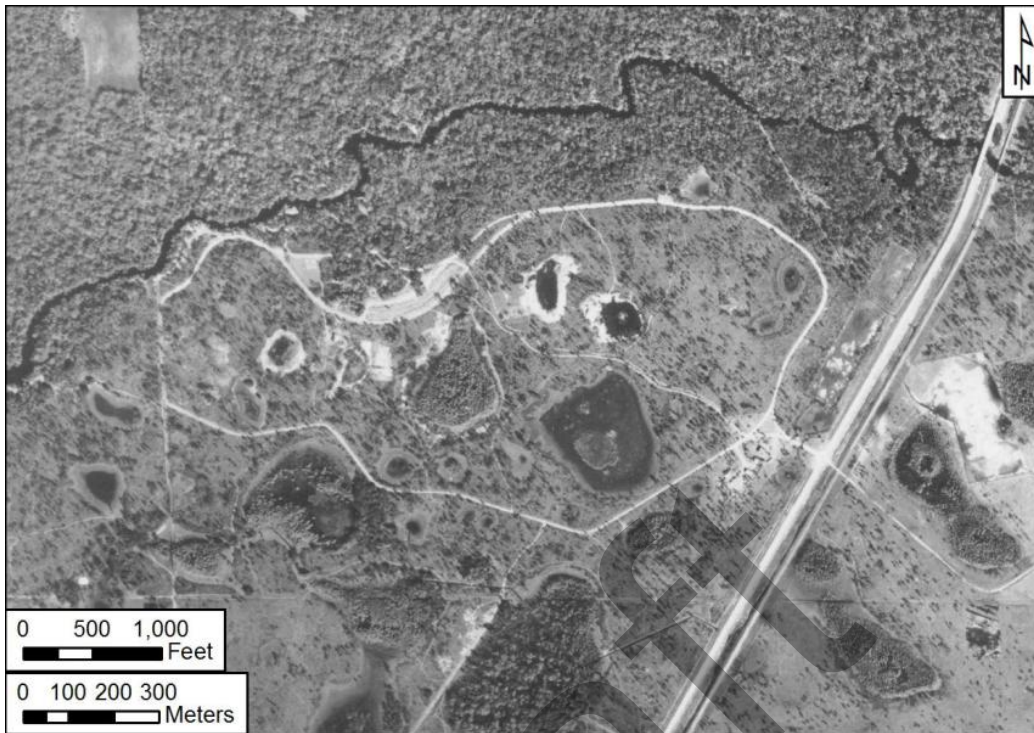
Figure 2. 1941 aerial of Hillsborough River State Park (USDA 1941).

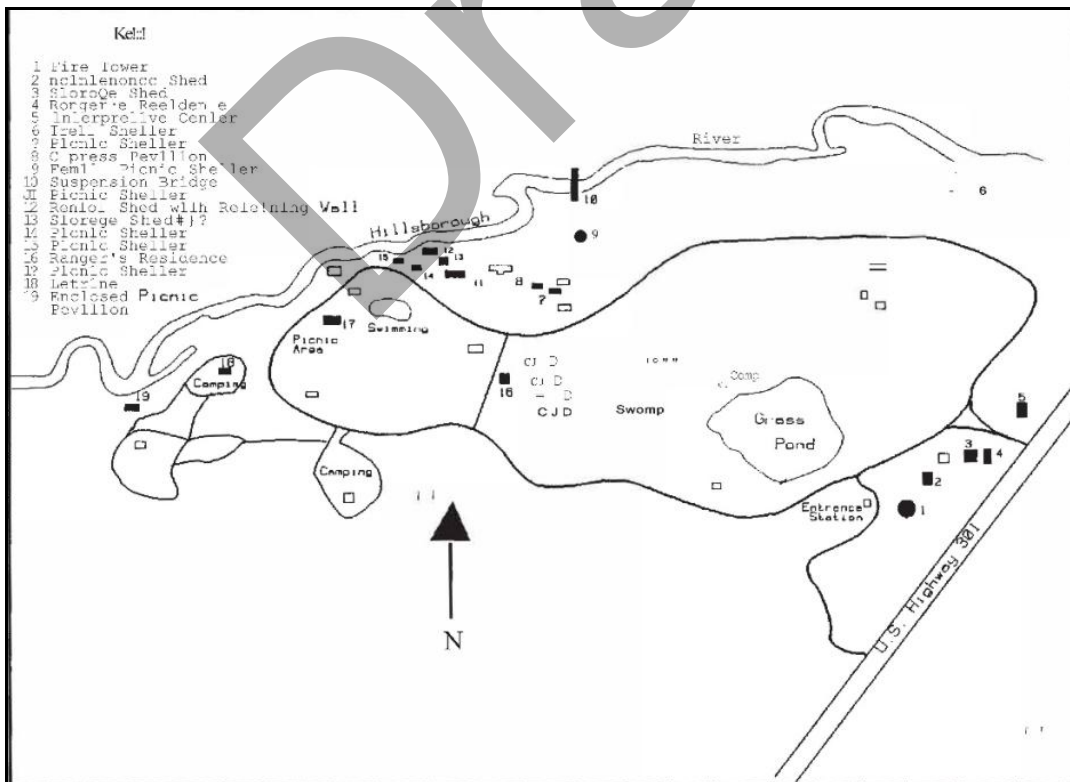
Figure 3. CCC facilities at Hillsborough River State Park (Adams et al. 1989).

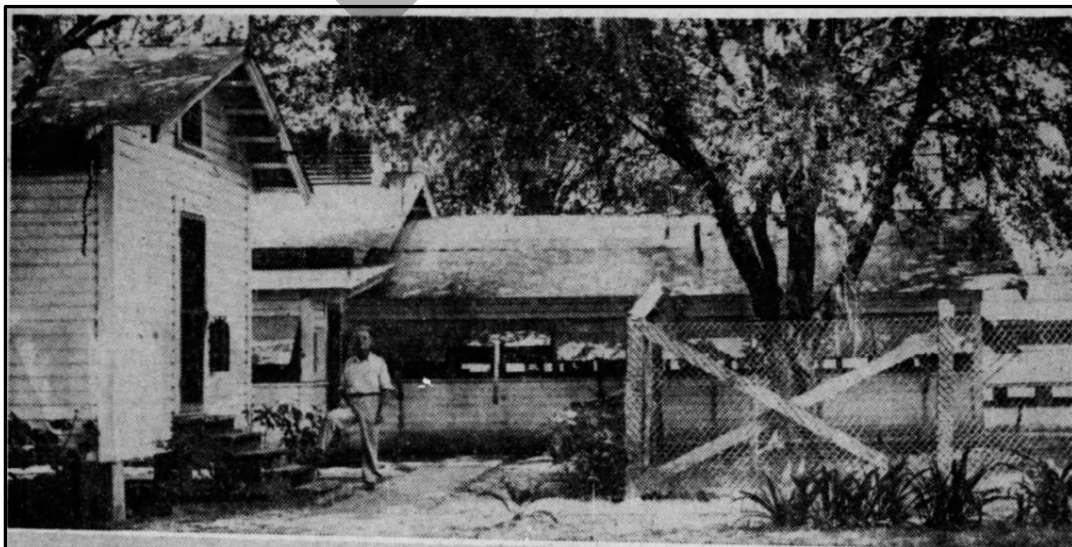
In Hillsborough County, a county level camp was located at Six Mile Creek in Tampa while State Road Department Camp No. 8502 – known previously as Camp No. 33 – served at a state level, albeit also in Hillsborough County (Murray 1945; Miami News 1942). State Road Department Camp No. 8502 appears to have been constructed as early as ca. 1934 to provide convict labor for the construction of State Road 156 (later known as US 301); however, the exact date could not be determined (Tampa Tribune 1934). The land upon which the camp was constructed was historically owned by Wayne Thomas, who donated several hundred acres to the south along Hillsborough River for use as Hillsborough River State Park (Tampa Times 1934). The road camp is not associated with the state park. Historic aerials and photographs reveal that the camp was equipped with several buildings, including a known commissary, mess hall, and sweatboxes (USDA 1941; Murray 1945) (**Photos 1 - 3**).

Photo 1. A ca. 1945 photograph depicting Road Camp No. 8502 with the commissary in the foreground (left) and a portion of the mess hall visible in the background (center to right) (Murray 1945).

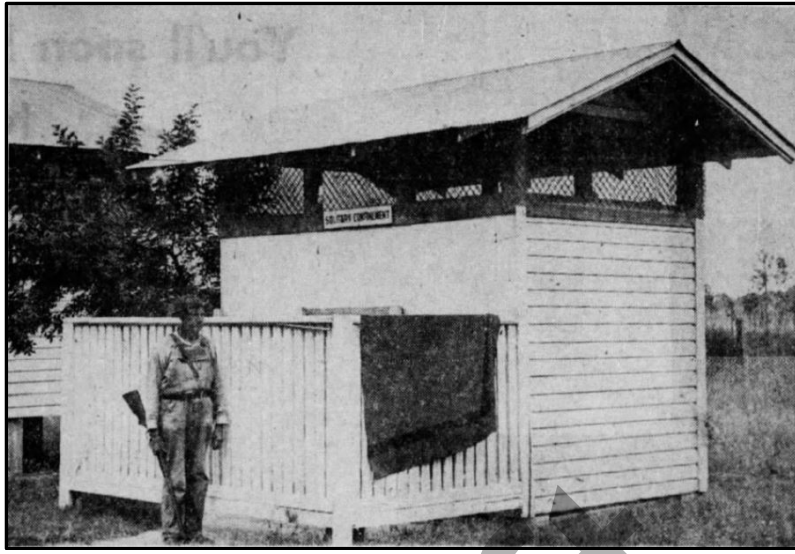
Photo 2. A “deluxe” sweatbox containing three double solitary confinement cells at Road Camp No. 8502 (Murray 1945).

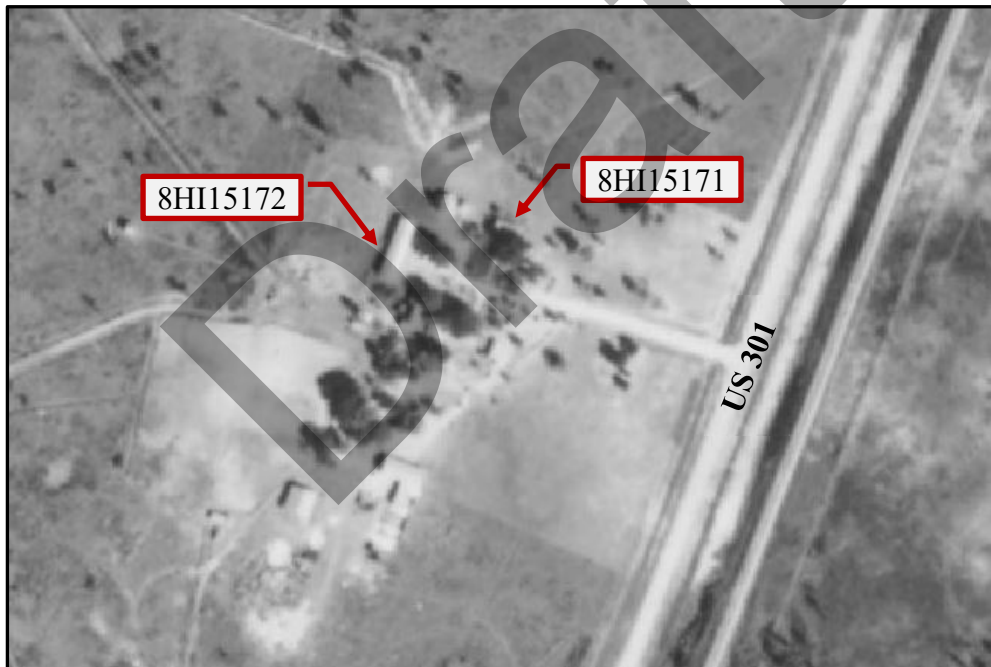
Photo 3. Aerial photograph depicting State Road Department Camp No. 8502 in 1941 (USDA 1941b). The extant contributing resources include a Frame Vernacular style building (8HI15171) and the mess hall (8HI15172).

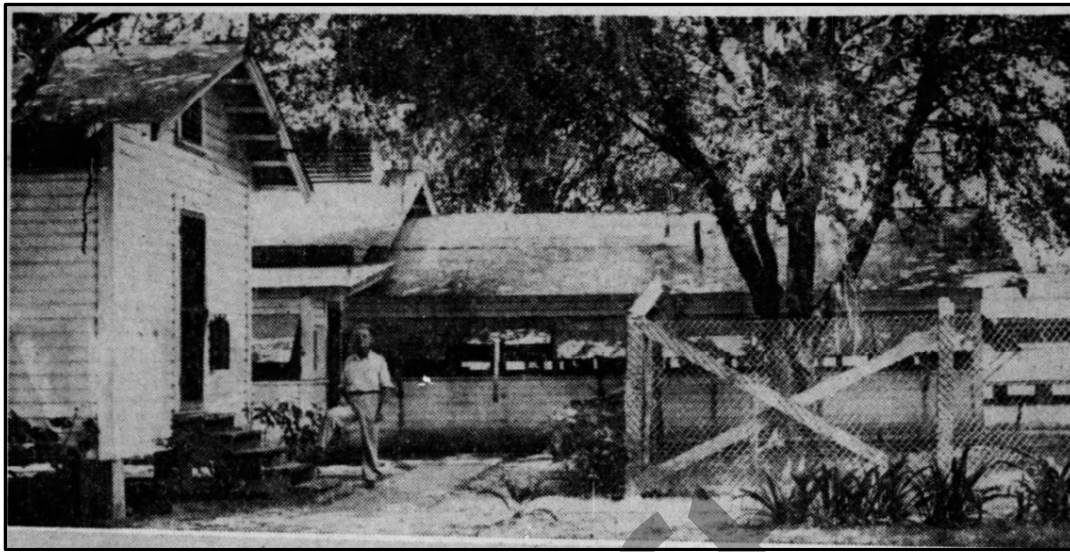
Despite the demolition of the majority of the buildings associated with State Road Department Camp No. 8502, the mess hall and ca. 1934 Frame Vernacular style building (8HI15171), likely used as living quarters, are the only remaining buildings within the State Road Department Camp No. 8502 (8HI15170) building complex resource group. Several non-historic outbuildings and agricultural equipment are located south of the main buildings. Overall, the building is largely intact and has been minimally altered since its use as a mess hall, as is evidenced by a ca. 1945 historic photograph of the building (**Photo 1**).

Photo 1. A ca. 1945 photograph depicting Road Camp No. 8502 with the commissary in the foreground (left) and a portion of the mess hall in the background (center to right) (Murray 1945).

Explanation of Evaluation: This resource, as well as the adjacent Frame Vernacular style building (8HI15171), are the only known examples of early road camp architecture remaining in the region. The only known additions or alterations were conducted during the building's use within the road camp and include two shed roof additions to expand the mess hall. With the exception of some deteriorated siding and roofing, the overall building remains a significant example of early twentieth century penal practices in the State of Florida which brought negative attention to the state for decades, eventually leading the modernization of facilities in the state. Although simple in appearance, the building is an extant example of the rudimentary construction methods utilized to house the convicts and personnel, and sheds light on the living conditions experienced as prisoners served their sentences at the camp. As a result, the resource appears eligible for listing in the NRHP under Criteria A and C in the areas of Law, Politics/Government, and Architecture as an example of prison road camp architecture commonly used throughout the state in early- to mid-twentieth century Florida.

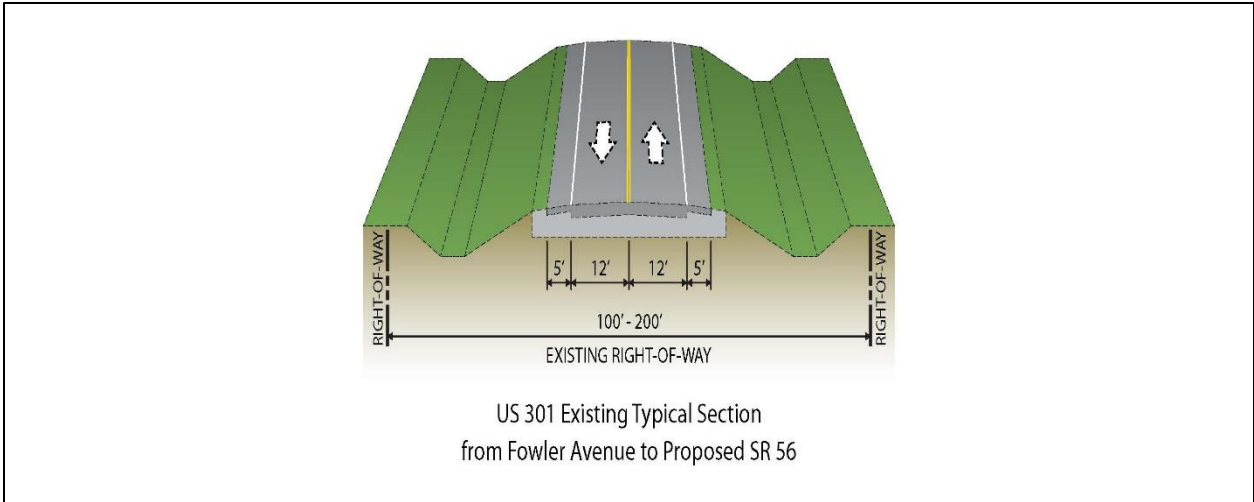
Figure 1. Existing US 301 Typical Section

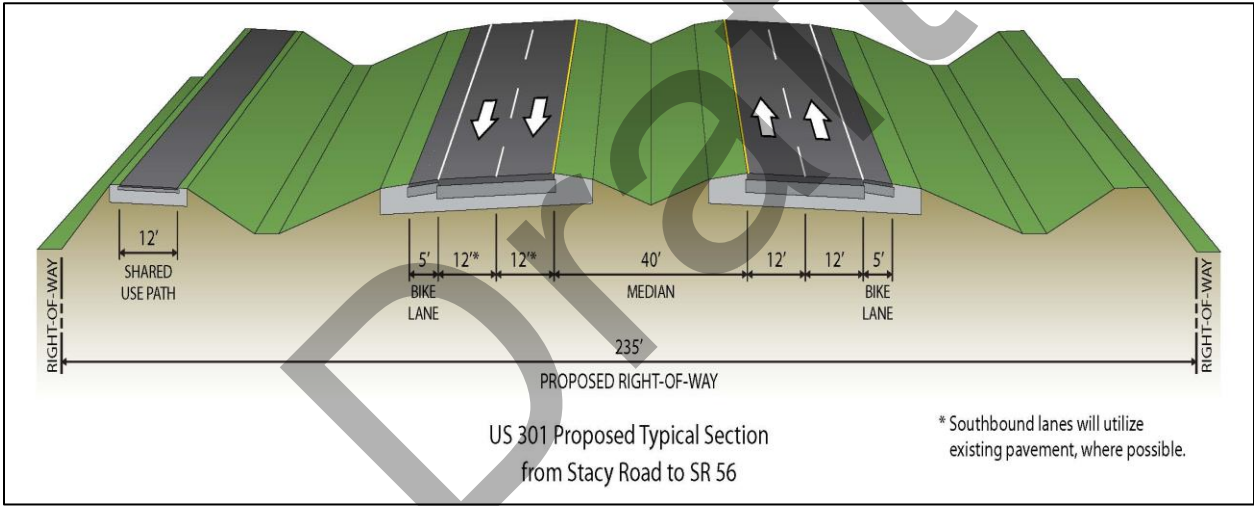
Figure 2. Proposed Rural Typical Section
