**CULTURAL RESOURCE ASSESSMENT SURVEY  
ADDENDUM  
TECHNICAL MEMORANDUM**

**PREFERRED STORMWATER MANAGEMENT FACILITY (SMF) &  
FLOODPLAIN COMPENSATION (FPC) SITES**

**US 301 from Fowler Avenue to SR 56  
Hillsborough & Pasco Counties, Florida**

**ETDM Number: 14194  
WPI Segment Number: 255796-1**

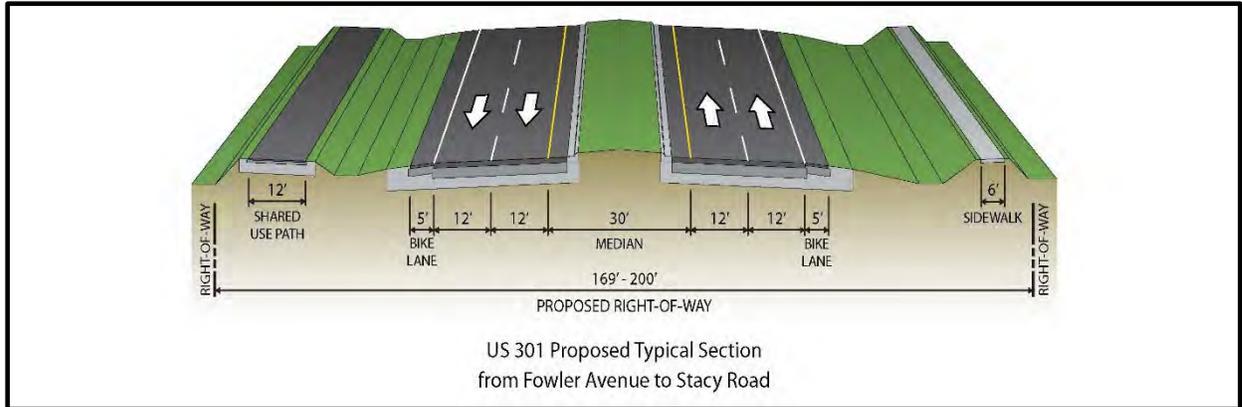
**Figure 2.** Proposed Suburban Typical Section.

The proposed build alternative is composed of two typical sections. A suburban typical section with a design speed of 55 mph is proposed from Fowler Avenue to Stacy Road. This typical section has two 12-ft travel lanes in each direction, a 30-ft raised median, 4-ft paved inside shoulders, and 5-ft paved outside shoulders. There is a 6-ft sidewalk on the east side of the roadway and a 12-ft shared use path on the west side of the road, as seen in **Figure 2**. The proposed ROW varies in width from 169 ft to 200 ft.

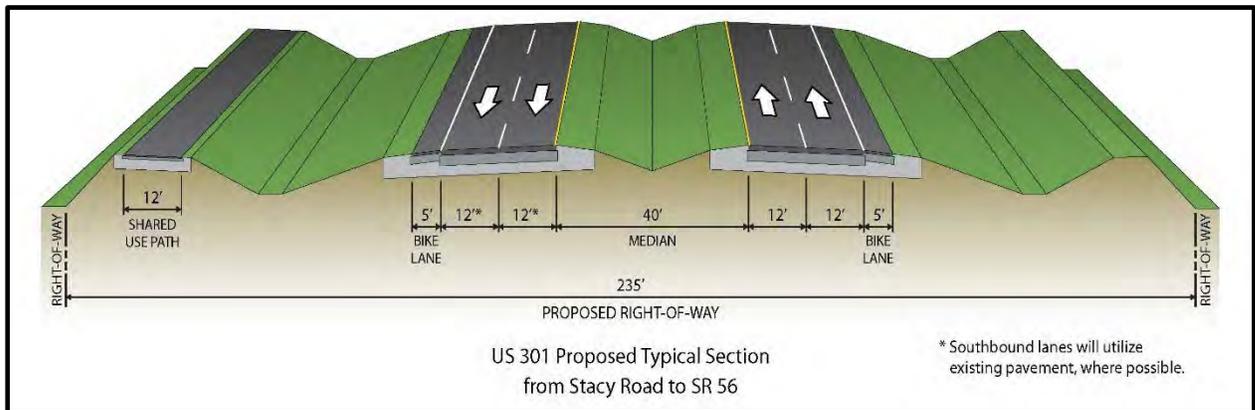
**Figure 3.** Proposed Rural Typical Section.

A rural typical section with a design speed of 65 mph is proposed from Stacy Road to SR 56. This typical section has two 12-ft travel lanes in each direction, a 40-ft depressed median, 8-ft unpaved inside shoulders, and 5-ft paved outside shoulders. There is a 12-ft shared use path on the west side of the roadway, as shown in **Figure 3**. The proposed ROW is 235 ft in width. Where possible, pavement savings will be achieved by converting the existing two-lane roadway to southbound operation.

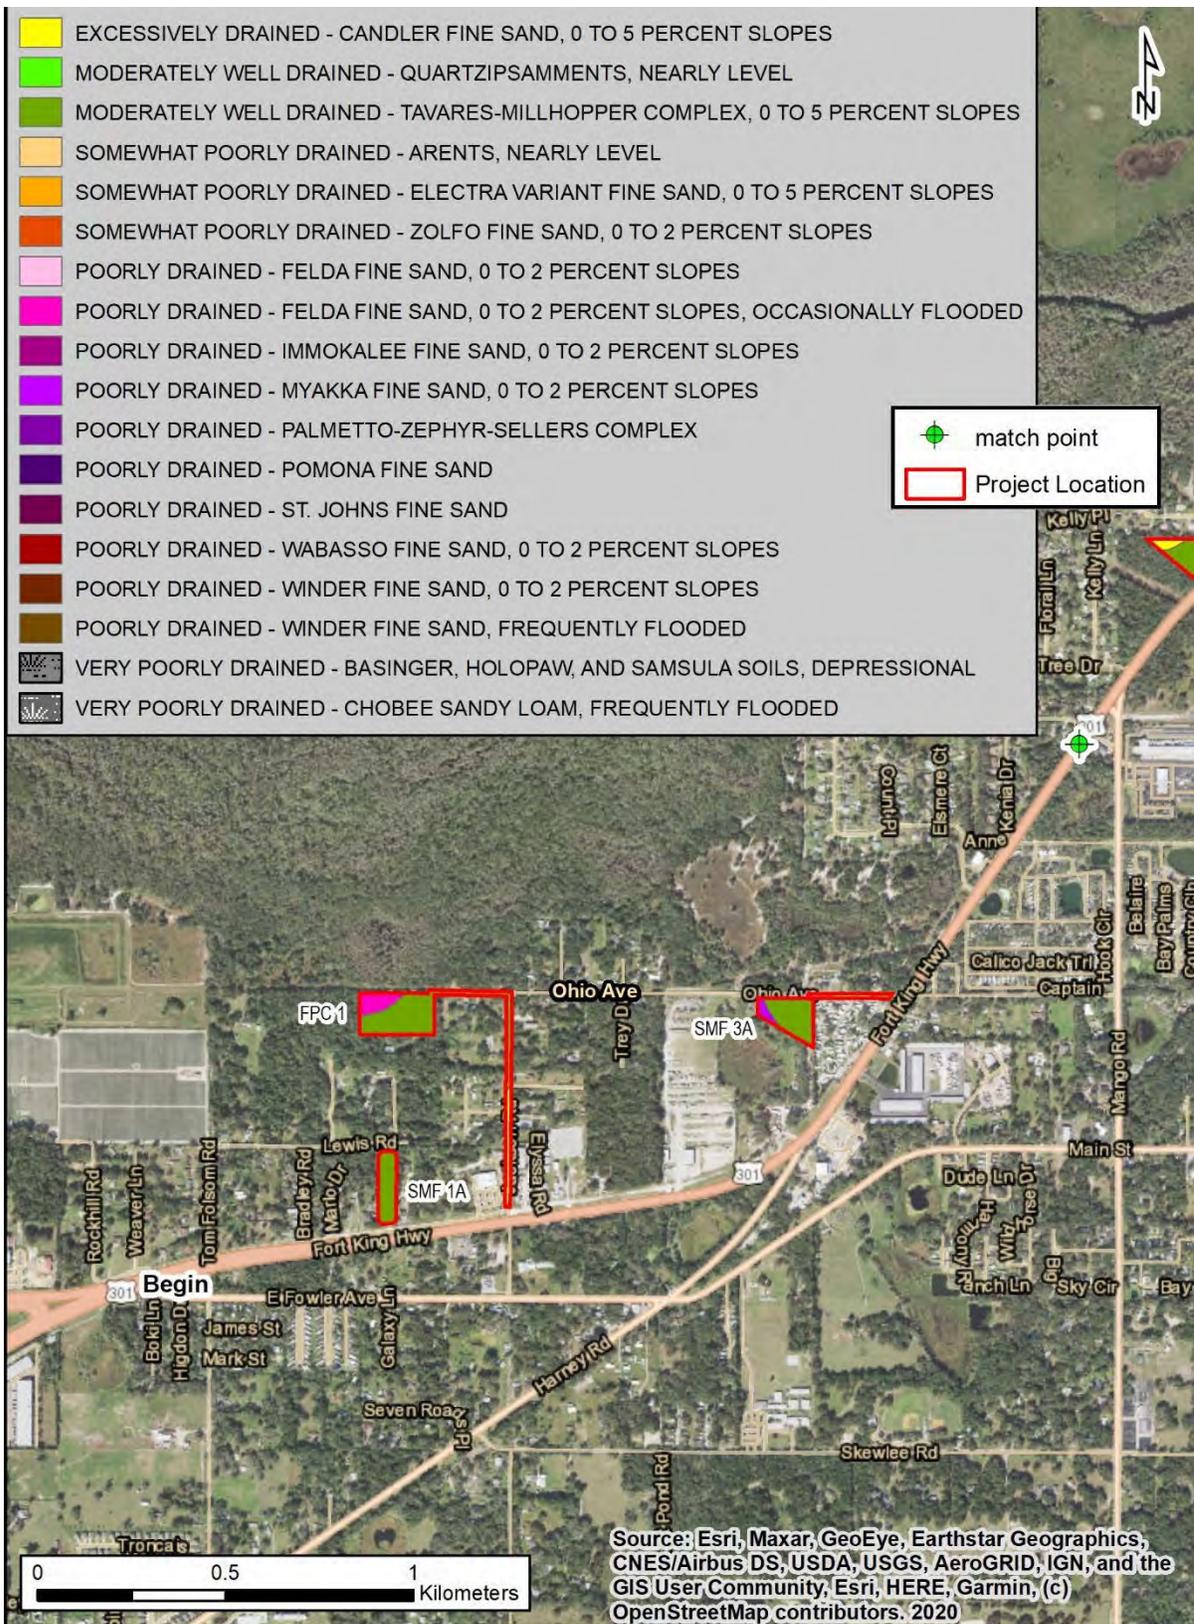
Figure 4. Soil types within the APE.

The Pasco County soil associations consist of Tavares-Sparr-Adamsville and Pomona-EauGallie-Sellers (USDA 1982). The former consists of soils of the uplands that are nearly level to sloping, moderately well and somewhat poorly drained. The natural vegetation consists of scattered longleaf pine, slash pine, turkey oak, blackjack oak, post oak, hickory, and sweetgum, with an understory of pineland threeawn, creeping bluestem, lopsided indiagrass, panicum, broomsedge, and scattered sawpalmetto. The Pomona-EauGallie-Sellers association occurs on the flatwoods and in depressions. These are nearly level, poorly and very poorly drained sandy or loamy soils. The flatwoods vegetation consists of longleaf and slash pine with an understory of sawpalmetto, waxmyrtle, inkberry, running oak, native grasses, and forbs. The vegetation of the depressions and swamps include dense stands of maidencane and St. Johnswort as well as mixed stands of cypress, bay, and gum trees (Stankey 1982). Specific soil types found in each of the pond sites are shown in **Figures 4-8**.

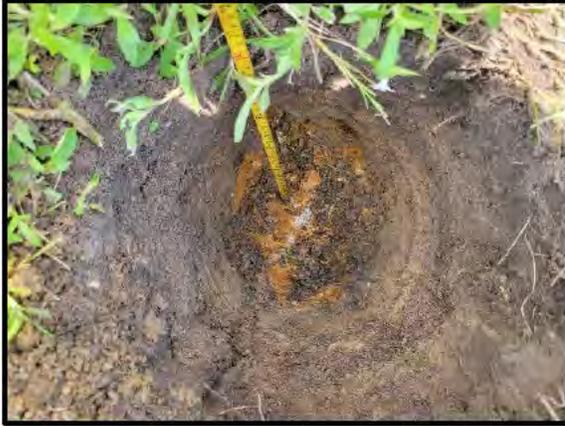
**Photo 11.** Compacted clay noted in SMF 1A.

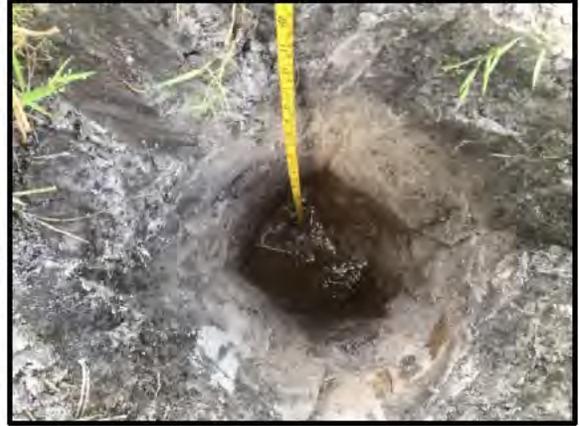
**Photo 12.** SMF 8A, note water seeping in.

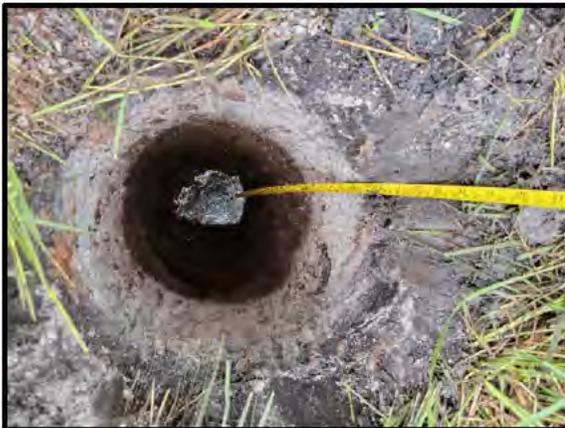
**Photo 13.** SMF 12A, dark brown is hard pan.

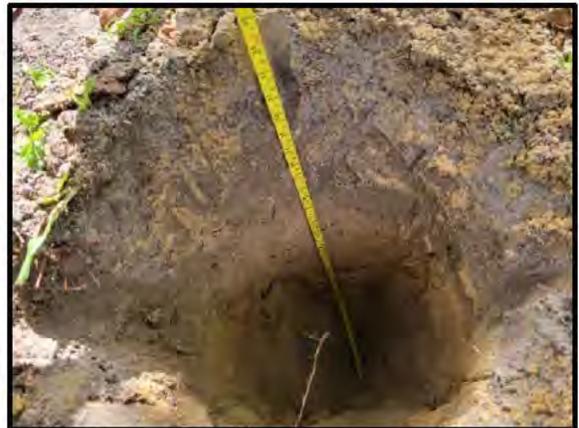
**Photo 14.** FPC 1, an area of well-drained soil.

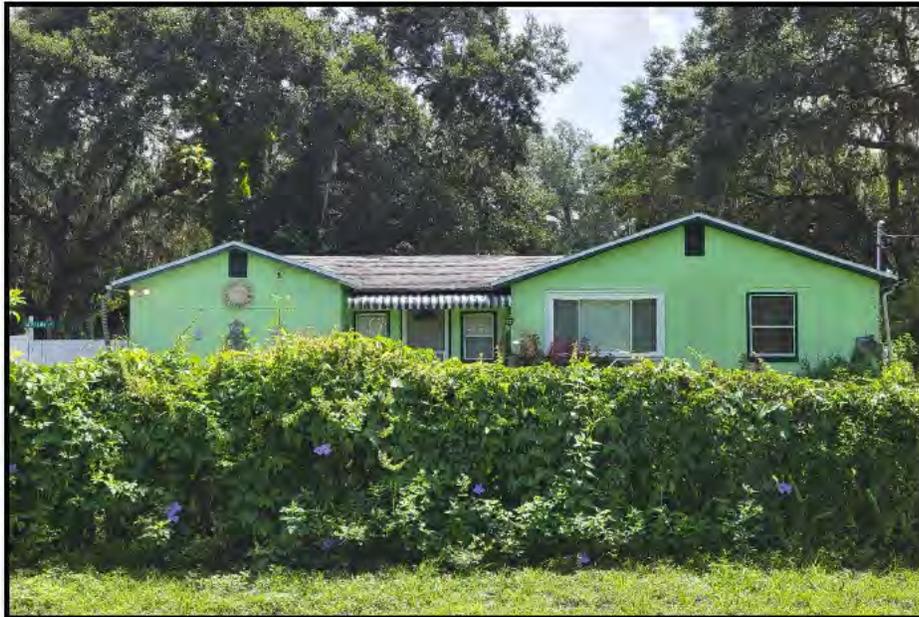
**Photo 23.** 12045 Jackson Road (8HI15143), looking east.

**8HI15143:** The Frame Vernacular style building at 12045 Jackson Road was constructed in ca. 1960 and is located adjacent to the FPC 1 easement along Jackson Road (**Photo 23**). The one-story, irregular plan building rests on a continuous concrete block foundation and has a wood frame structural system clad in stucco and plywood siding. The cross-gabled roof comprised of two front gables connected with a side gable segment is covered with composition shingles. The main entryway is on the west elevation through a single door with paneling, an inset light, and metal frame screen door beneath a metal clamshell awning. Visible windows include a mixture of individual, one-over-

one vinyl single-hung sash units and an individual vinyl picture unit comprised of a fixed central pane flanked by sliding units. Distinguishing architectural features include overhanging eaves with boxed rafter tails, rectangular gable vents, a metal clamshell awning, and wood trim around the windows and doors. Alterations include replacement roofing, windows, and siding, as well as the enclosure of an attached garage on the north side of the west elevation. A non-historic utility shed and carport are located to the east of the building. Overall, the building has been altered, lacks sufficient architectural features, and is not a significant embodiment of a type, period, or method of construction. In addition, background research did not reveal any historic associations with significant persons and/or events. As a result, 8HI15143 does not appear eligible for listing in the NRHP, either individually or as part of a historic district.

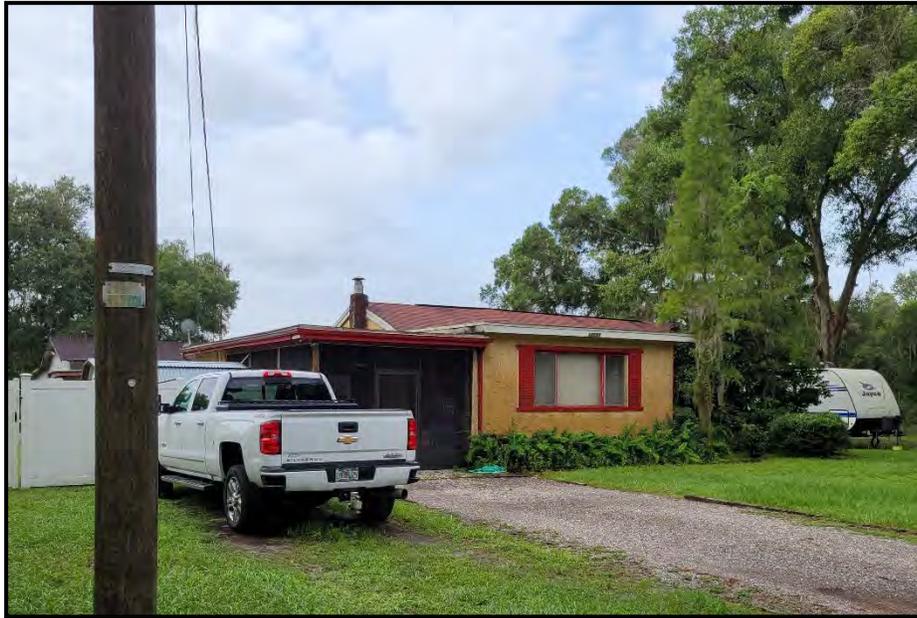
**Photo 24.** 10103 Ohio Avenue (8HI15144), looking south-southwest.

**8HI15144:** The Frame Vernacular style building at 10103 Ohio Avenue was constructed in ca. 1945 and is located adjacent to SMF 3A (**Photo 24**). The one-story, irregular plan building rests on a continuous concrete block foundation and has a wood frame structural system clad in heavily textured stucco. The side gable roof is covered with composition shingles, while the shed and flat roof additions are covered with built-up roofing. A masonry chimney is located on the gable end of the east elevation. The main entryway is on the north elevation through an obscured doorway within a partial width open porch beneath a flat roof with metal porch supports and screening. Visible windows include a mixture of individual, three-stacked and four-stacked metal awning units; individual wood picture units comprised of a central fixed pane flanked by jalousie units. Distinguishing architectural features include minimal eave overhang on the principal side gable roof, smooth stucco windowsills, shutters, and rectangular gable vents. Alterations include replacement roofing, windows, and siding, as well as the installation of shutters. A shed roof and flat roof addition are located on the north and east elevations, respectively, and a shed roof addition was also constructed on the south elevation. An inaccessible ca. 1965 utility shed/detached garage is located to the south of the building, as well as a non-historic above-ground swimming pool. Overall, the building has been altered, lacks sufficient architectural features, and is not a significant embodiment of a type, period, or method of construction. In addition, background research did not reveal any historic associations with significant persons and/or events. As a result, 8HI15144 does not appear eligible for listing in the NRHP, either individually or as part of a historic district.

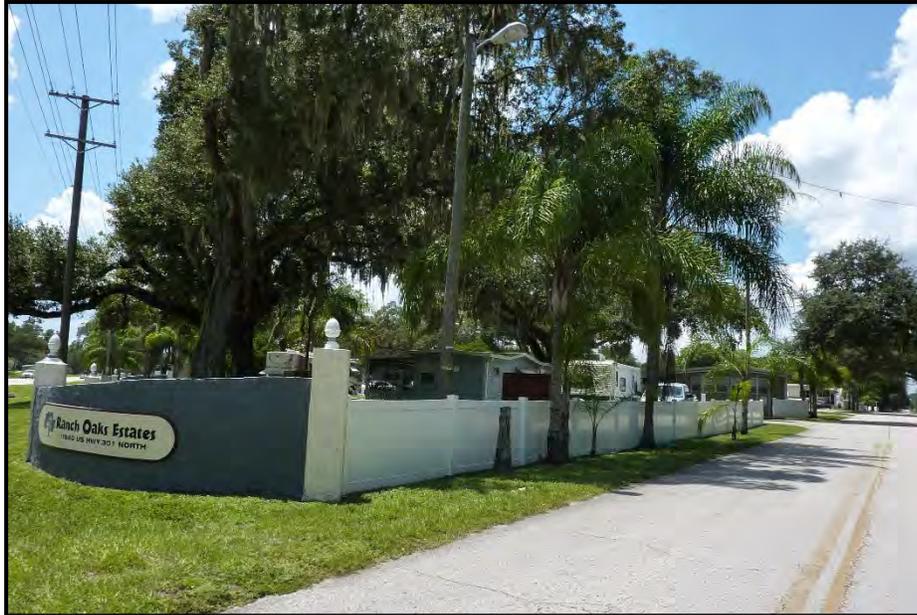
**Photo 25.** 11940 N US 301/Ranch Oaks Estates Mobile Home Park (8HI15145), looking southwest.

**8HI15145:** The Ranch Oaks Estates Mobile Home Park is a building complex resource group located at 11940 N US 301, adjacent to SMF 3A and the easement along Ohio Avenue (**Photo 25**). It is located in Section 9 of Township 28 South, Range 20 East (USGS Thonotosassa 1943). The Ranch Oaks Estates Mobile Home Park is a post-World War II era trailer park that was established by ca. 1965 and the current overall development includes approximately 82 lots (Henriquez 2021; FDOT 1965). Only the portion of the mobile home park that is located within the APE was recorded as it was beyond the scope of work for this CRAS to identify all resources within the entire MHP, and only representative mobile homes or permanent structures within the APE were evaluated. Within the boundaries of the resource group, as contained within the APE, there are two contributing resources. These include two representative mobile homes constructed between 1973 and 1975 (8HI15146 & 8HI15147).

The Ranch Oaks Estates Mobile Home Park is comprised of five main north-south streets and one primary east-west street with a loop spanning from east to west south of it. The building complex is bounded roughly by a triangle with N US 301 to the east, Ohio Avenue to the north, and extending approximately 0.19 miles along the property line south to N US 301. The mobile home park is approximately eight miles south of the Hillsborough River State Park. An analysis of historic aerial imagery reveals that the Ranch Oaks Estates Mobile Home Park began in ca. 1965 as four north-south streets located south of Ohio Avenue and connected to N US 301 by a primary east-west street, as well as a short east-west entry segment (FDOT 1965). The majority of the lots existing at this time had been filled. The Ranch Oaks Estates Mobile Home Park continued to expand westward and southward, with a southern east-west loop constructed in ca. 1975, until reaching the current configuration in ca. 1980 with mobile homes located south of the east-west loop (FDOT 1975, 1980). During the early 2000s several of the southernmost mobile homes – south of the east-west loop – were removed from the property and replaced with storage warehouses (Google Earth 2021). Community amenities are limited to a centrally located mobile home utilized as an office, a community laundry facility, and storage units located in the southernmost section of the building complex. Multiple lots are occupied by RVs rather than trailers or mobile homes.

The overall configuration and layout of the trailer park began by ca. 1965 and did not reach its full configuration until ca. 1980. Few alterations have occurred since the late 1970s with the exception of several historic mobile homes being replaced or removed and the addition of several mobile homes and storage units in the southernmost section of the resource group. The building complex resource group is limited to a basic layout with few community amenities and an office. The Ranch Oaks Estates Mobile Home Park is a common mobile home park found throughout Florida. The resource group is not a significant embodiment of a type, period, or method of construction and background research did not reveal any historic associations with significant persons and/or events. As a result, 8HI15145 does not appear eligible for listing in the NRHP, either individually or as part of a historic district.

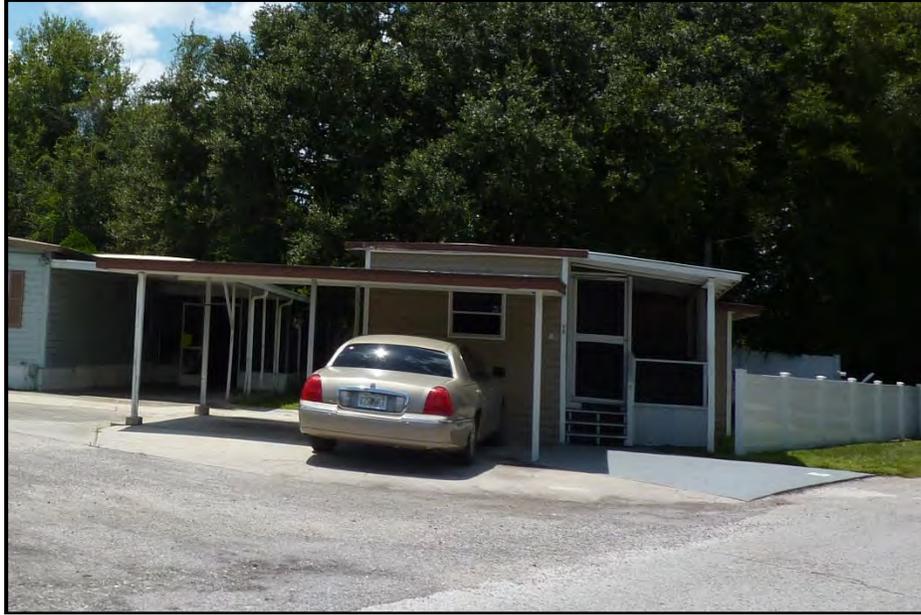
**Photo 26.** 11940 N US 301/Ranch Oaks Estates # 70 (8HI15146), looking southwest.

**8HI15146:** The mobile home at 11940 N US 301 was constructed in ca. 1975 and is located adjacent to SMF 3A and the easement along Ohio Avenue (**Photo 26**). The one-story, irregular plan building rests on an obscured pier foundation and has a wood frame structural system clad in vinyl siding. The flat roof is covered with corrugated sheet metal and has a gable-like projection at the mid-section, while the shed roofs are covered with 3V crimp sheet metal. The main entryway is on the north elevation through a single door with an inset nine-light fixed unit within a partial-width screened porch beneath a shed roof with metal porch supports. Visible windows include individual, one-over-one metal single-hung sash units. Distinguishing architectural features include overhanging eaves with boxed rafter tails and vinyl corner boards. Alterations include replacement roofing and siding. Additions include two shed roofs on the north elevation and a shed roof carport with metal supports on the east elevation. The mobile home and an additional ca. 1973 mobile home (8HI15147) are contributing resources within the Ranch Oaks Estates Mobile Home Park (8HI15145). Overall, the mobile home has been altered, lacks sufficient architectural features, and is not a significant embodiment of a type, period, or method of construction. In addition, background research did not reveal any historic associations with significant persons and/or events. As a result, 8HI15146 does not appear eligible for listing in the NRHP, either individually or as part of a historic district.

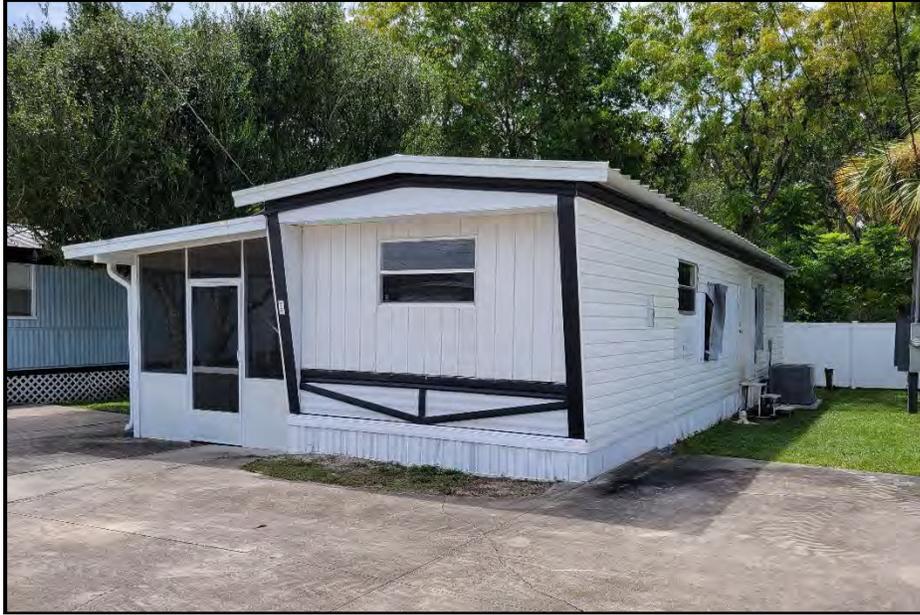
**Photo 27.** 11940 N US 301/Ranch Oaks Estates # 72 (8HI15147), looking west.

**8HI15147:** The mobile home at 11940 N US 301 was constructed in ca. 1973 and is located adjacent to SMF 3A (**Photo 27**). The one-story, irregular plan building rests on an obscured pier foundation and has a wood frame structural system clad in sections of aluminum, vinyl, and plywood siding. The front gable roof and shed roof are covered with standing seam sheet metal. The main entryway is on the south elevation through a single door with an inset diamond-shaped light within a partial-width screened porch beneath a shed roof with metal porch supports and a knee wall. Visible windows include individual, one-over-one metal single-hung sash units. Distinguishing architectural features include an overhanging roof line (roofing material only), a decorative gable projection with angled brackets on the east elevation, half-timbered style contrasting trim, and metal skirting. Alterations include replacement roofing, siding, and windows, and the removal of the original windows and shutters. Additions include the shed roof porch on the south elevation. The mobile home and an additional ca. 1975 mobile home (8HI15146) are contributing resources within the Ranch Oaks Estates Mobile Home Park (8HI15145). Overall, the mobile home has been altered, lacks sufficient architectural features, and is not a significant embodiment of a type, period, or method of construction. In addition, background research did not reveal any historic associations with significant persons and/or events. As a result, 8HI15147 does not appear eligible for listing in the NRHP, either individually or as part of a historic district.

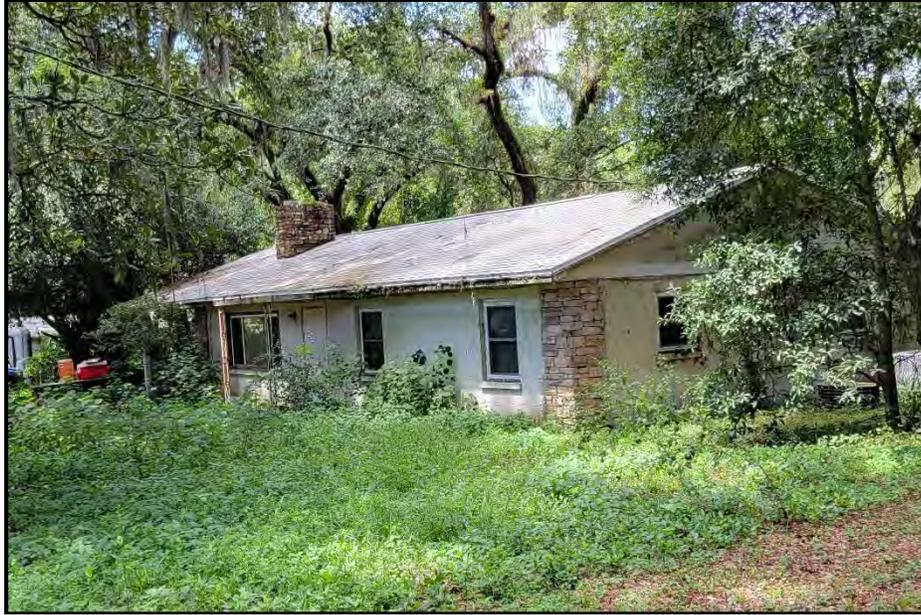
**Photo 28.** 13640 N US 301 (8HI15148), looking southwest.

**8HI15148:** The Masonry Vernacular style building at 13640 N US 301 was constructed in ca. 1958 and is located within FPC 3 (**Photo 28**). The one-story, irregular plan building rests on a continuous concrete block foundation and has a concrete block structural system with painted concrete block walls, vinyl siding in the gable ends, and artificial stone veneer accents. The side gable roof with a shed roof extension is covered with composition shingles. A masonry chimney with matching artificial stone veneer is located within the slope of the south elevation. The main entryway is on the south elevation through a single door with paneling within a partial width open porch beneath a shed roof extension with metal scroll porch supports. Visible windows include a mixture of individual, one-over-one vinyl single-hung sash units and an individual vinyl picture unit comprised of a central fixed pane flanked by sliding units. Distinguishing architectural features include overhanging eaves with boxed rafter tails, stucco windowsills, and decorative artificial stone veneer accents. Alterations include replacement roofing, windows, and siding. An integrated carport is located on the west side of the south elevation. A non-historic carport and modular/portable building are located on the property which is highly overgrown. Overall, the building has been altered, lacks sufficient architectural features, and is not a significant embodiment of a type, period, or method of construction. In addition, background research did not reveal any historic associations with significant persons and/or events. As a result, 8HI15148 does not appear eligible for listing in the NRHP, either individually or as part of a historic district.

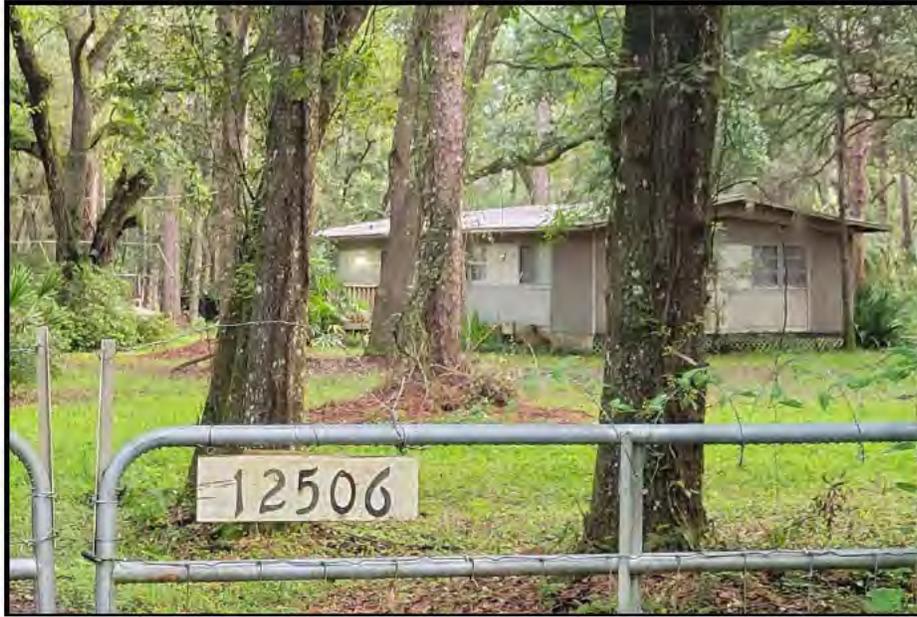
**Photo 29.** 12506 Avery Road (8HI15149), looking north.

**8HI15149:** The mobile home at 12506 Avery Road was constructed in ca. 1974 and is located within FPC 5 (**Photo 29**). The one-story, irregular plan building rests on an obscured pier foundation and has a wood frame structural system clad in aluminum and vinyl siding. The side gable roof is covered with composition shingles. The main entryway is on the west elevation and the view is obscured from the public ROW by vegetation and distance from the property line. Visible windows include a mixture of paired 3-stacked metal awning units; individual, six-over-six vinyl single-hung sash units; individual one-over-one vinyl sliding units. Distinguishing architectural features include overhanging eaves with boxed rafter tails, a decorative gable projection beneath the west eaves, and wooden lattice foundation trim. Alterations include replacement roofing, windows, and siding, and the installation of a wooden deck on the west elevation. Multiple non-historic utility sheds are located on the property. Overall, the mobile home has been altered, lacks sufficient architectural features, and is not a significant embodiment of a type, period, or method of construction. In addition, background research did not reveal any historic associations with significant persons and/or events. As a result, 8HI15149 does not appear eligible for listing in the NRHP, either individually or as part of a historic district.
