# CULTURAL RESOURCES ASSESSMENT SURVEY

**US 301** FROM FOWLER AVENUE TO PROPOSED SR 56  
Hillsborough and Pasco Counties  
WPI Segment No. 255796-1

Project Development and Environment Study

June 2017

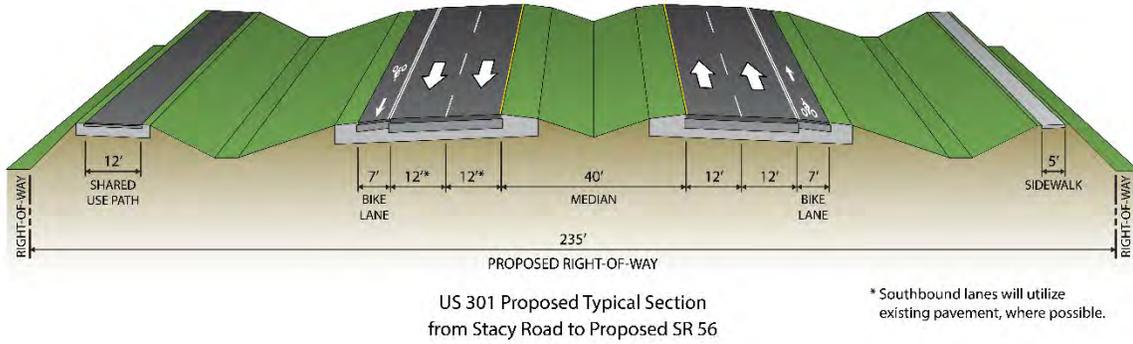
**Figure 1.4: Proposed Rural Typical Section**

A rural typical section with a design speed of 65 mph is proposed from Stacy Road to proposed SR 56. This typical section has two 12-ft travel lanes in each direction, a 40-ft depressed median, 8-ft unpaved inside shoulders, and 12-ft outside shoulders with 7-ft buffered bike lanes. There is a 5-ft sidewalk in the northbound direction and a 12-ft shared use path in the southbound direction; the proposed ROW is 235 ft in width. Where possible,

pavement savings will be achieved by converting the existing two-lane roadway to southbound operation. **Figure 1.4** illustrates the proposed rural typical section.

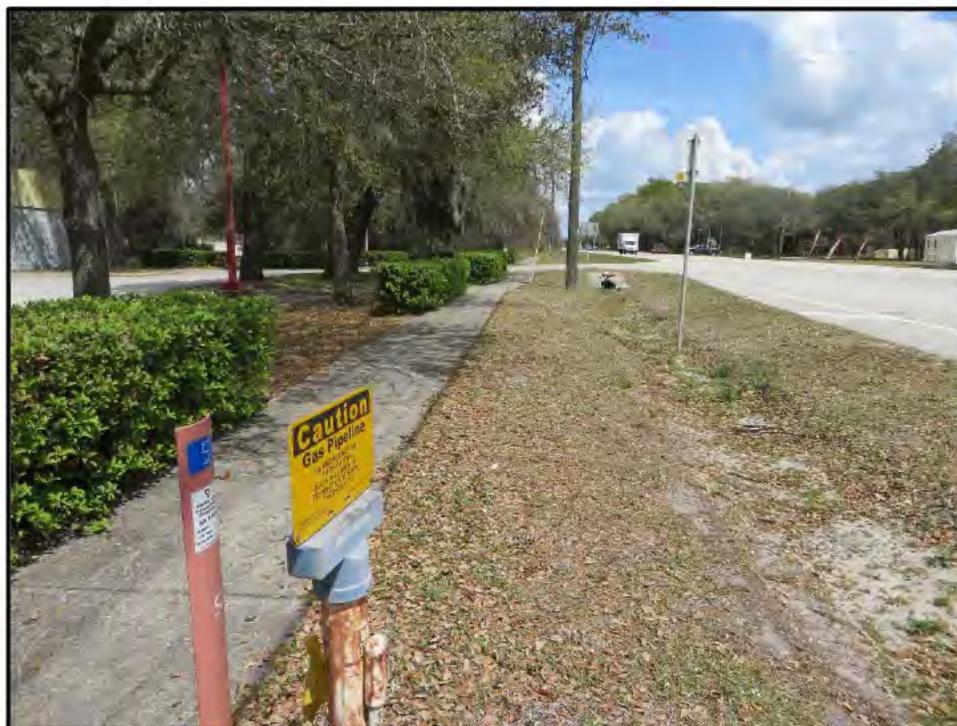
**Photo 4.1: Utility lines, ditch, and sidewalks in ZAP H**

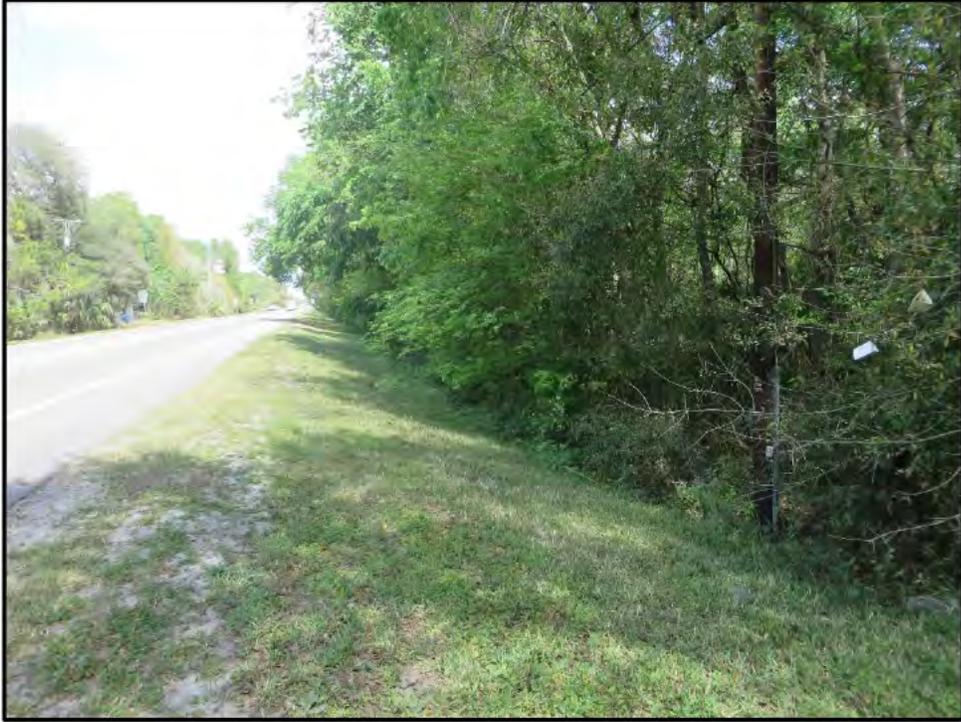
**Photo 4.2: Built up road berm to edge of ROW, ZAP AA**

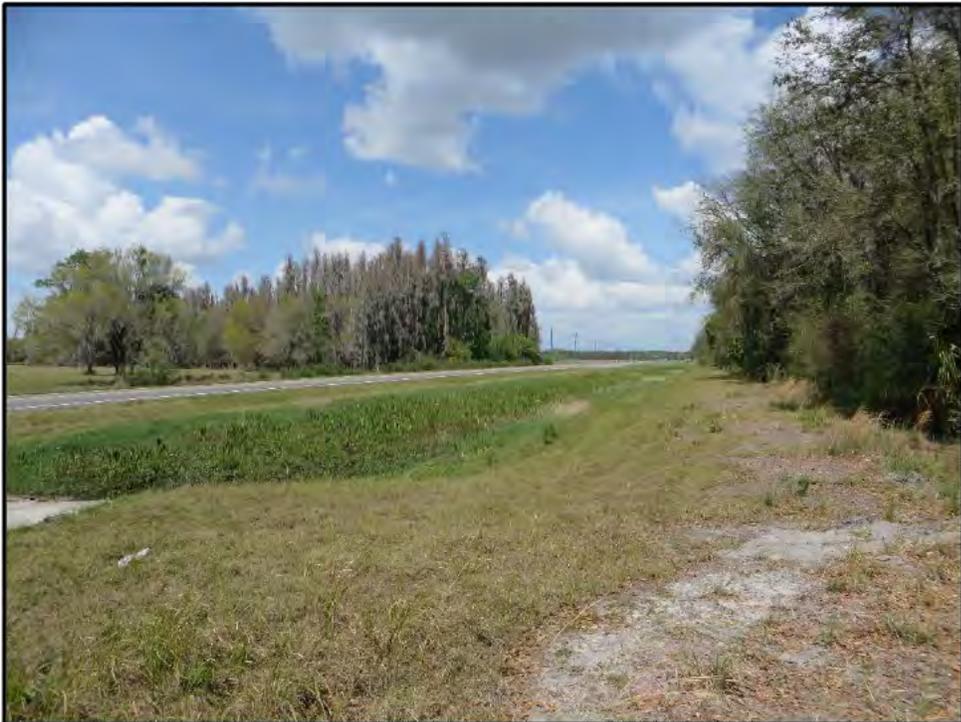
**Photo 4.3: Swale at ZAP LL**

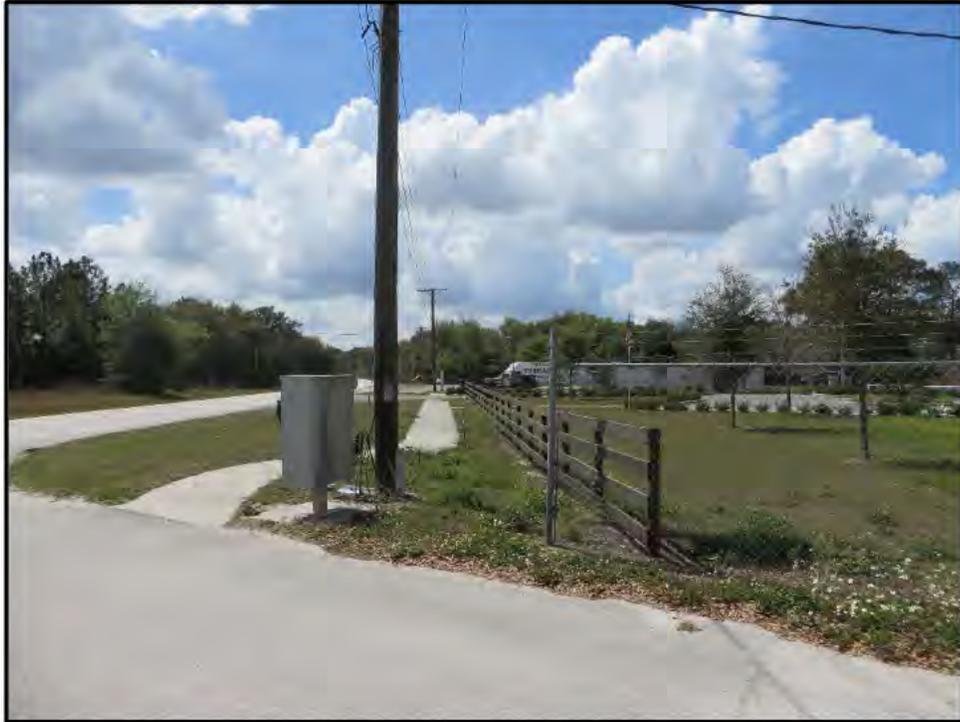
**Photo 4.4: Sidewalk, underground and above ground utilities, ZAP L**

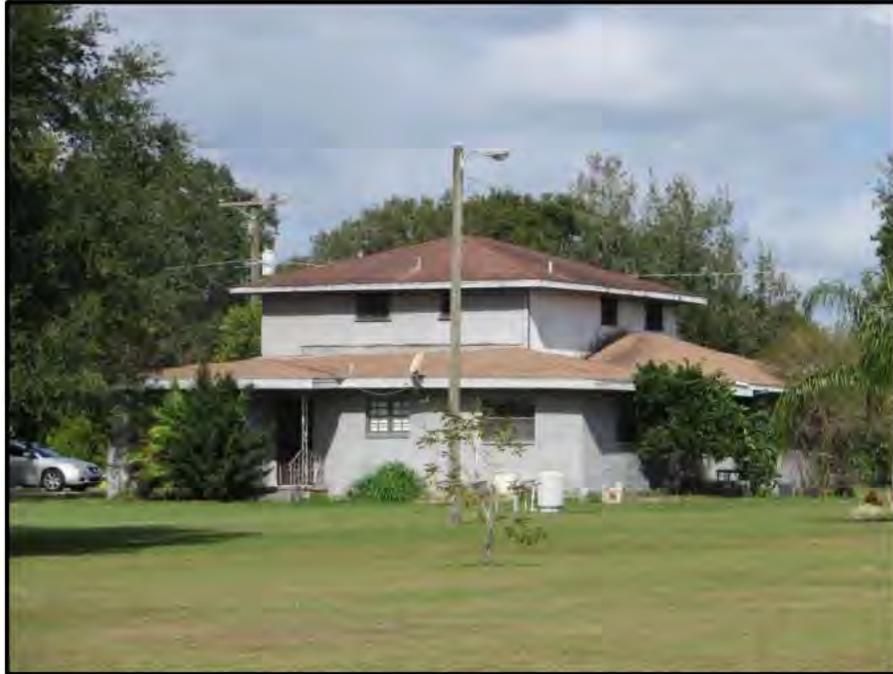
**Photo 5.5: 9546 Rockhill Road (8HI13503), looking north**

**8HI13503:** The Masonry Vernacular style building at 9546 Rockhill Road was constructed in 1960 (Photo 5.5). The two-story, square plan dwelling sits on a concrete slab foundation and has concrete block walls covered with stucco and wood siding. The multi-hipped roof is covered with composition shingles. The main entryway is on the west elevation through a single 8-panel wood door within a partial-width open front porch beneath a hipped roof overhang. The porch has Syrian arches supporting the hipped roof overhang on the northern, southern, and western sides. Windows are a mixture of paired and grouped 4/4 wood single-hung sash units and paired and independent 6/6 metal single-hung sash units. Several replacement windows were installed circa 1980. The building's second story appears to be a later addition that was likely constructed in the 1970's, and the primary façade appears to have changed several times (potentially due to the construction of the second story). The north elevation features two garage doors and a single wood door that do not appear to be in use; this elevation could have functioned as the primary façade at one point. There is also an additional entrance on the south elevation atop a concrete stoop within a partial-width open front porch beneath a hip roof with a decorative metal column and railing. However, judging by the active circular driveway and porch furniture on the western elevation, the western elevation was identified as the dwelling's current primary façade. Structural and decorative features include concrete window sills, a faux stone finish on the north elevation, extended eaves, and brick quoins on the northwest and southwest corners. There is a small animal pen about 10 meters north of the north elevation. The dwelling is in fair condition and retains little historic exterior fabric. Overall, it is a typical example of a Masonry Vernacular style building found throughout Hillsborough County, and research revealed no significant historic associations. As a result, 8HI13503 does not appear eligible for listing in the NRHP, either individually or as part of a historic district.

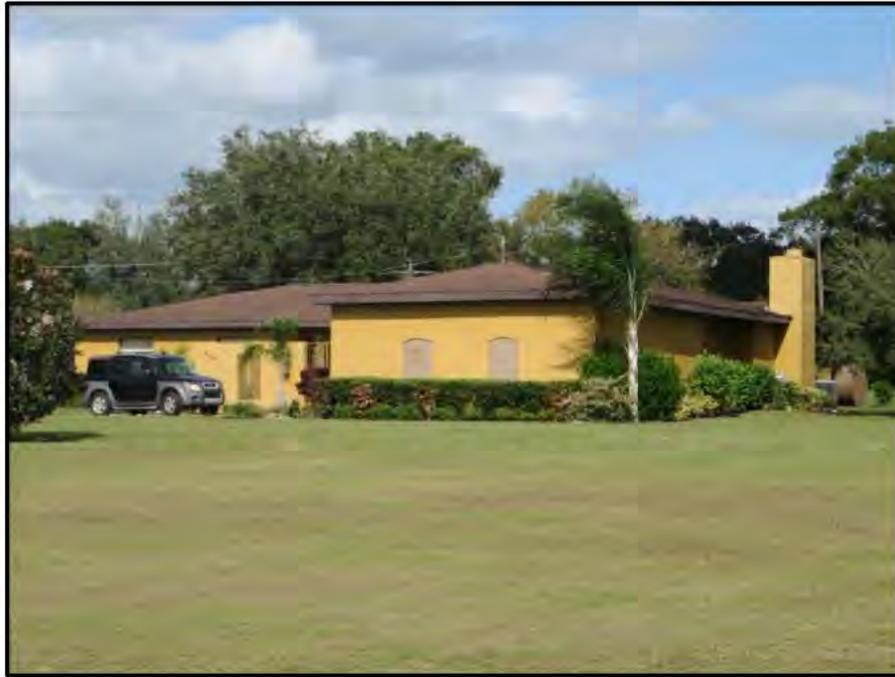
**Photo 5.6: 9614 Rockhill Road (8HI13504), looking north**

**8HI13504:** The Masonry Vernacular style building at 9614 Rockhill Road was constructed in 1963 (**Photo 5.6**). The one-story, L-shaped dwelling sits on a concrete slab foundation and has concrete block walls covered with stucco. The hip-on-hip roof is covered with composition shingles. The main entryway is on the south elevation through the south side of an entrance courtyard with a decorative iron gate. The partial width, partially enclosed patio/courtyard on the south elevation is walled off, and the walls are inset with decorative iron panels within arched window frames. Windows are a mixture of independent 1/1 metal single-hung sash units and independent metal fixed pane units. New windows were installed and fenestration changes were made to the building circa 1985. There is a concrete block chimney on the east elevation. Structural and decorative features include concrete window sills, extended eaves, and several arched window frames. There is a shed and several small outbuildings slightly north of the north elevation. The dwelling is in fair condition and retains some historic exterior fabric. Overall, however, it is a typical example of a Masonry Vernacular style building found throughout Hillsborough County, and research revealed no significant historic associations. As a result, 8HI13504 does not appear eligible for listing in the NRHP, either individually or as part of a historic district.

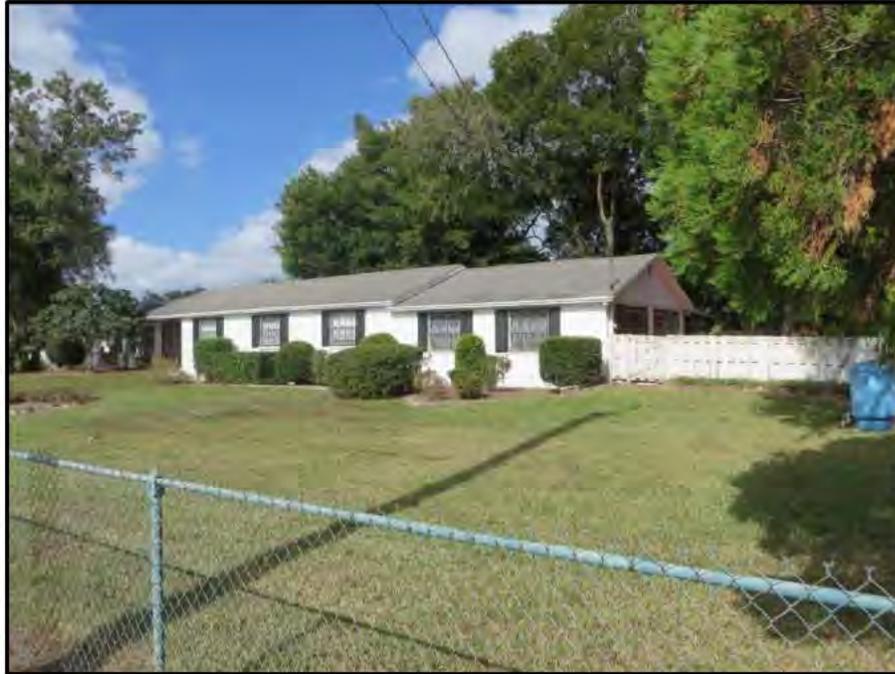
**Photo 5.7: 9646 Rockhill Road (8HI13505), looking north**

**8HI13505:** The Masonry Vernacular style building at 9646 Rockhill Road was constructed in 1965 (Photo 5.7). The one-story, rectangular dwelling sits on a concrete slab foundation and has concrete block walls partially covered with drop siding and a brick veneer. The stepped gable roof is covered with composition shingles. The main entryway is on the south elevation through a single door within a partial-width, partially inset open front porch clad in faux brick veneer beneath a gable roof supported by simple square wood posts. Windows are a mixture of independent 8/1 metal single-hung sash units and an independent 4-lite metal bow unit. Structural and decorative features include concrete window sills, extended eaves, faux shutters and decorative window grates. The dwelling is in good condition and retains its historic exterior fabric. Overall, however, it is a typical example of a Masonry Vernacular style building found throughout Hillsborough County, and research revealed no significant historic associations. As a result, 8HI13505 does not appear eligible for listing in the NRHP, either individually or as part of a historic district.

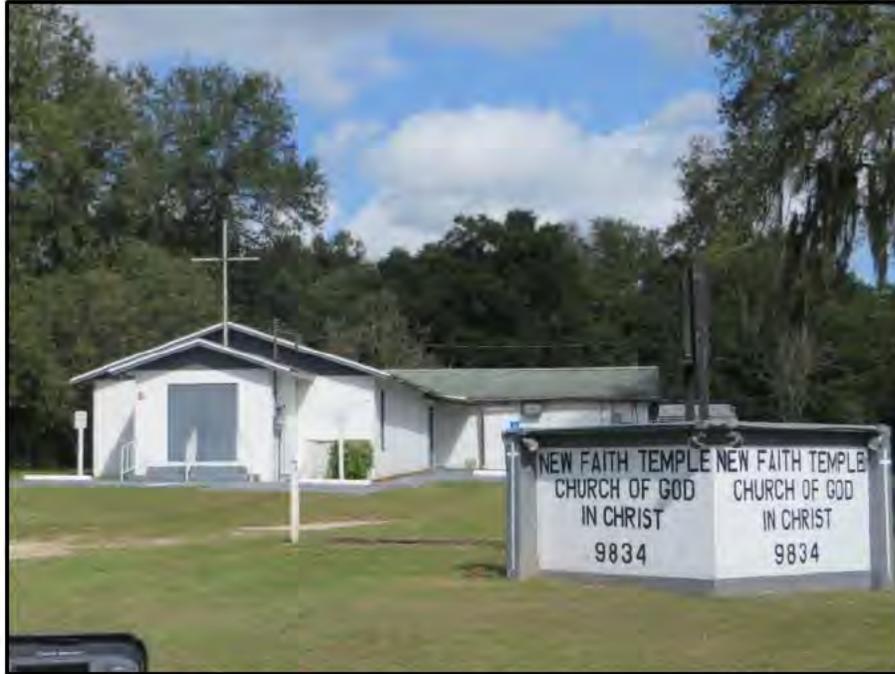
**Photo 5.8: 9834 Rockhill Road (8HI13506), looking north**

**8HI13506:** The Masonry Vernacular style building at 9834 Rockhill Road was constructed in 1935 (**Photo 5.8**). The one-story, L-shaped church sits on a concrete slab foundation and has concrete block walls partially covered with drop siding. The cross-gabled roof is covered with both asphalt and composition shingles. The main entrance is on the south elevation through a double composite door and opens on to a partial-width enclosed front porch beneath a gable roof overhang atop a concrete stoop with three simple metal railings. Windows are independent fixed pane metal pane units throughout. New doors and windows were installed circa 1975, the roof was partially resingled circa 1985, and the building was covered in new stucco circa 1995. Structural and decorative features include concrete window sills, extended eaves, and a metal roof ridge. The church is in fair condition and retains little historic exterior fabric. Overall, it is a typical example of a Masonry Vernacular style building found throughout Hillsborough County, and research revealed no significant historic associations. As a result, 8HI13506 does not appear eligible for listing in the NRHP, either individually or as part of a historic district.

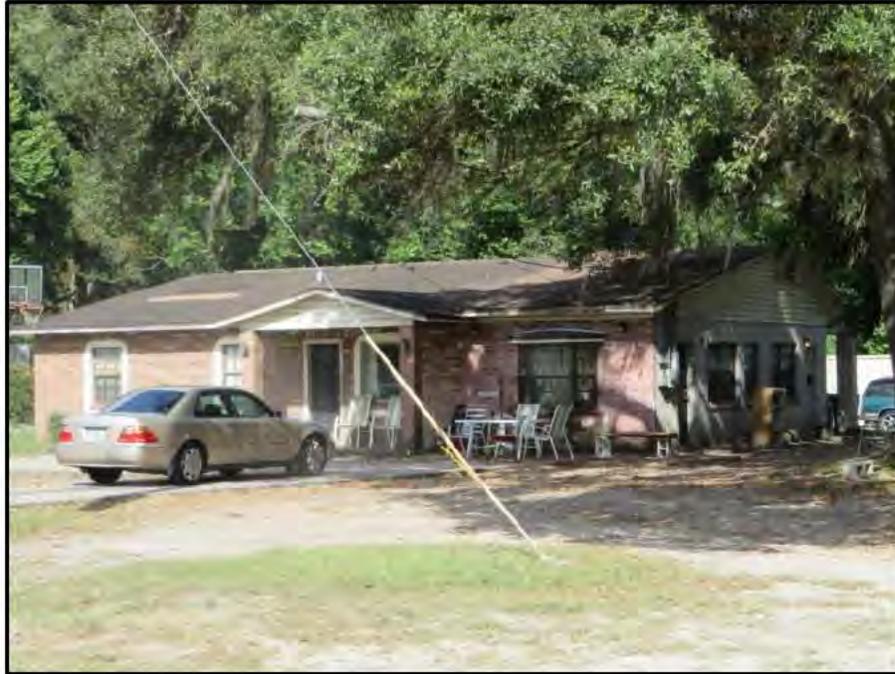
**Photo 5.9: 9870 Rockhill Road (8HI13507), looking north**

**8HI13507:** The Masonry Vernacular style building at 9870 Rockhill Road was constructed in 1958 (Photo 5.9). The one-story, rectangular plan dwelling sits on a concrete slab foundation and has concrete block walls covered with a combination of stucco, vinyl, and brick veneer. The gable roof is covered with both asphalt and composition shingles. The main entryway is on the south elevation through a single composite door with a fanlight within a partial-width open front porch beneath a gable roof overhang supported by brick columns. Windows are a mixture of independent 2/2, 4/4, and 6/6 metal single-hung sash units with snap-in muntins, one fixed pane picture unit, and one 3-lite metal bay unit. New windows were installed circa 1975, and since then the building's façade has been covered with a brick veneer (c. 1985), new doors have been installed (c. 1995) and the dwelling has been partially re-roofed (c. 2000). Structural and decorative features include concrete window sills, extended eaves, a metal roof ridge, and several rounded concrete window frames. The dwelling is in fair condition but retains little historic exterior fabric. Overall, it is a typical example of a Masonry Vernacular style building found throughout Hillsborough County, and research revealed no significant historic associations. As a result, 8HI13507 does not appear eligible for listing in the NRHP, either individually or as part of a historic district.

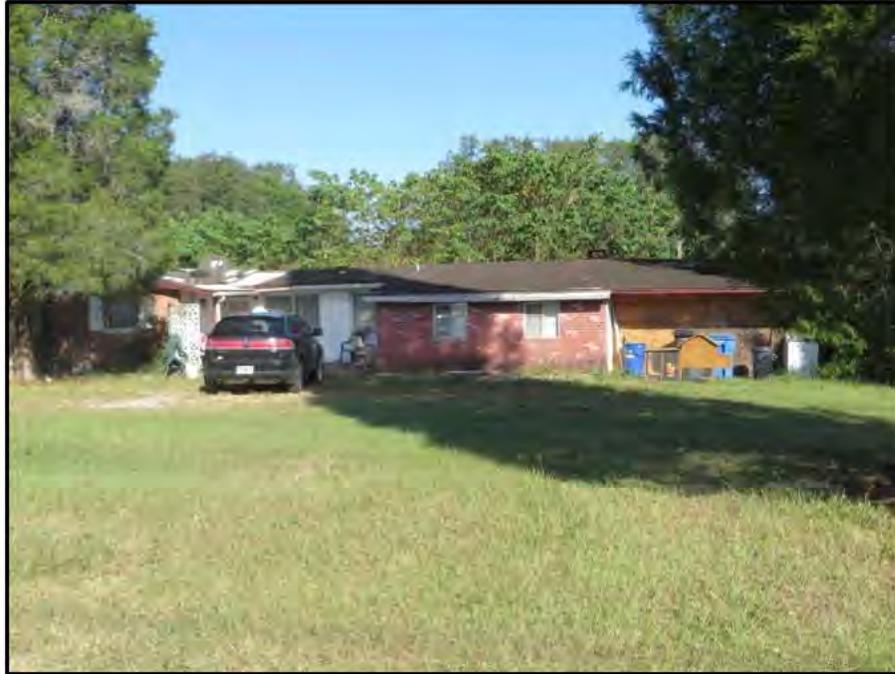
**Photo 5.10: 9830 East Fowler Avenue (8HI13508), looking north**

**8HI13508:** The Masonry Vernacular style building at 9830 East Fowler Avenue was constructed in 1961 (**Photo 5.10**). The one-story, rectangular plan dwelling sits on a concrete slab foundation and has concrete block walls partially covered with a brick veneer and plywood. The cross-gabled roof is covered with asphalt shingles. The main entryway is on the south elevation through a single wood door which is somewhat hidden behind a curved decorative CMU block screen wall that also obscures a portion of the partial-width inset open front porch. Windows are all aluminum and are a mixture of independent 2-lite slider units, paired 3-lite jalousie units, and an independent 1/1 single-hung sash unit. Fenestration changes were made to the building circa 2010. There is a brick chimney on the slope of the side gable roof that appears to be partially dismantled. Structural and decorative features include concrete window sills, extended eaves, a partial decorative CMU block screen wall, and faux shutters. The dwelling is in fair condition and retains some historic exterior fabric. Overall, however, it is a typical example of a Masonry Vernacular style building found throughout Hillsborough County, and research revealed no significant historic associations. As a result, 8HI13508 does not appear eligible for listing in the NRHP, either individually or as part of a historic district.

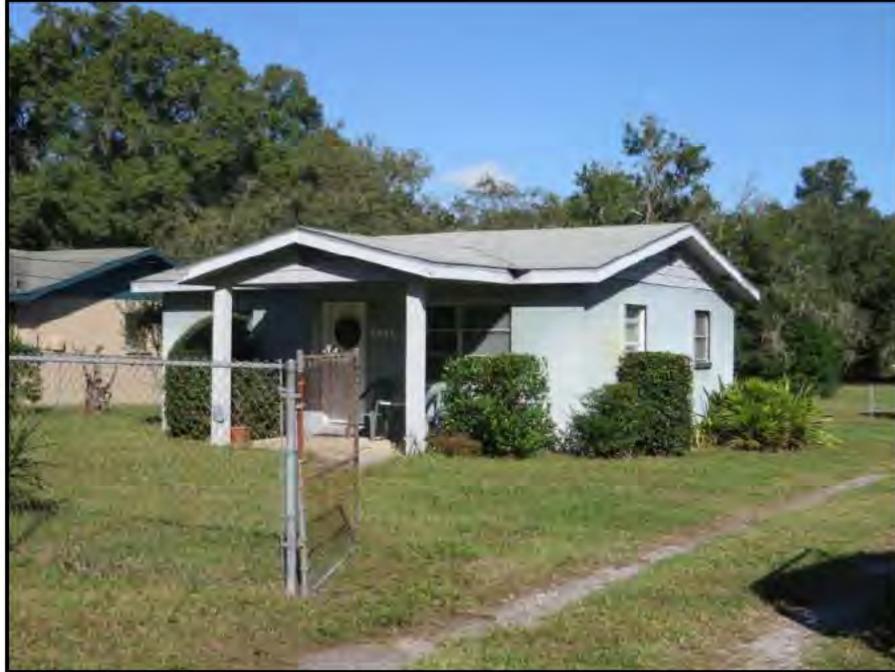
**Photo 5.11: 9908 East Fowler Avenue (8HI13509), looking north**

**8HI13509 (Photo 5.11):** The Masonry Vernacular style building at 9908 East Fowler Avenue was constructed in 1959. The one-story, square plan dwelling sits on a concrete slab foundation and has concrete block walls partially covered with wood siding. The cross-gabled roof is covered with composition shingles. The main entryway is on the south elevation through a single composite door within a partial-width open front porch beneath a gable roof overhang supported by squared CMU columns. Windows are a mixture of independent aluminum and vinyl 1/1 single-hung sash units and paired aluminum 3-lite jalousie units. The dwelling was outfitted with a new door, several new windows, and a new roof circa 2000. Structural and decorative features include concrete window sills, extended eaves, and attic louvers. The dwelling is in fair condition and retains most of its historic exterior fabric. Overall, however, it is a typical example of a Masonry Vernacular style building found throughout Hillsborough County, and research revealed no significant historic associations. As a result, 8HI13509 does not appear eligible for listing in the NRHP, either individually or as part of a historic district.

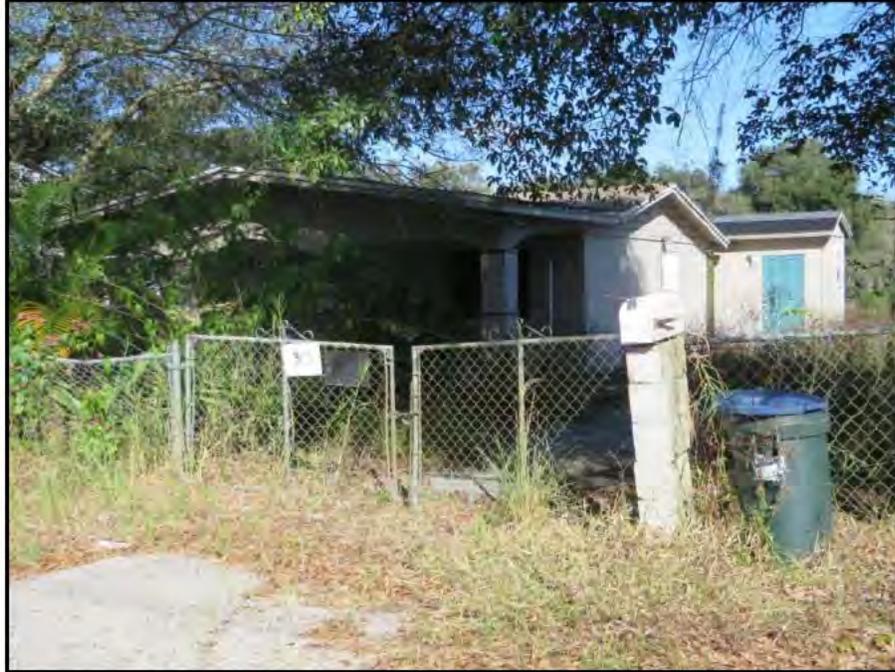
**Photo 5.12: 9916 East Fowler Avenue (8HI13510), looking north**

**8HI13510:** The Masonry Vernacular style building at 9916 East Fowler Avenue was constructed in 1960 (Photo 5.12). The one-story, square plan dwelling sits on a concrete slab foundation and has concrete block walls partially covered with wood siding. The cross-gabled roof is covered with composition shingles. The main entryway is on the south elevation through a single composite door within a full-width open front porch beneath a gable roof overhang supported by squared concrete columns clad in stucco. Windows are a mixture of independent metal and vinyl 1/1 single-hung sash and independent 2-lite slider units. The dwelling was outfitted with some new windows circa 1980, and fenestration changes were made to the building circa 1995. Structural and decorative features include concrete window sills, extended eaves, and attic louvers. There is a wooden shed slightly northeast of the building. The dwelling is in fair condition and retains some of its historic exterior fabric. Overall, however, it is a typical example of a Masonry Vernacular style building found throughout Hillsborough County, and research revealed no significant historic associations. As a result, 8HI13510 does not appear eligible for listing in the NRHP, either individually or as part of a historic district.

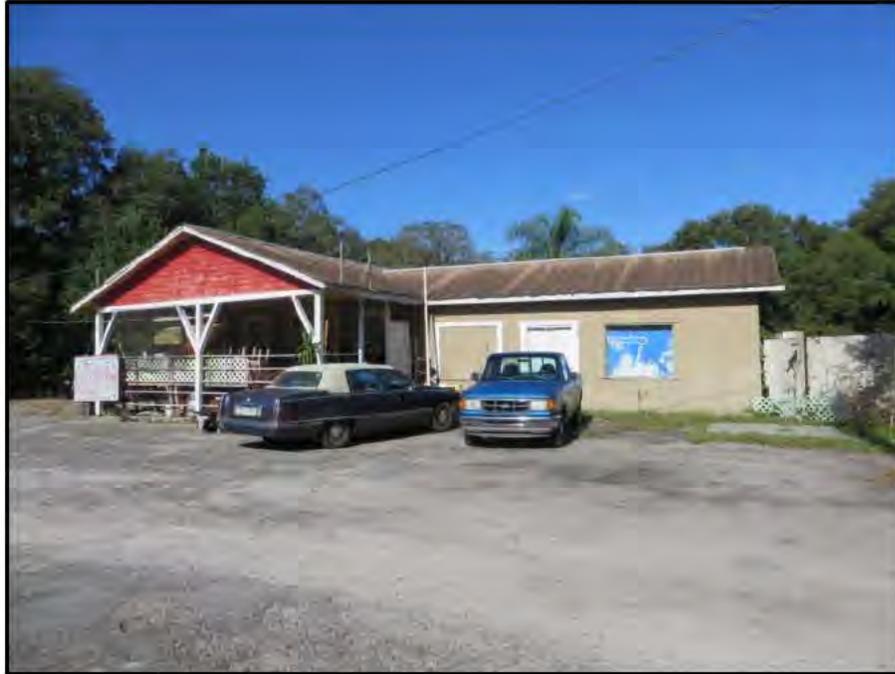
**Photo 5.13: 10330 Harney Road (8HI13511), looking north**

**8HI13511:** The Frame Vernacular style building at 10330 Harney Road was constructed in 1937 (Photo 5.13). The one-story, Latin cross plan building sits on a concrete slab foundation and has a wood frame structural system clad in wood siding with a concrete block wall addition on the east elevation added circa 1955. The cross-gabled roof is covered with a composition roll membrane. The main entryway is on the south elevation through a single door beneath a vinyl awning towards the southwestern corner of the building. There is a partial-width open front porch adjacent to the main entrance on the south elevation beneath a gable roof overhang supported by Stick style wood posts and brackets. Visible windows are independent wood 1/1 single-hung sash. The building was reroofed circa 1975, and fenestration changes were made to the building circa 1995. Structural and decorative features include wood window frames, extended eaves, attic louvers, a metal roof ridge, and a vinyl awning. The building is in fair condition and retains some of its historic exterior fabric. Overall, however, it is a typical example of a Frame Vernacular style building found throughout Hillsborough County, and research revealed no significant historic associations. As a result, 8HI13511 does not appear eligible for listing in the NRHP, either individually or as part of a historic district.

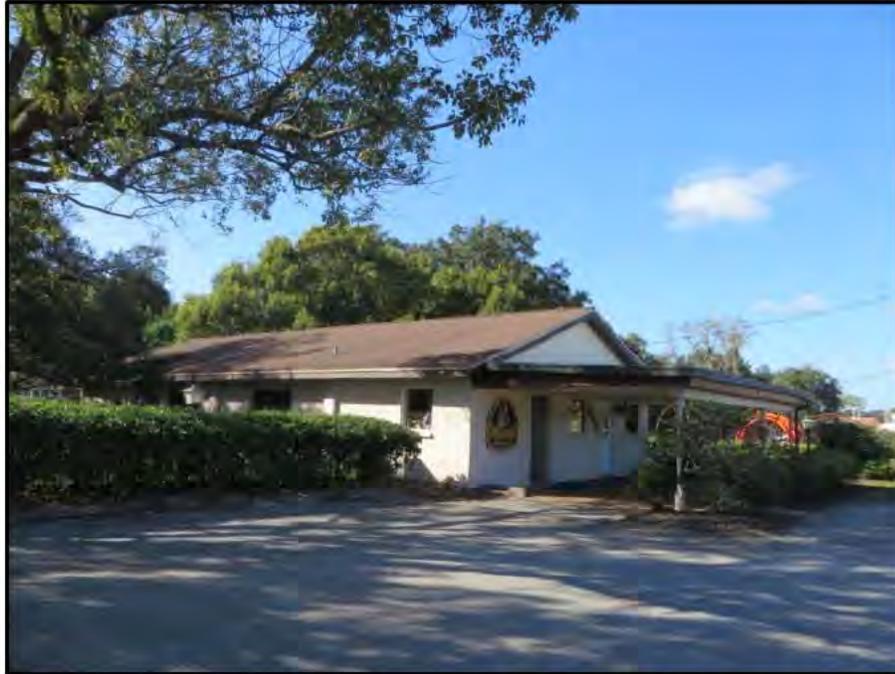
**Photo 5.14: 11499 N. US Highway 301 (8HI13512), looking west**

**8HI13512:** The Masonry Vernacular style building at 11499 N. US Highway 301 was constructed in 1964 (**Photo 5.14**). The one-story, rectangular plan veterinary hospital sits on a concrete slab foundation and has concrete block walls covered with a combination of vinyl siding, stucco, and concrete tiles. The gable roof is clad in composition shingles, while the shed roof overhang is covered with a built-up roof membrane. The main entryway is on the south elevation through an entry vestibule within a full-width open front porch beneath a shed roof overhang supported by decorative wooden posts. Windows are independent fixed pane units throughout. The building was outfitted with some new siding and reroofed circa 1995. Structural and decorative features include concrete window sills, extended eaves, and concrete piers. The dwelling is in good condition and retains some of its historic exterior fabric. Overall, however, it is a typical example of a Masonry Vernacular style building found throughout Hillsborough County, and research revealed no significant historic associations. As a result, 8HI13512 does not appear eligible for listing in the NRHP, either individually or as part of a historic district.

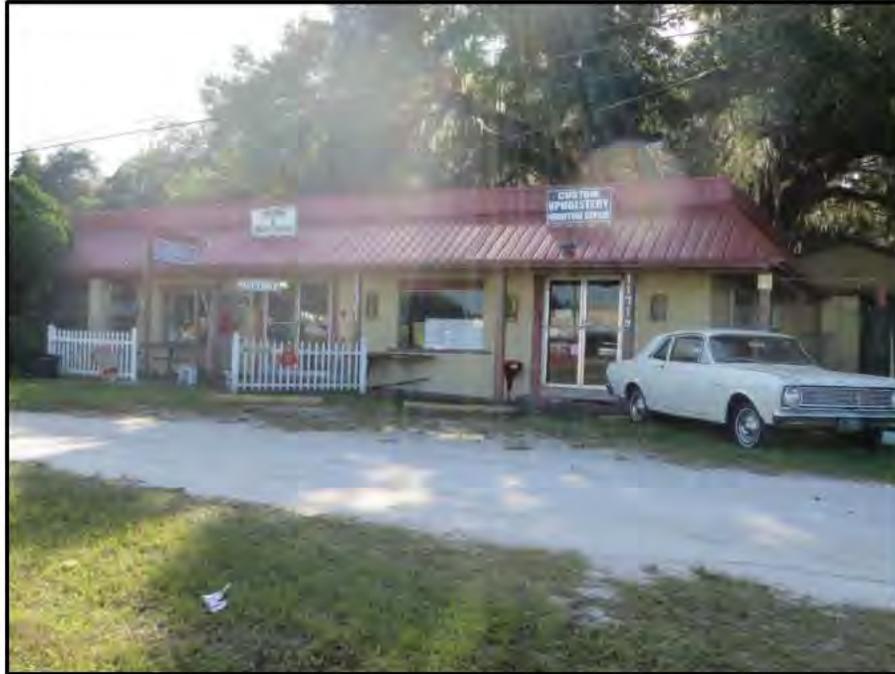
**Photo 5.15: 11719 N. US Highway 301 (8HI13513), looking south**

**8HI13513:** The Frame Vernacular style building at 11719 N. US Highway 301 was constructed in 1935 (**Photo 5.15**). The one-story, irregular plan commercial/residential building sits on a concrete slab foundation and has a wood frame structural system covered in stucco. The hip roof is covered with standing seam sheet metal panels, while the flat roof is covered with a built-up roof membrane. There are two entryways on the north elevation through double metal doors within a full-width wraparound open front porch beneath a hip roof supported by simple square posts. Windows are a combination of independent fixed pane picture units and independent and paired 4-lite jalousie units. The building was outfitted with new doors and windows circa 1975, and the hip roof was reroofed circa 2005. Structural and decorative features include brick window sills and lintels, a faux parapet along the hip roof, and faux shutters. The building is in fair condition and retains some of its historic exterior fabric. Overall, however, it is a typical example of a Frame Vernacular style building found throughout Hillsborough County, and research revealed no significant historic associations. As a result, 8HI13513 does not appear eligible for listing in the NRHP, either individually or as part of a historic district.

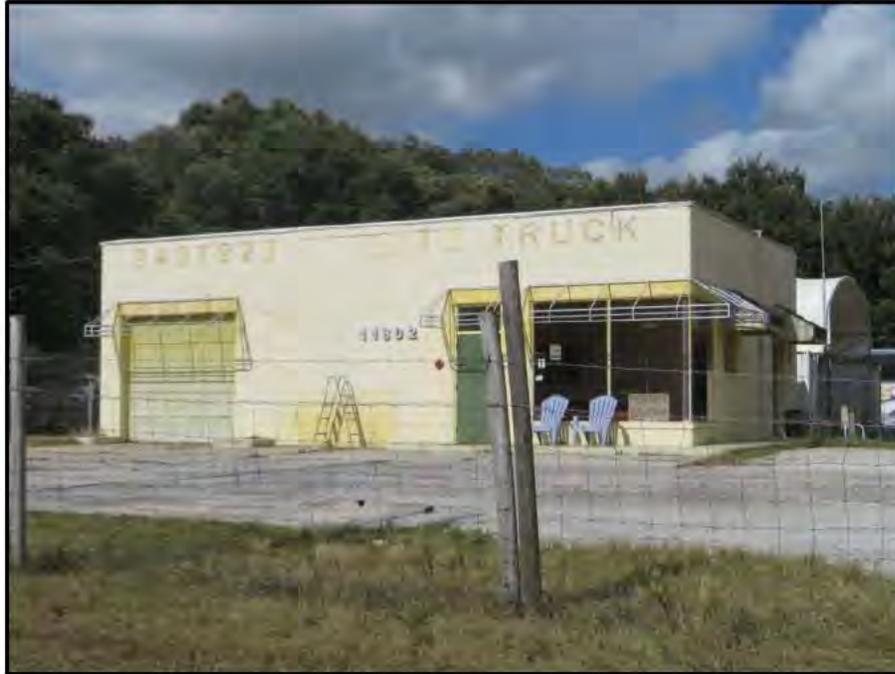
**Photo 5.16: 11802 N. US Highway 301 (8HI13514), looking north**

**8HI13514:** The Masonry Vernacular style building at 11802 N. US Highway 301 was constructed in 1955 (**Photo 5.16**). The one-story, rectangular plan former service station sits on a concrete slab foundation and has concrete block walls. The flat roof is covered with a built-up roof membrane. The main entryway is on the south elevation through a single composite door with a transom above within a partial-width wraparound open front porch/patio beneath a vinyl awning frame. Windows are a combination of grouped fixed pane picture units and paired 3-lite casement units. The building was outfitted with new doors circa 1990. Structural and decorative features include metal coping and vinyl awnings. There is a large storage area/garage structure with a steel framed curved roof directly north of the building. The building is in fair condition and retains most of its historic exterior fabric. Overall, however, it is a typical example of a Masonry Vernacular style building found throughout Hillsborough County, and research revealed no significant historic associations. As a result, 8HI13514 does not appear eligible for listing in the NRHP, either individually or as part of a historic district.

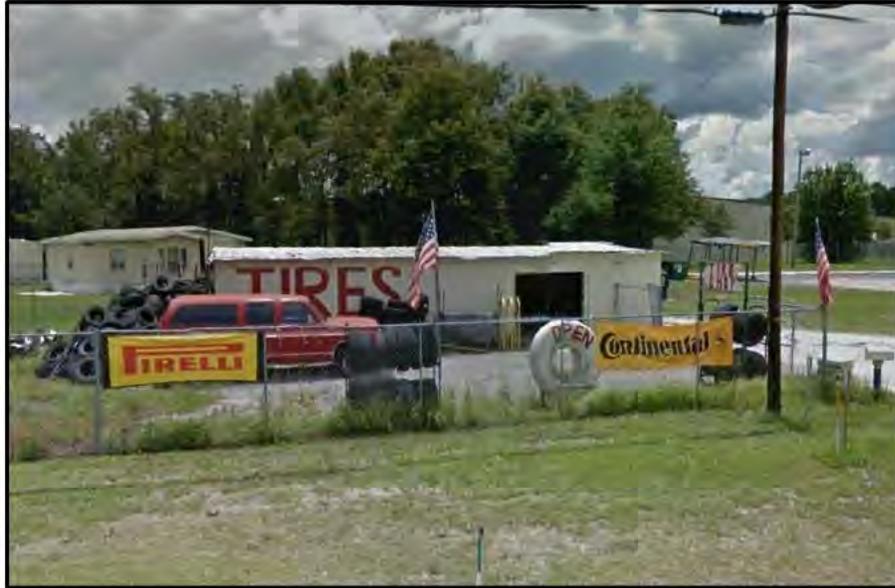
**Photo 5.17: 11939 N. US Highway 301 (8HI13515), looking east**

**8HI13515:** The Frame Vernacular style building at 11939 N. US Highway 301 was constructed in 1957 (Photo 5.17). The one-story, L-shaped commercial building sits on a concrete slab foundation and has a wood frame structural system clad in metal and plywood. The flat roof is covered with a built-up roof membrane, while the shed roof is covered with corrugated sheet metal panels. The main entryway is on the west elevation through a one-car garage opening. The building has no windows. The structure was reroofed circa 1987. Structural and decorative features include extended eaves and a partial cornice on the east elevation. The building is in poor condition and retains little historic exterior fabric. Overall, it is a typical example of a Frame Vernacular style building found throughout Hillsborough County, and research revealed no significant historic associations. As a result, 8HI13515 does not appear eligible for listing in the NRHP, either individually or as part of a historic district.

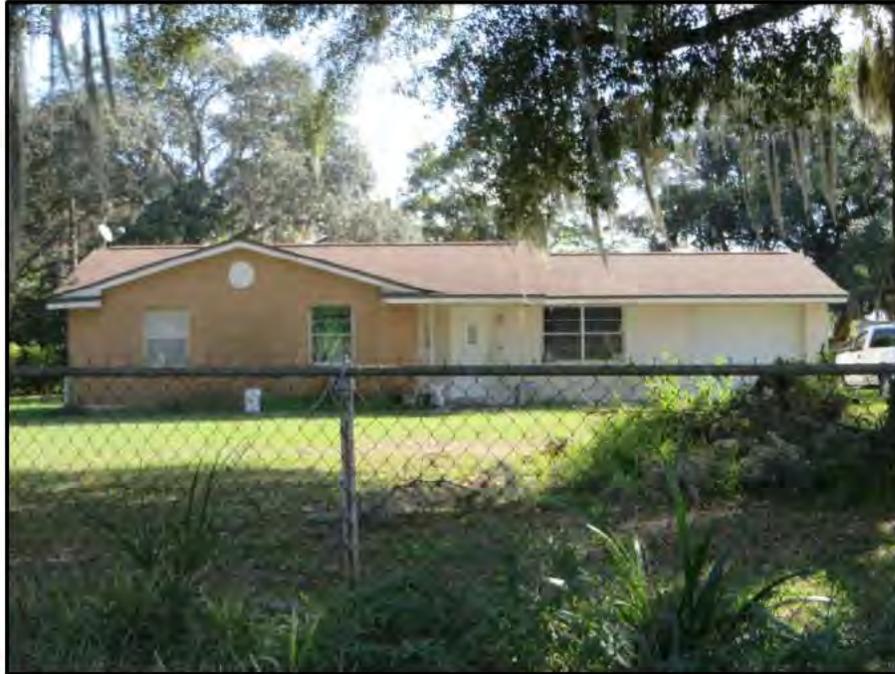
**Photo 5.18: 11959 N. US Highway 301 (8HI13516), looking south**

**8HI13516:** The Masonry Vernacular style building at 11959 N. US Highway 301 was constructed in 1964 (**Photo 5.18**). The one-story, irregular plan dwelling sits on a concrete slab foundation and has concrete block walls clad in a combination of stucco, brick veneer, and wood siding. The cross-gabled and shed roofs are covered with composition shingles. The main entryway is on the west elevation through a single 12-panel wood door within a partial-width open front porch beneath a side gable roof supported by decorative metal columns. Visible windows are a mixture of paired and independent 2/2 metal single-hung sash units and independent 1/1 vinyl single-hung sash units. The building was outfitted with several new windows circa 1990 and was reroofed circa 2000. Structural and decorative features include extended eaves, cornice returns, and concrete window sills. The building is in fair condition and retains some of its historic exterior fabric. Overall, however, it is a typical example of a Frame Vernacular style building found throughout Hillsborough County, and research revealed no significant historic associations. As a result, 8HI13516 does not appear eligible for listing in the NRHP, either individually or as part of a historic district.

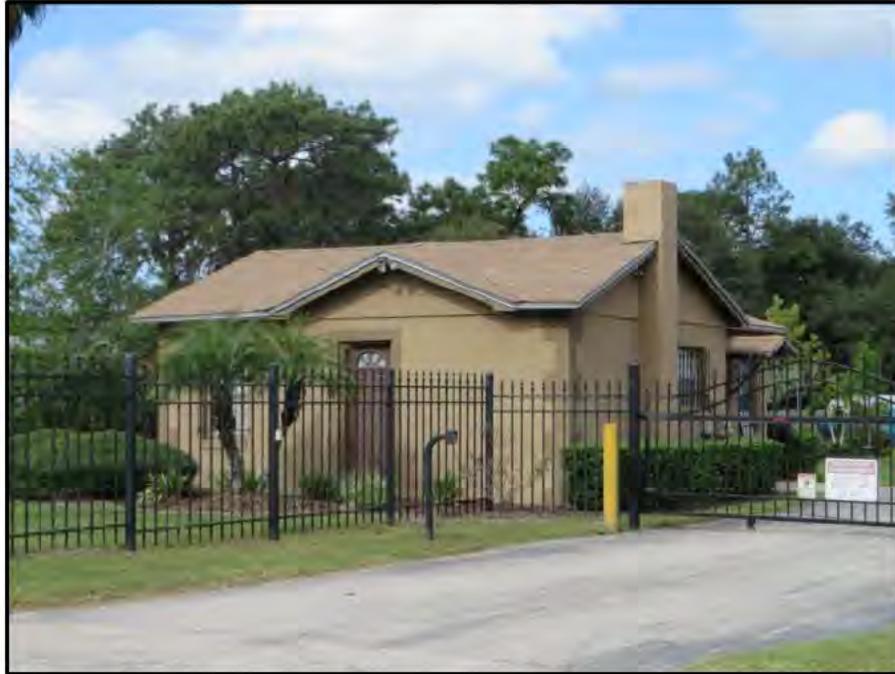
**Photo 5.19: 12560 N. US Highway 301 (8HI13517), looking north**

**8HI13517:** The Masonry Vernacular style building at 12560 N. US Highway 301 was constructed in 1948 (**Photo 5.19**). The one-story, L-shaped office building sits on a concrete slab foundation and has concrete block walls covered with stucco. The cross-gabled roof is covered with composition shingles. The main entryway is on the east elevation through a single composite door within a partial-width open front porch beneath a gable roof overhang supported by simple wood brackets. Windows are independent 2/2 single-hung sash units throughout. The building was outfitted with new windows and doors circa 1990, was reroofed circa 2000, and covered with new stucco circa 2005. Structural and decorative features include extended eaves, decorative metal window grates, faux quoins, concrete window sills, and attic louvers. There is a concrete block chimney covered with stucco along the east elevation. The building is in fair condition and retains little historic exterior fabric. Overall, it is a typical example of a Masonry Vernacular style building found throughout Hillsborough County, and research revealed no significant historic associations. As a result, 8HI13517 does not appear eligible for listing in the NRHP, either individually or as part of a historic district.

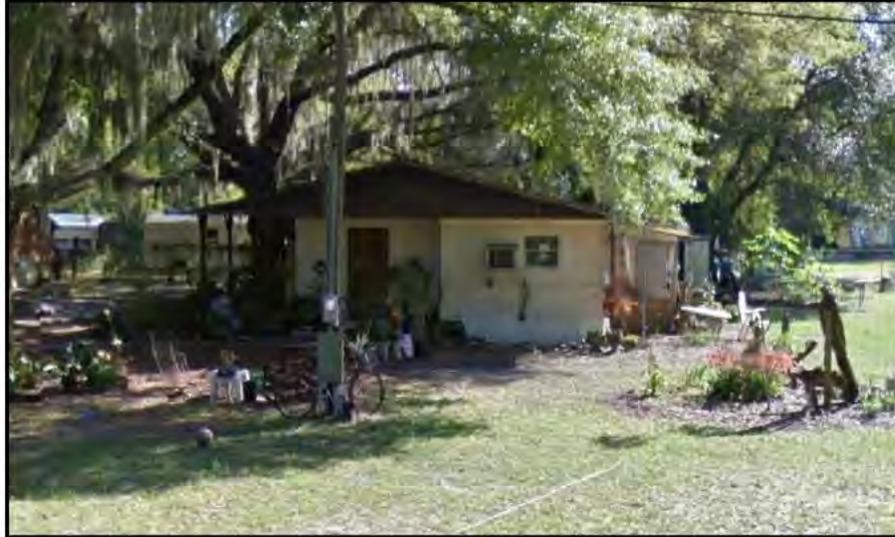
**Photo 5.20: 14240 N. US Highway 301 (8HI13518), looking southwest**

**8HI13518:** The Frame Vernacular style building at 14240 N. US Highway 301 was constructed in 1964 (**Photo 5.20**). The one-story, rectangular plan building incorporates a mobile home and has a partial wood frame structural system clad in a combination of metal, aluminum, and masonry veneer. The gable roof is covered with composition shingles. The main entryway is on the north elevation through a single 8-panel wood door within a partial-width open wraparound front porch beneath a gable roof supported by simple wood posts and brackets. Windows are a combination of paired 1/1 aluminum single-hung sash units and independent 1/1 aluminum awning units. The building was reroofed circa 1985, and the eastern portion of the building was added on to a stationary mobile home circa 1965. Structural and decorative features include extended eaves and a brick veneer on the eastern elevation. The building is in fair condition and retains some historic exterior fabric. Overall, however, it is a typical example of a Frame Vernacular style building found throughout Hillsborough County, and research revealed no significant historic associations. As a result, 8HI13518 does not appear eligible for listing in the NRHP, either individually or as part of a historic district.

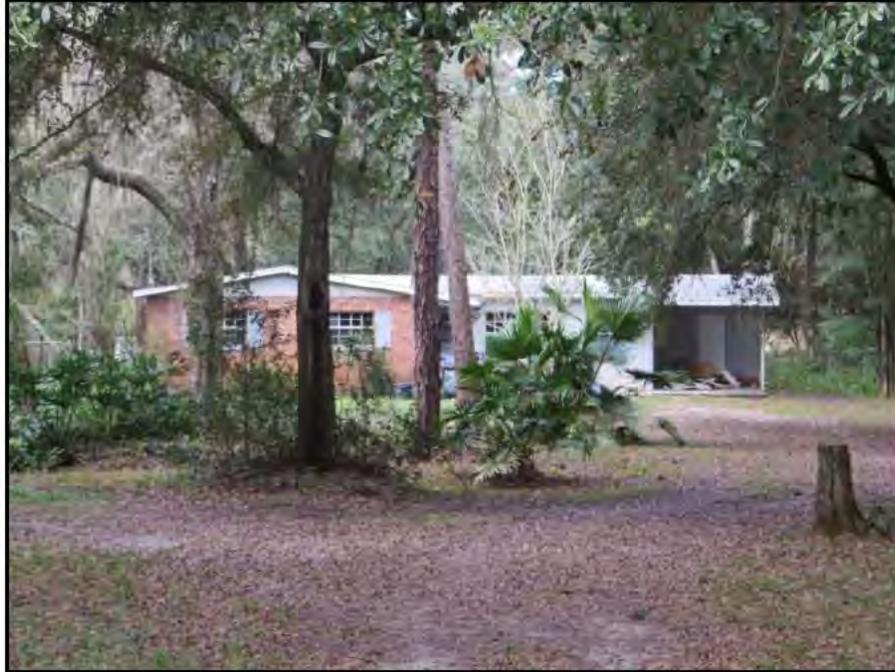
**Photo 5.21: 14326 N. US Highway 301 (8HI13519), looking north**

**8HI13519:** The Masonry Vernacular style building at 14326 N. US Highway 301 was constructed in 1964 (**Photo 5.21**). The one-story, irregular plan dwelling sits on a concrete slab foundation and has concrete block walls partially clad in a combination of brick veneer and wood siding. The cross-gabled roof is covered with composition shingles. The main entryway is on the east elevation through a single wood door within a partial-width open front porch. Visible windows are a mixture of independent 8/8 and 1/1 vinyl single-hung sash units with snap-in muntins. The building was outfitted with several new windows circa 1990 and was reroofed circa 2000. Structural and decorative features include extended eaves, faux shutters, and concrete window sills. The building is in fair condition and retains some of its historic exterior fabric. Overall, however, it is a typical example of a Masonry Vernacular style building found throughout Hillsborough County, and research revealed no significant historic associations. As a result, 8HI13519 does not appear eligible for listing in the NRHP, either individually or as part of a historic district.

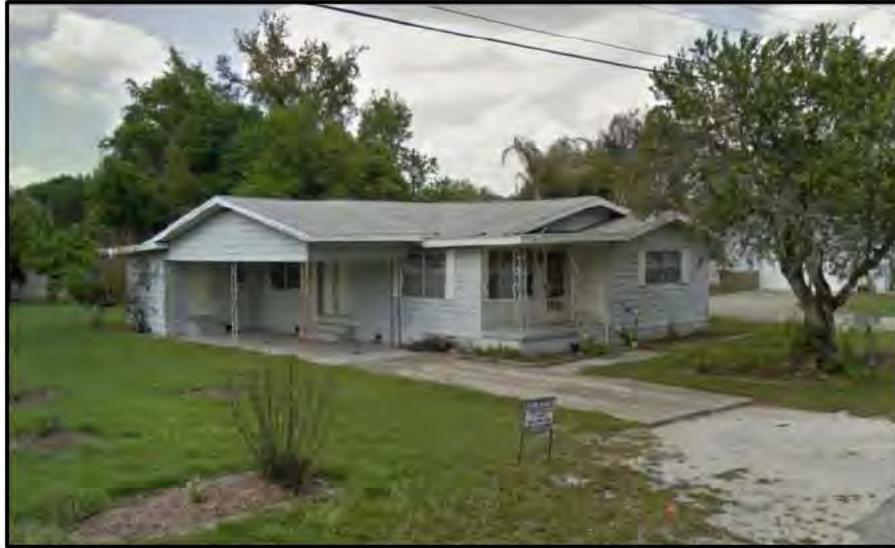
**Photo 5.22: 11710 Bradley Road (8HI13520), looking northwest**

**8HI13520:** The Frame Vernacular style building at 11710 Bradley Road was constructed in 1959 (Photo 5.22). The one-story, irregular plan dwelling sits on a concrete slab foundation and has a wood frame structural system clad in a combination of masonry veneer and aluminum siding. The cross-gabled and shed roofs are covered with composition shingles. The main entryway is on the east elevation through a single door within a partial-width, partially inset open front porch atop a concrete stoop beneath a gable roof with decorative metal columns and a metal railing. Windows are a mixture of independent and paired 2/1 aluminum single-hung sash units and a fixed pane picture window flanked by casement window units. The building was outfitted with several new doors and reroofed circa 2000. Structural and decorative features include extended eaves, faux shutters, and corner boards. The building is in fair condition and retains most of its historic exterior fabric. Overall, however, it is a typical example of a Frame Vernacular style building found throughout Hillsborough County, and research revealed no significant historic associations. As a result, 8HI13520 does not appear eligible for listing in the NRHP, either individually or as part of a historic district.

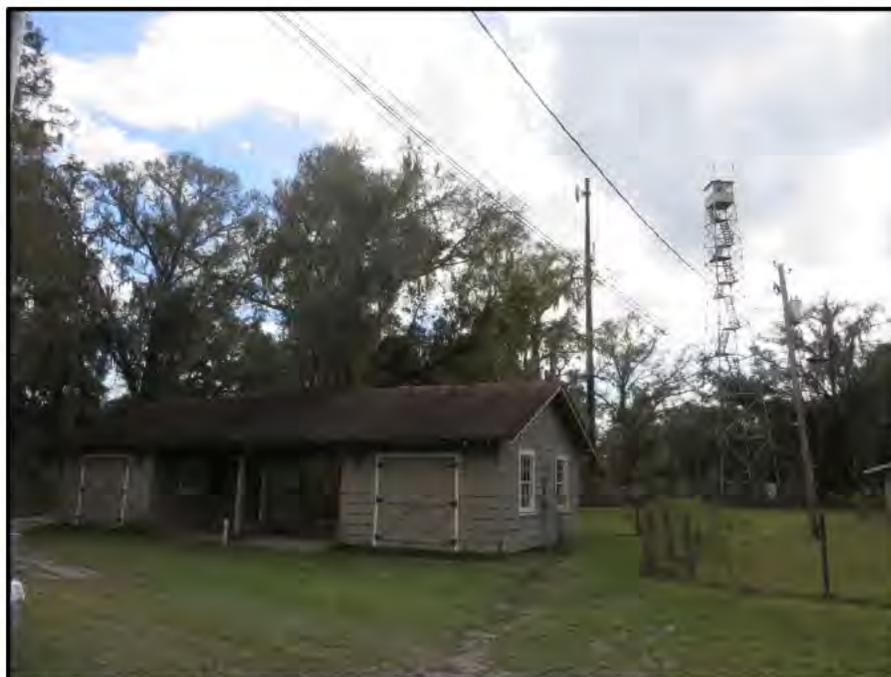
**Photo 5.23: Representative View, HRSP New Deal Resources (8HI13526), looking southwest**

**8HI13526:** The building complex resource group known as the HRSP New Deal Resources is comprised of four Rustic style buildings (two sheds, a ranger’s residence, and an interpretive center) and one Industrial Vernacular fire tower built by the Civilian Conservation Corps (CCC) as part of Hillsborough River State Park between 1934-1938 and previously recorded as 8HI03890-8HI03894 (Table 5.5). These resources are clustered together near the auxiliary entrance to the HRSP slightly north of the main entrance. Distinguishing architectural details include log walls, square-hewn timbers, and cypress plank siding (Photos 5.23 to 5.28).
