# CULTURAL RESOURCES ASSESSMENT SURVEY

**US 301** FROM FOWLER AVENUE TO PROPOSED SR 56  
Hillsborough and Pasco Counties  
WPI Segment No. 255796-1

Project Development and Environment Study

June 2017

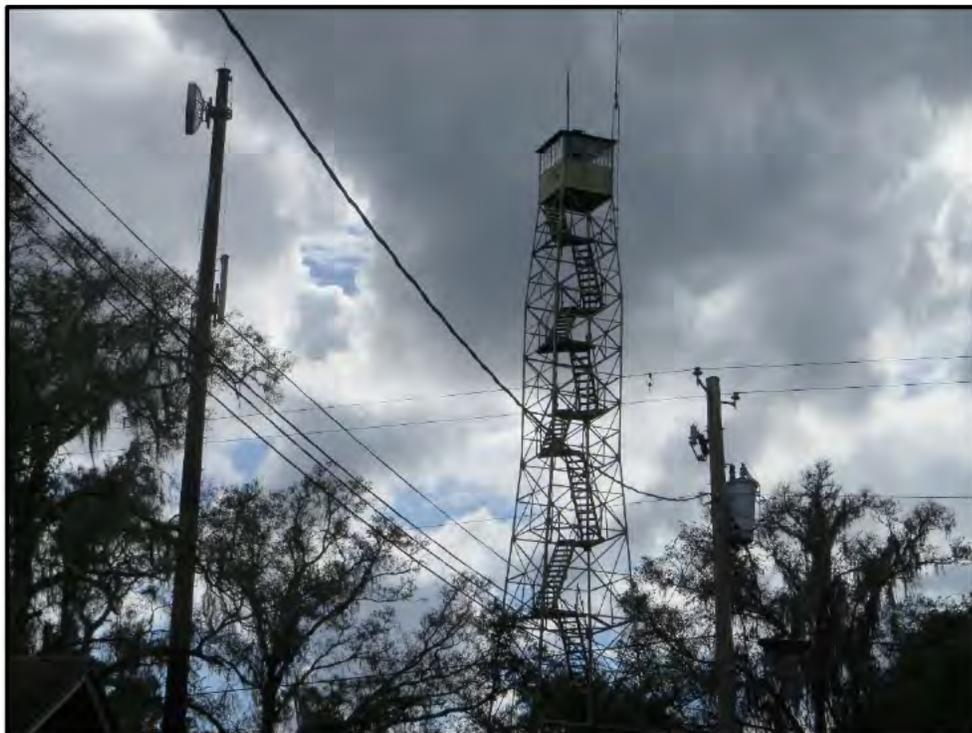
**Photo 5.24. Fire Tower (8HI03890), looking southwest**

**8HI13526:** The building complex resource group known as the HRSP New Deal Resources is comprised of four Rustic style buildings (two sheds, a ranger’s residence, and an interpretive center) and one Industrial Vernacular fire tower built by the Civilian Conservation Corps (CCC) as part of Hillsborough River State Park between 1934-1938 and previously recorded as 8HI03890-8HI03894 (Table 5.5). These resources are clustered together near the auxiliary entrance to the HRSP slightly north of the main entrance. Distinguishing architectural details include log walls, square-hewn timbers, and cypress plank siding (Photos 5.23 to 5.28).

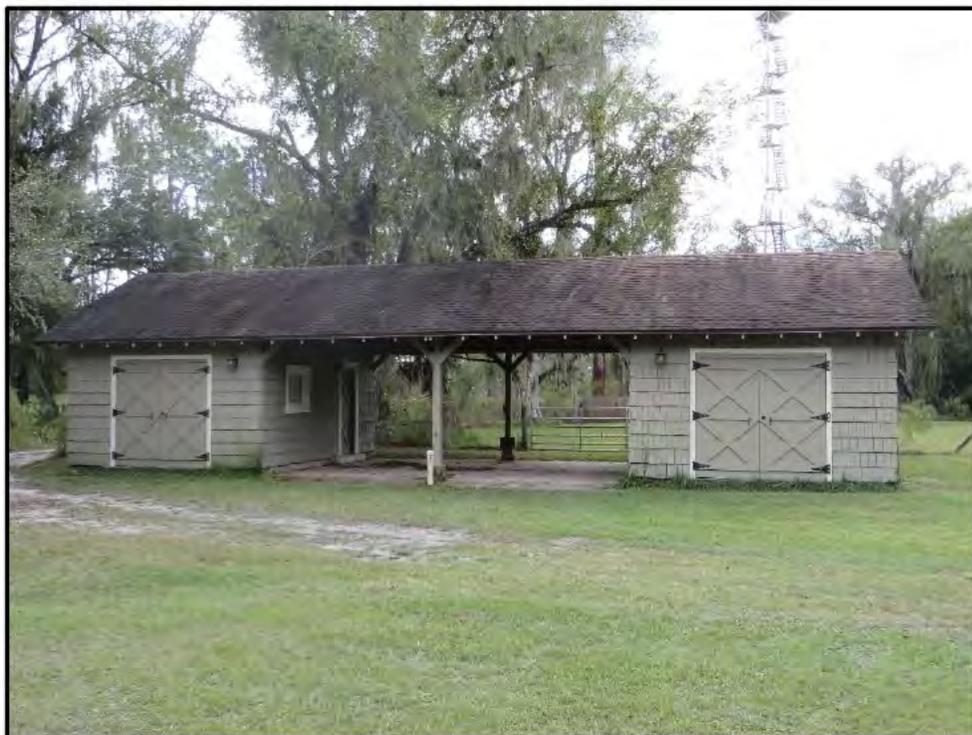
**Photo 5.25. Maintenance Shed 1 (8HI03891), looking south**

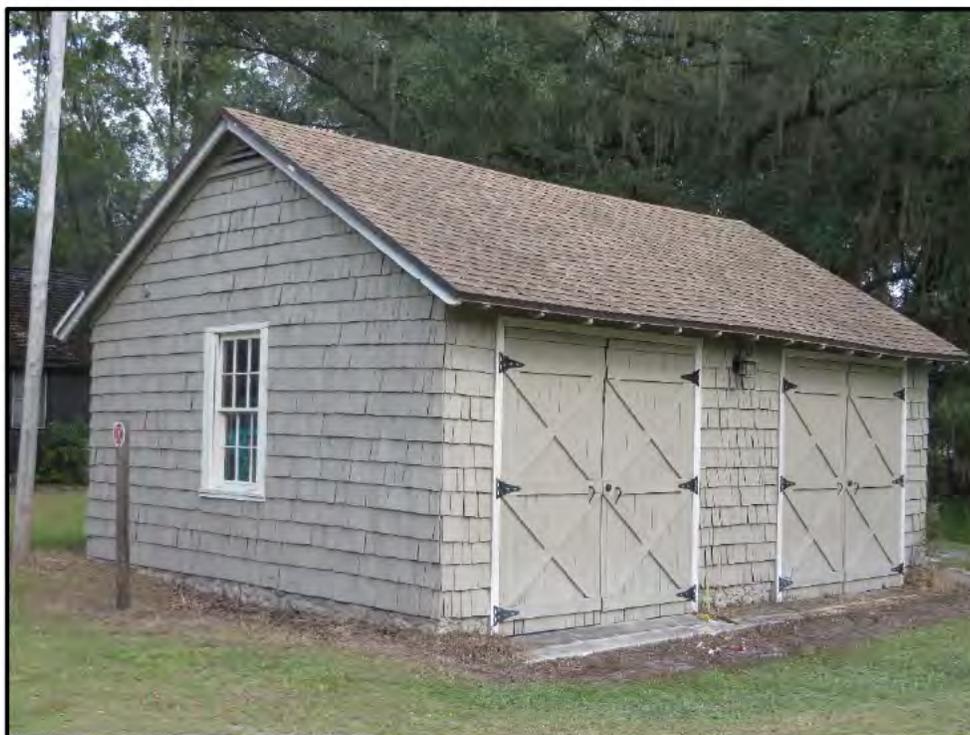
**Photo 5.26. Maintenance Shed 2 (8HI03892), looking east**

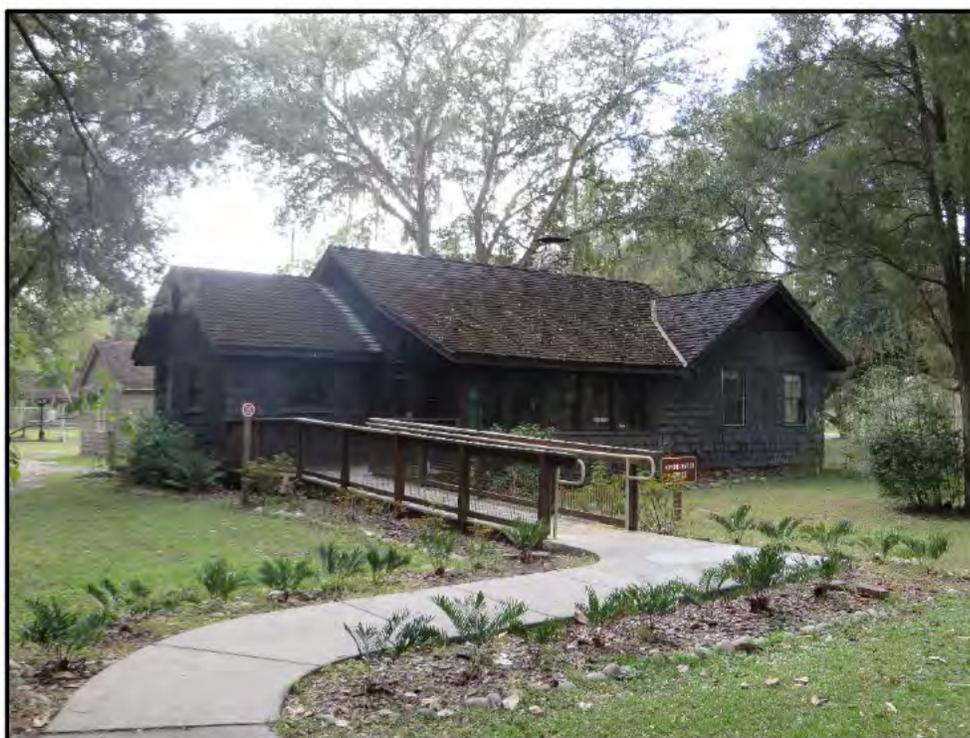
**Photo 5.27. Ranger's Residence (8HI03893), looking east**

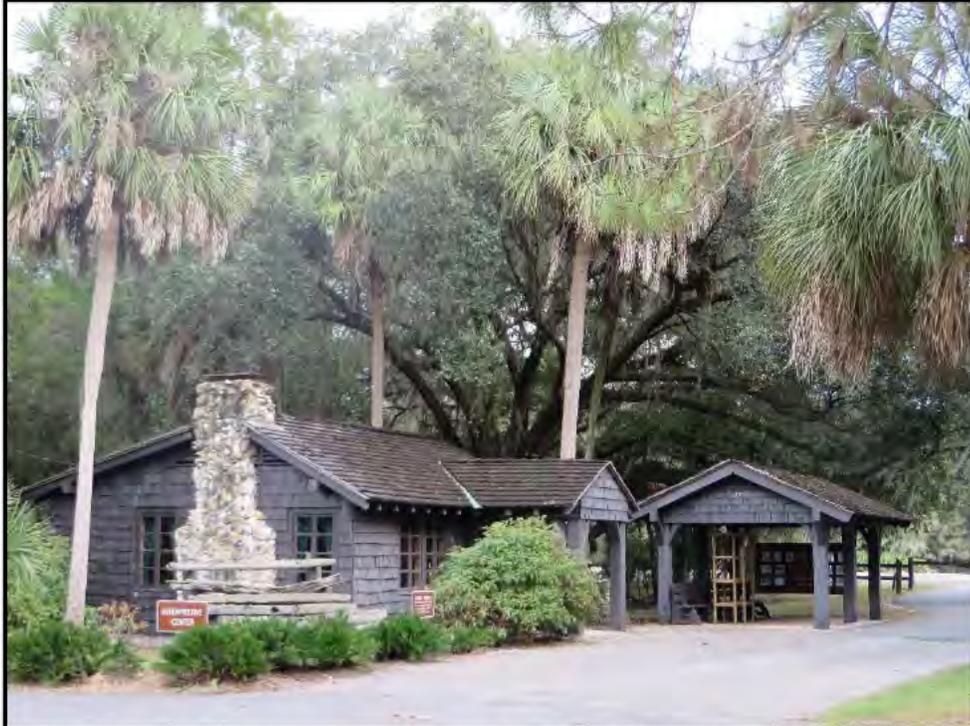
**Photo 5.28. Interpretive Center (8HI03894), looking northeast**

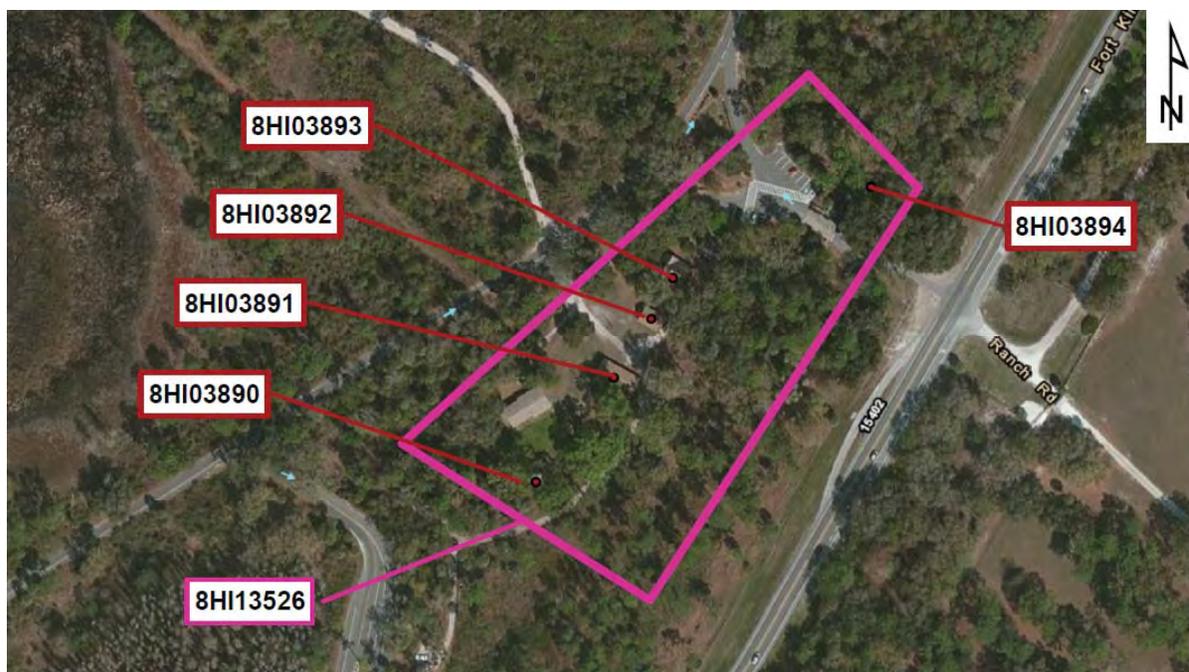
**Figure 5.33. Aerial view of Resource Group 8HI13526 showing proposed resource group boundaries and location of contributing resources 8HI03890-8HI03894. The resource group boundaries are the proposed NRHP-eligible boundaries and contain the significant historic structures and access roads. Image courtesy Esri**

The five resources within the HRSP New Deal Resources Resource Group are in proximity to the US 301 project APE (**Figure 5.21**). The resource group boundaries are the proposed NRHP-eligible boundaries and contain the significant historic structures and access roads (**Figure 5.33**).

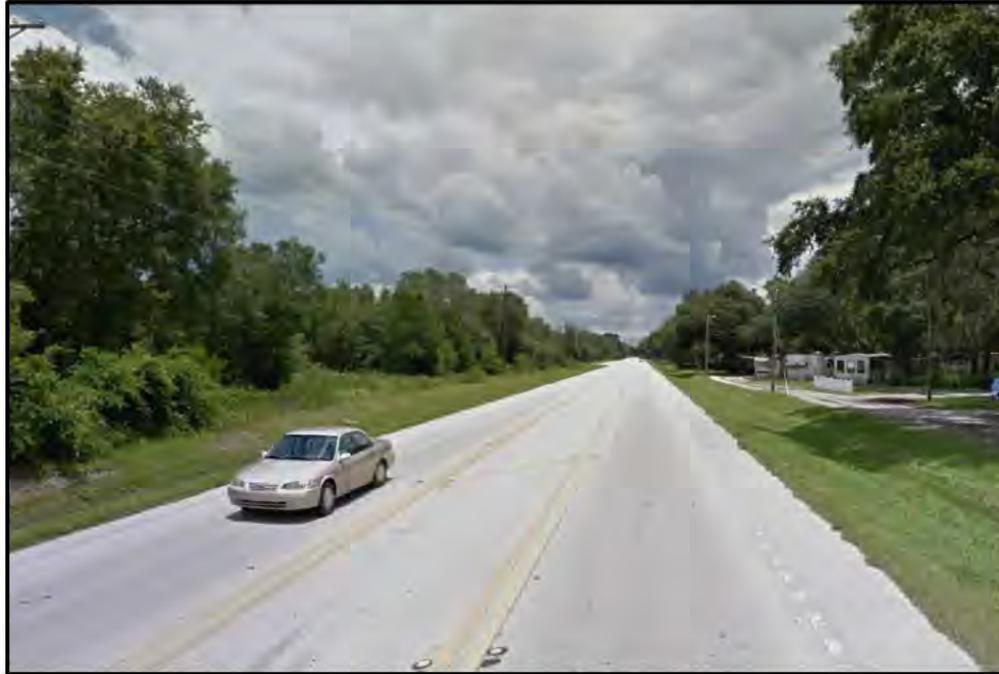
**Photo 5.29: US 301 (8HI12137), looking north**

**8HI12137:** US 301 originated as US 41 (Historic Roads and Highways of Florida [HRHF] 2013) and was built ca. 1936 to connect Zephyrhills and Dade City to Tampa (Bohren 1989) (**Photo 5.29**). It is first evident on a 1936 county map in which it is labeled US 41/SR 5 (Florida State Road Department 1936). It was designated US 301 in 1952 (HRHF 2013). In the late 1930s, the route was rural with a few agricultural enterprises and residences (PALMM 1938). The aerial photos available from the Publication of Archival Library and Museum Materials (PALMM) show that in 1938, most of the roadway corridor was rural with scattered farms, pastures, and groves, and was mostly undeveloped in the swamps and low-lying areas associated with the river and creeks. By the late 1950s, the area included a few commercial buildings and more residences, but was still largely rural in character (PALMM 1957). At that time, the southern segment of the current US 301 corridor had not been constructed along the present alignment and extended along what is now known as Harney Road (as visible on **Figure 3.7**); the current alignment appears to have been under construction by 1957 (USDA 1938, 1941, 1951, 1957a, 1957b, 1957c). Much of the area retains its rural setting today, although the railroad is no longer extant and the southern corridor is more developed. Most development occurred within the past three decades (Henriquez 2015).

As contained within the current project APE, US 301 is predominately a two-lane arterial road with sporadic central turn lanes. An approximately three-foot-wide paved shoulder is to either side, and a grassy clear zone separates the ROW from parallel swales. Several residences are present along the segment, and the Hillsborough River State Park is located at the northern end. Wooden power poles and electrical lines border both sides of US 301 from Fowler Avenue to SR 56 (proposed). Land uses along the road are mixed agricultural, residential, and commercial. The road has been resurfaced on multiple occasions. The

historic integrity of US 301 within the APE has been compromised by the addition of turn lanes. Further, it is of a common design and construction and lacks significant historical associations to events or persons. Moreover, the historic setting of US 301 from Fowler Avenue to the proposed extension of SR 56 has changed because of recent development. Therefore, the unrecorded segment of the US 301 linear resource within the APE does not appear to be potentially eligible for listing in the NRHP. Evaluating the NRHP eligibility of 8HI12137 throughout Hillsborough County was beyond the scope of this project

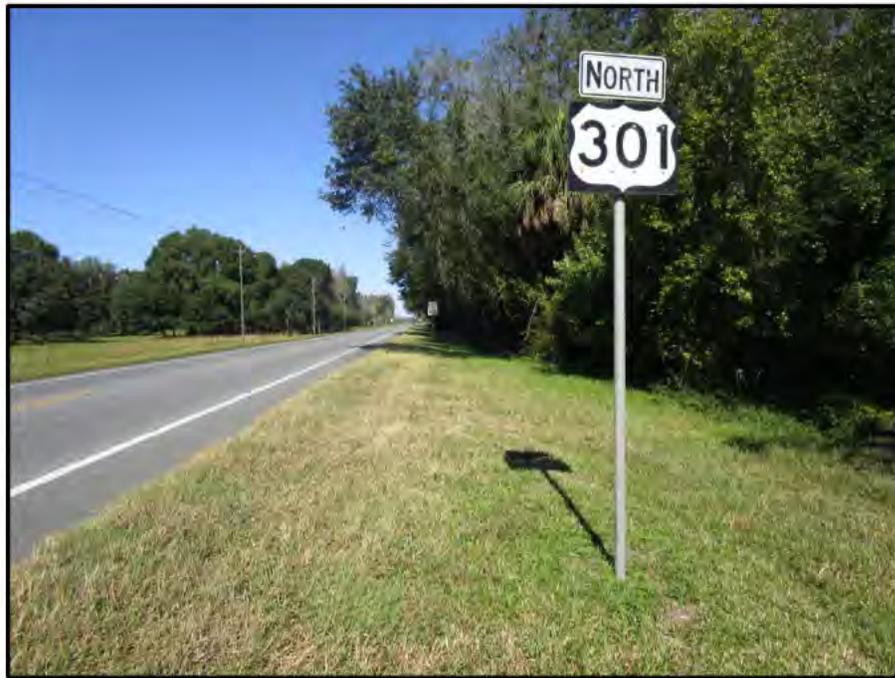
**Photo 5.30: US 301 (8PA02675), looking north**

**8PA02675:** US 301 originated as US 41 (HRHF 2013) and was built ca. 1936 to connect Zephyrhills and Dade City to Tampa (Bohren 1989) (**Photo 5.30**). It is first evident on a 1936 county map in which it is labeled US 41/SR 5 (Florida State Road Department 1936). It was designated US 301 in 1952 (HRHF 2013). In the late 1930s, the route was rural with a few agricultural enterprises and residences (PALMM 1938). By the late 1950s, the area included a few commercial buildings and more residences, but was still largely rural in character (PALMM 1957). By 1960, US 301 extended south from Folkston, Georgia to Sarasota, Florida. Within Florida, US 301 is approximately 260 miles long (Droz 1998). As contained within the current project APE, US 301 (Gall Blvd) is predominately a two-lane arterial road with sporadic central turn lanes. An approximately three-foot-wide paved shoulder is to either side, and a grassy clear zone separates the ROW from parallel swales. Wooden power poles and electrical lines flank the western side of US 301 from the Hillsborough County/Pasco County border to Rapid River Blvd. From there, the power poles and electrical lines are only present on the eastern side of US 301 to the end of the project APE at SR 56 (proposed). Land uses along the road are mixed agricultural, residential, and commercial. The road has been resurfaced on multiple occasions. The historic integrity of US 301 within

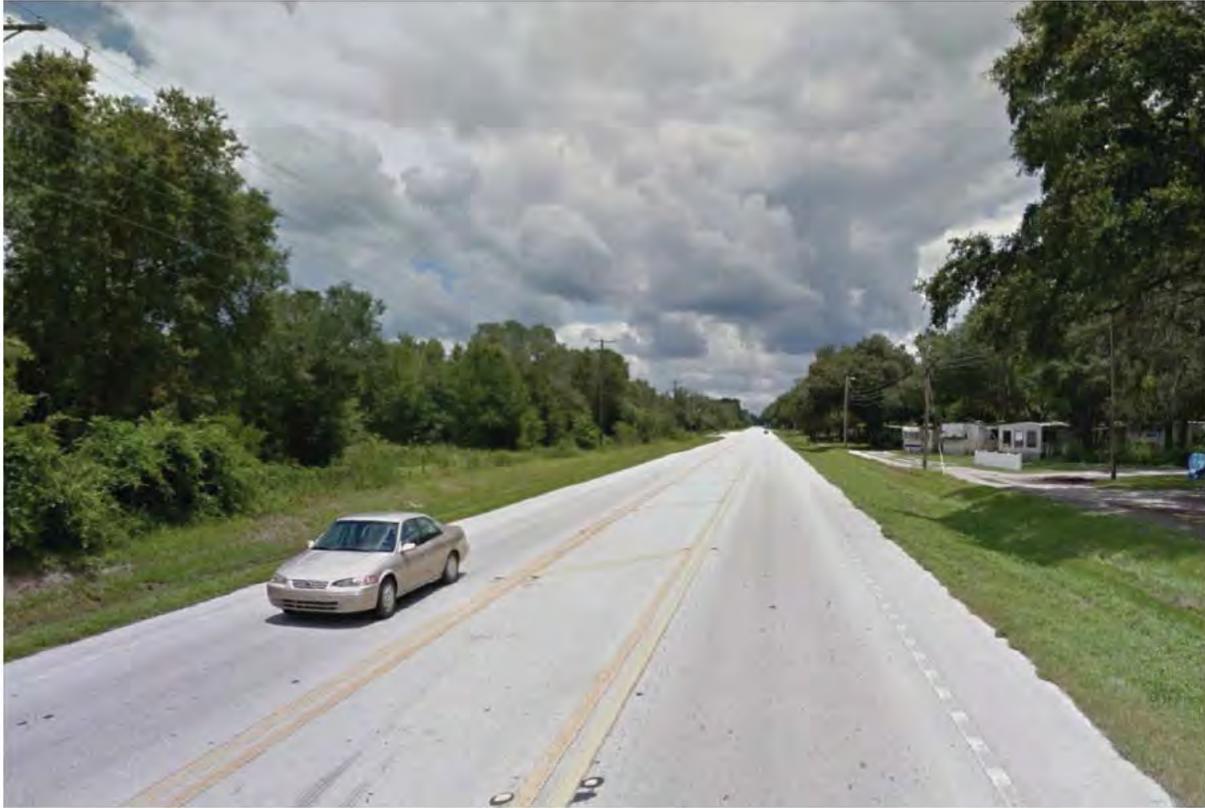
PHOTOGRAPH

This linear resource was updated as part of the current US 301 (Fowler Ave to Proposed SR 56) PD&E Study. This update adds the roadway segment of US 301 from just south of Fowler Avenue (SR 582) to the proposed realignment of SR 56, a distance of approximately 13.1 miles. It is located in Sections 2, 3, and 9 of Township 28 South, Range 20 East and Sections 36 and 30 of Township 27 South, Range 20 East (United States Geological Survey [USGS] Thonotosassa). It can also be found in Section 4 of Township 27 South, Range 21 East and Sections 33 and 37 of Township 26 South, Range 21 East (United States Geological Survey [USGS] Zephyrhills). As contained within the current project APE, US 301 is predominately a two-lane arterial road with sporadic central turn lanes. An approximately three-foot-wide paved shoulder flanks both sides of the roadway, and a grassy clear zone separates the ROW from parallel swales. Several residences are present along the segment, and the Hillsborough River State Park is located at the northern end. Wooden power poles and electrical lines border both sides of US 301 from Fowler Avenue to SR 56 (proposed). Land uses along the road are mixed agricultural, residential, and commercial. The road has been resurfaced on multiple occasions.

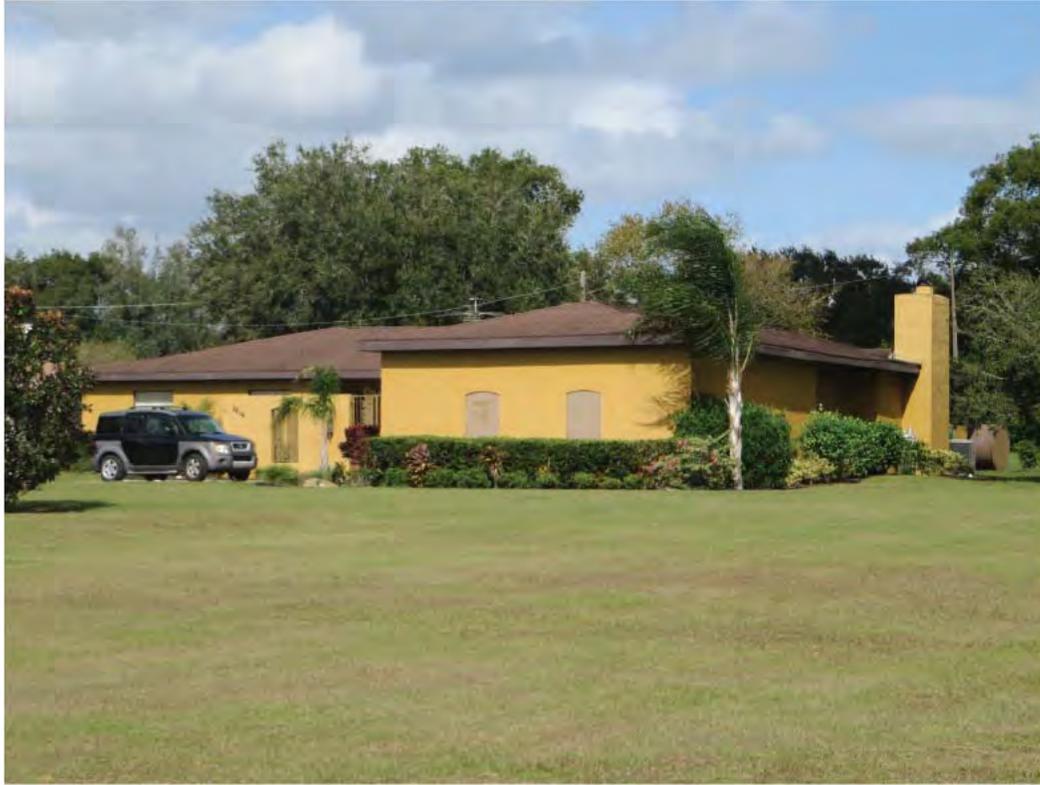
PHOTOGRAPH

Chimney: No. \_\_\_ Chimney Material(s): 1. \_\_\_ 2. \_\_\_
Structural System(s): 1. Concrete block 2. \_\_\_ 3. \_\_\_
Foundation Type(s): 1. Slab 2. \_\_\_
Foundation Material(s): 1. Concrete, Generic 2. \_\_\_
Main Entrance (stylistic details) S elevation, single door

Narrative Description of Resource One-story Masonry Vernacular dwelling is in good condition and retains its historic exterior fabric. Overall, however, it is a typical style found in the area and throughout the State.

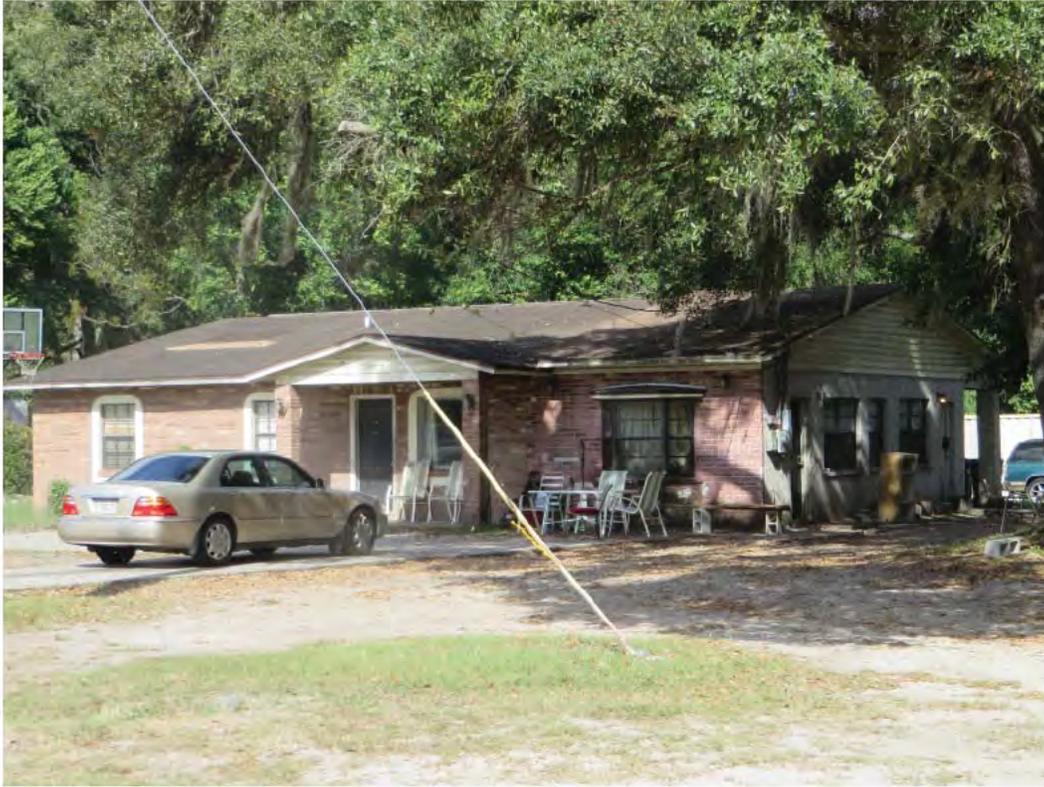
PHOTOGRAPH

Chimney: No. 1 Chimney Material(s): 1. Brick 2. \_\_\_\_\_  
 Structural System(s): 1. Concrete block 2. \_\_\_\_\_ 3. \_\_\_\_\_  
 Foundation Type(s): 1. Slab 2. \_\_\_\_\_  
 Foundation Material(s): 1. Concrete, Generic 2. \_\_\_\_\_  
 Main Entrance (stylistic details) S elevation, single wood door partially hidden behind curved CMU block screen wall

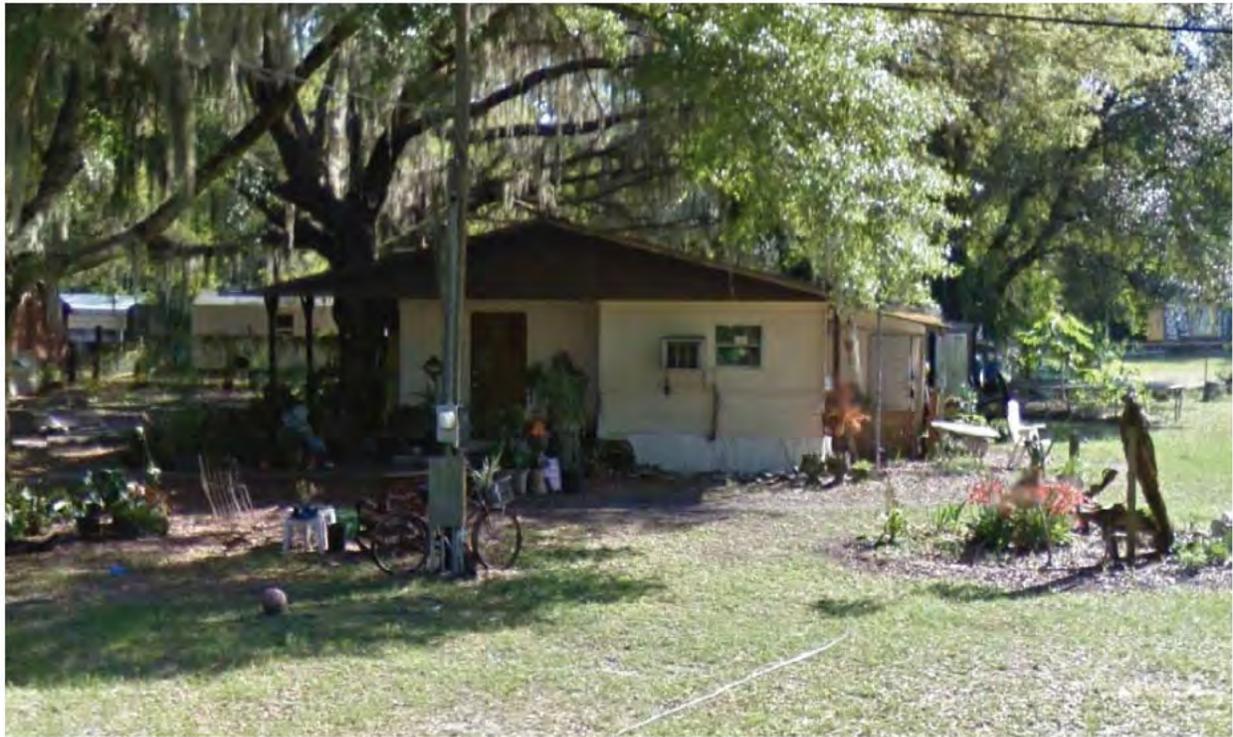
PHOTOGRAPH

Narrative Description of Resource One-story Frame Vernacular dwelling is in fair condition and retains some historic exterior fabric. Overall, however, it is a typical style found in the area and throughout the State.

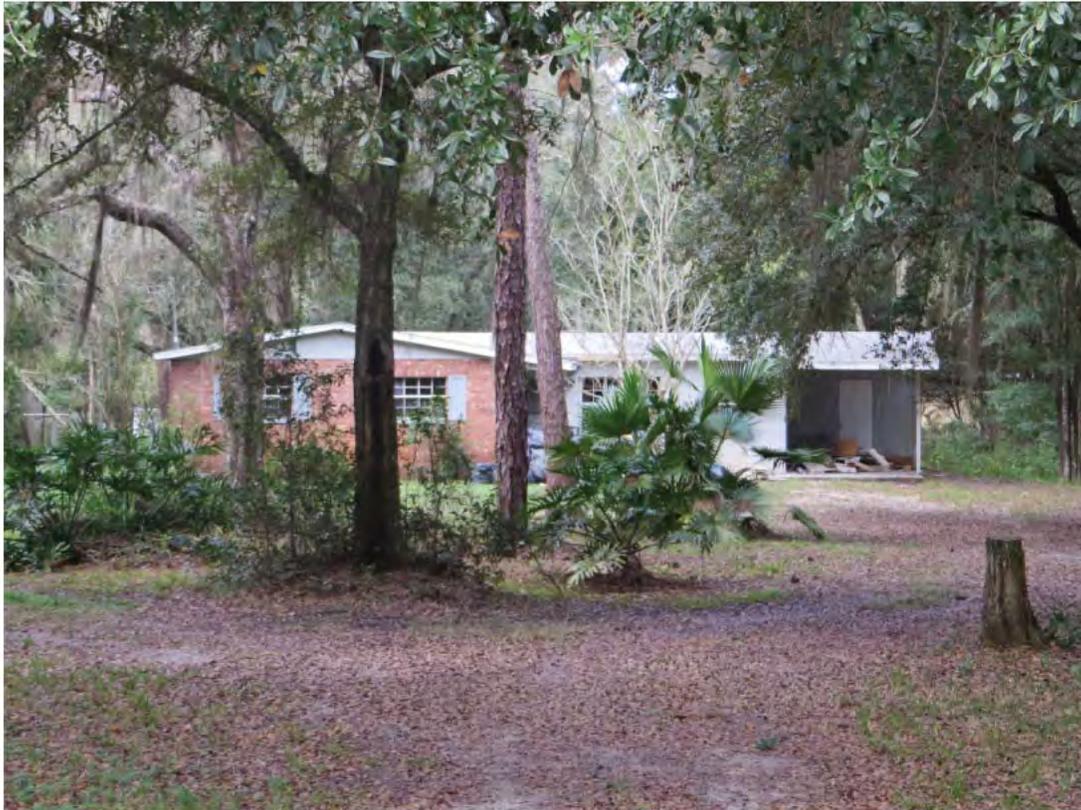
PHOTOGRAPH

Narrative Description of Resource One-story Masonry Vernacular dwelling is in fair condition and retains some historic exterior fabric. Overall, however, it is a typical style found in the area and throughout the State.

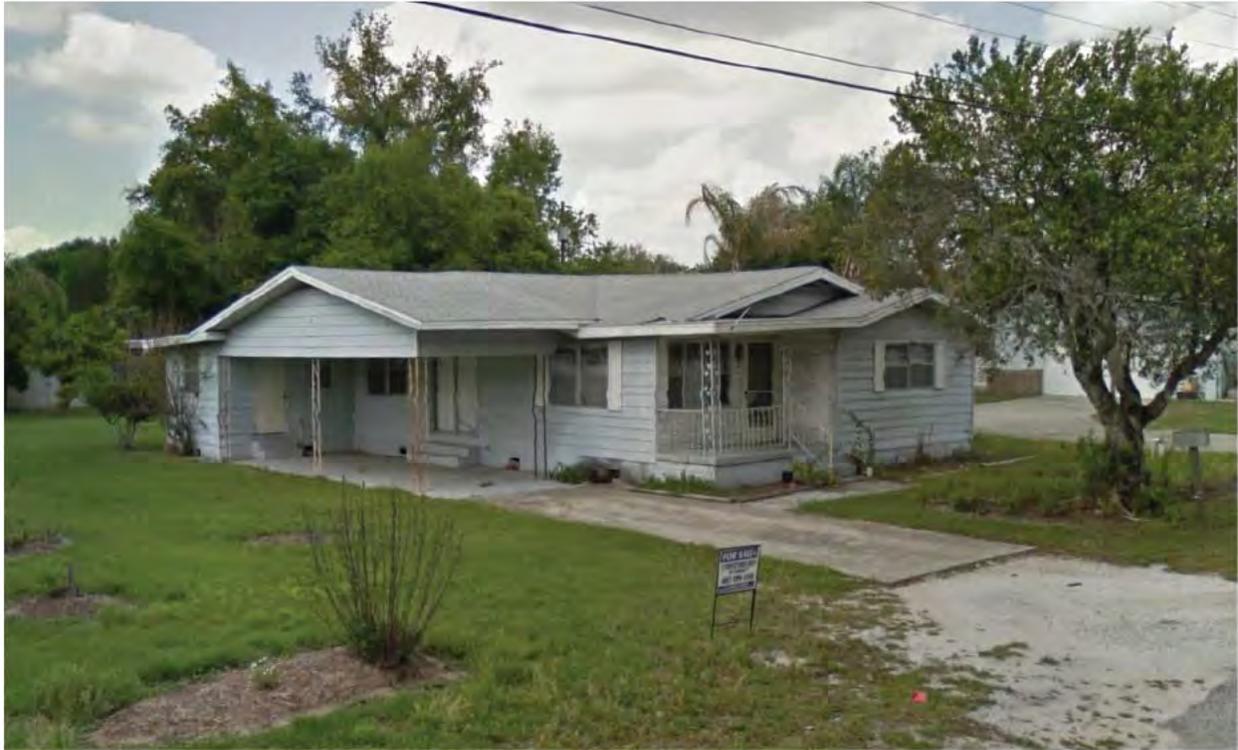
PHOTOGRAPH

Narrative Description of Resource One-story Frame Vernacular dwelling is in fair condition and retains most of its historic exterior fabric. Overall, however, it is a typical style found in the area and throughout the State.

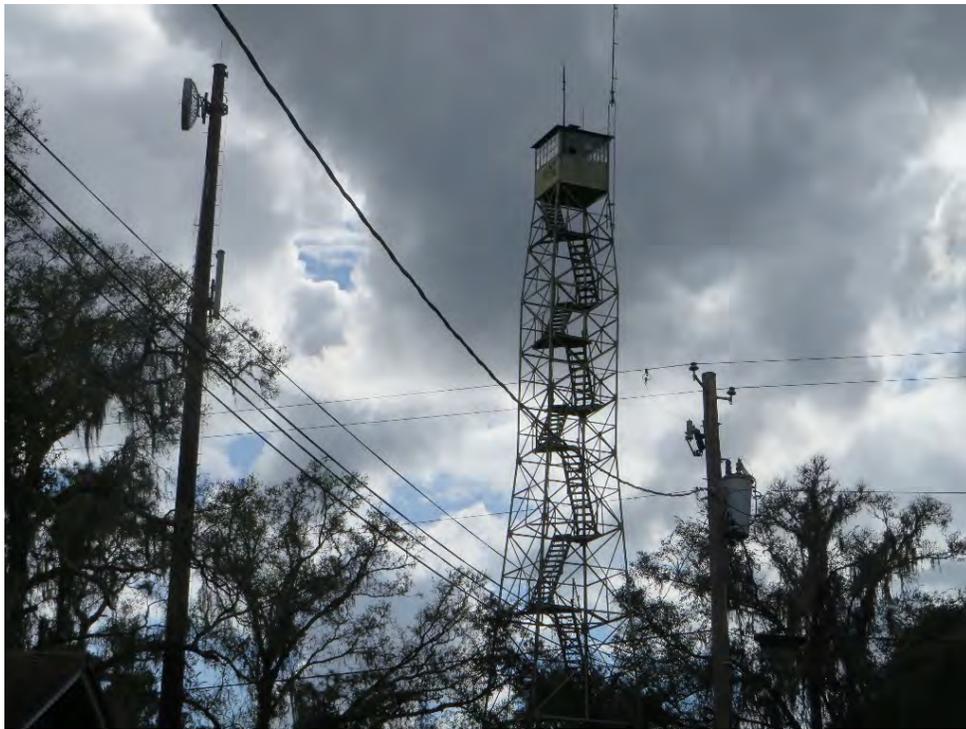
Photo 1. Fire Tower (8HI03890), facing southwest.

**Narrative Description:** The building complex resource group known as the HRSP New Deal Resources is comprised of four Rustic style buildings (a maintenance shed, a storage shed, a ranger’s residence, and an interpretive center) and one Industrial Vernacular fire tower built by the Civilian Conservation Corps (CCC) as part of Hillsborough River State Park between 1934-1938 and previously recorded as 8HI03890-8HI03894 (**Table 1**). The resource group boundaries are the proposed NRHP-eligible boundaries and contain the significant historic structures and access roads (**Figure 1**). Distinguishing architectural details include log walls, square-hewn timbers, and cypress plank siding (**Photos 1-5**). The five resources that comprise the HRSP New Deal Resources Resource Group are in proximity to the US 301 project APE.

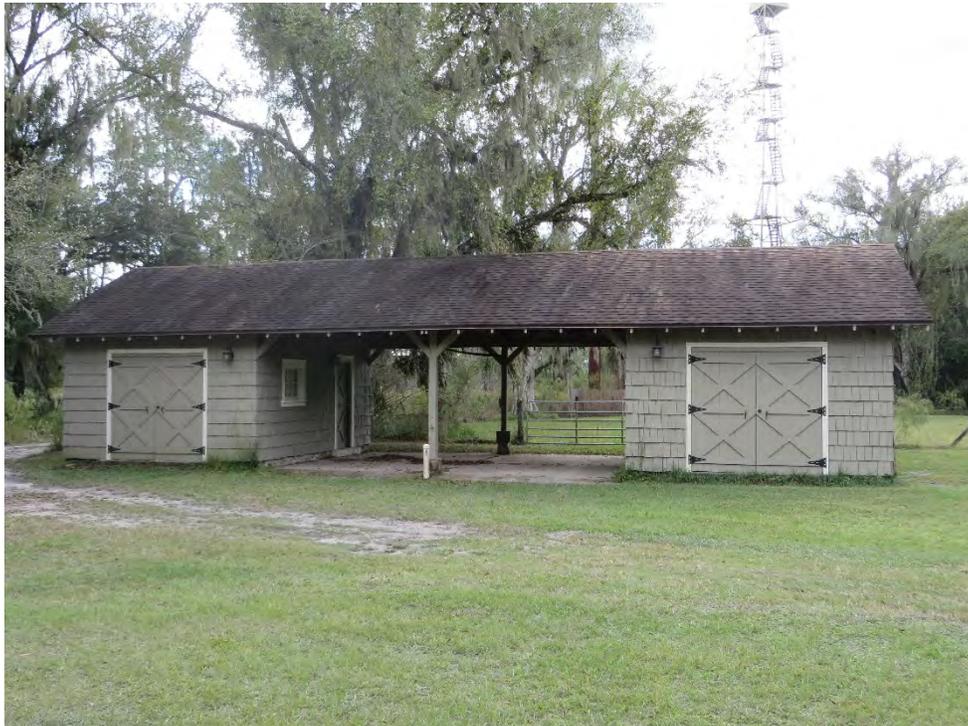
**Photo 2.** Maintenance Shed 1 (8HI03891), facing south.

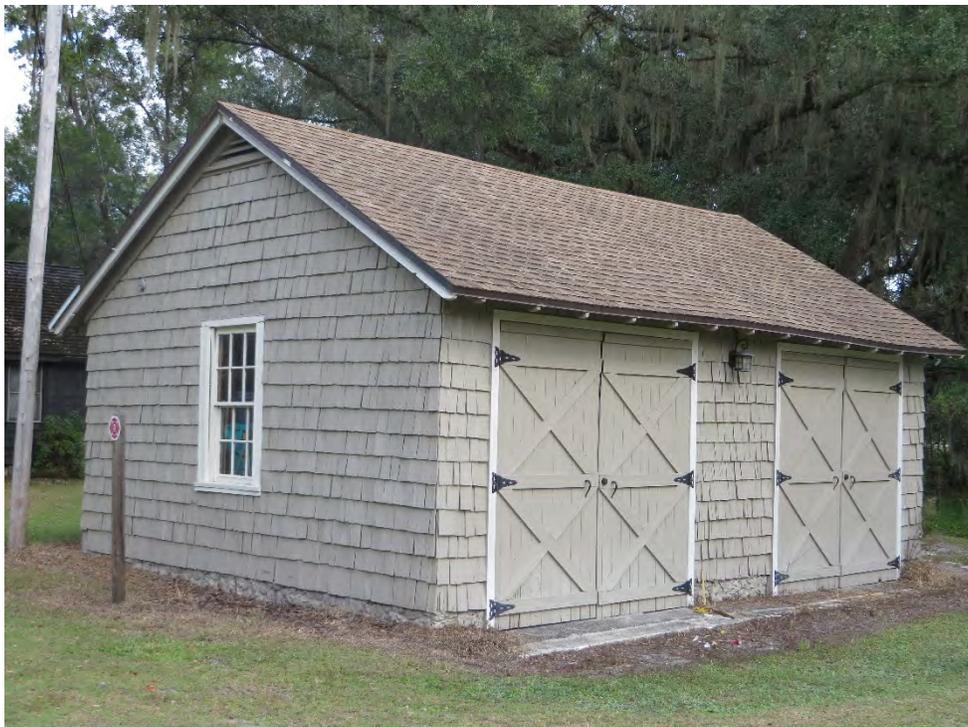
**Photo 3.** Maintenance Shed 2 (8HI03892), facing east.

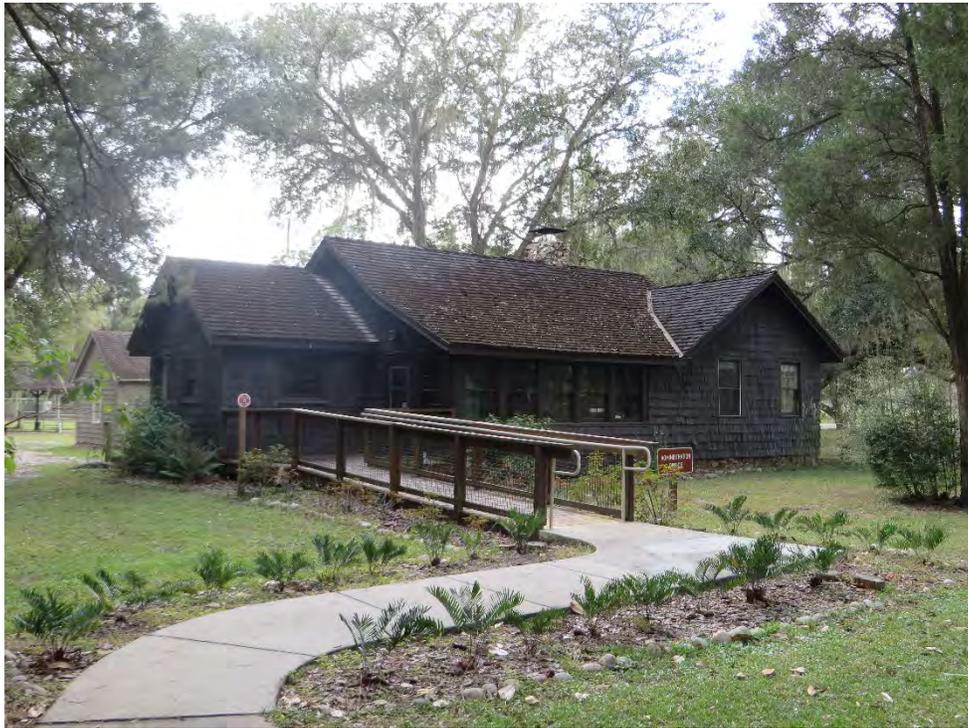
**Photo 4.** Ranger's Residence (8HI03893), facing east.

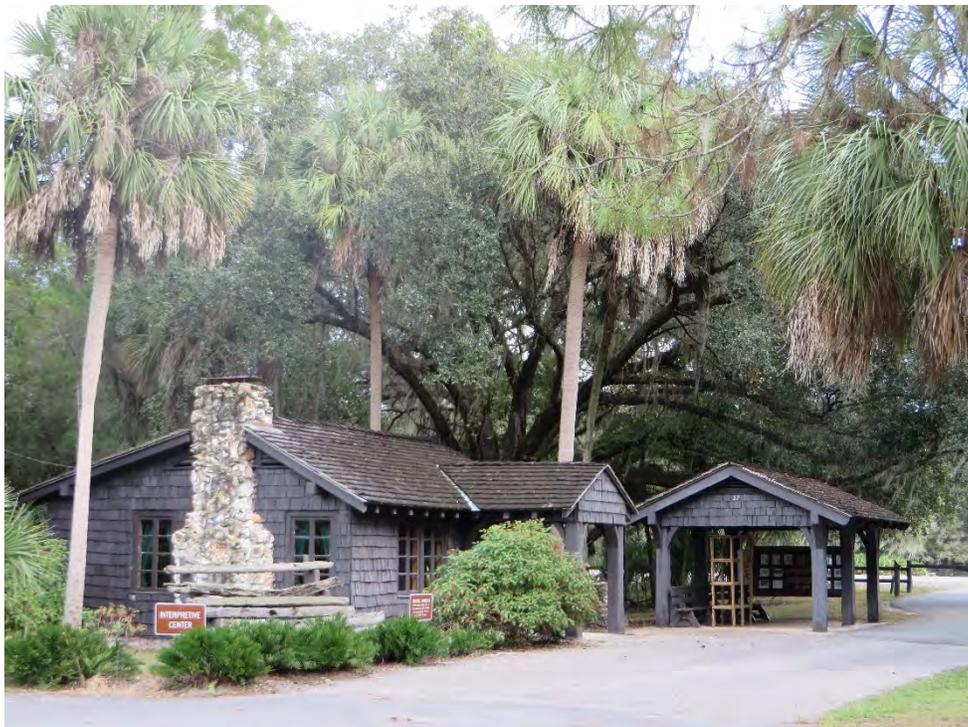
**Photo** Error! No text of specified style in document.. Interpretive Center (8HI03894), facing northeast.
