CULTURAL RESOURCES ASSESSMENT SURVEY REPORT

**US 41/SR 45 AT CSX GRADE SEPARATION
FROM S OF SR 676 TO N OF SR 676
Project Development & Environment (PD&E) Study
Design Change Reevaluation**

**Florida Department of Transportation
District 7**

January 2023

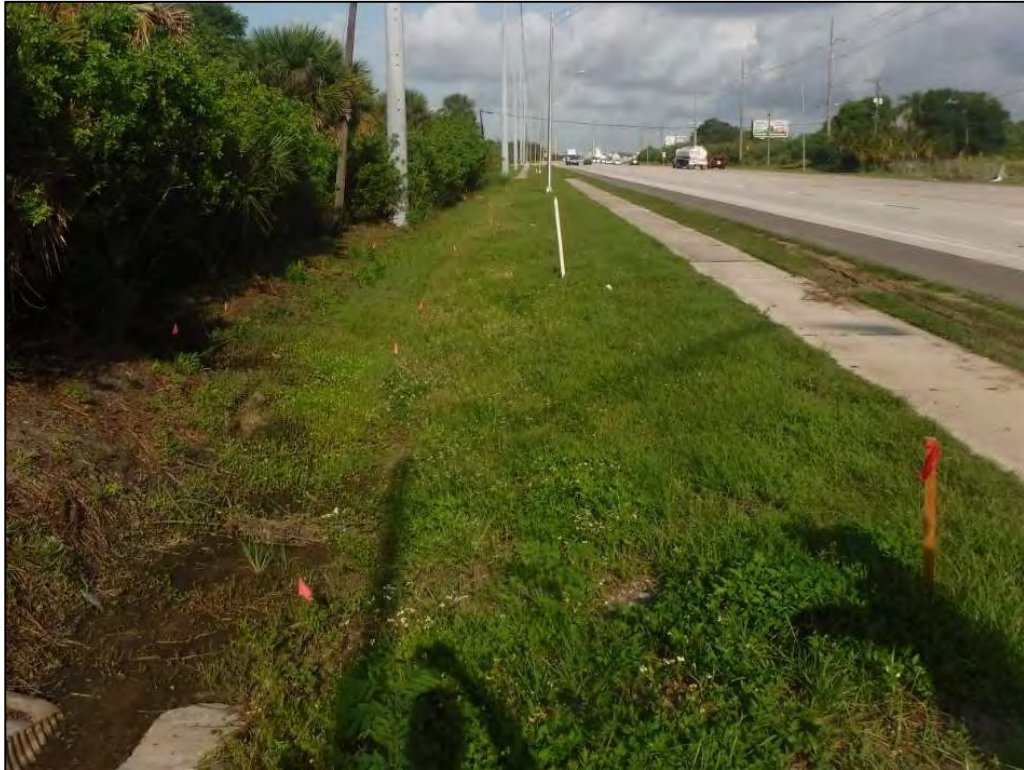
Figure 10-14 Representative View of Indicators of Underground Utilities, Ditching, and Hardscape Preventing Testing Along Causeway Boulevard, Facing West Along Causeway Boulevard

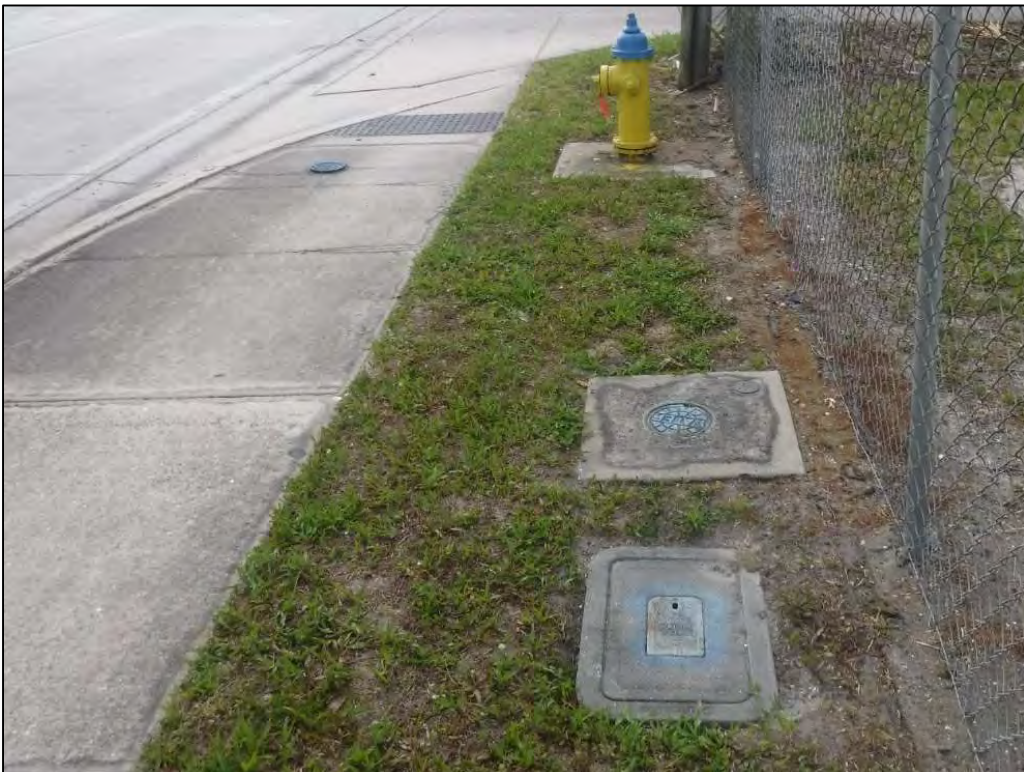
Figure 10-15 Representative View of Indicators of Underground Utilities and Hardscape Preventing Testing Along US 41, Facing North Along US 41
