CULTURAL RESOURCES ASSESSMENT SURVEY ADDENDUM REPORT

**US 41/SR 45 AT CSX GRADE SEPARATION
FROM S OF SR 676 TO N OF SR 676
Project Development & Environment (PD&E) Study
Design Change Reevaluation**

Florida Department of Transportation

Hillsborough County, Florida

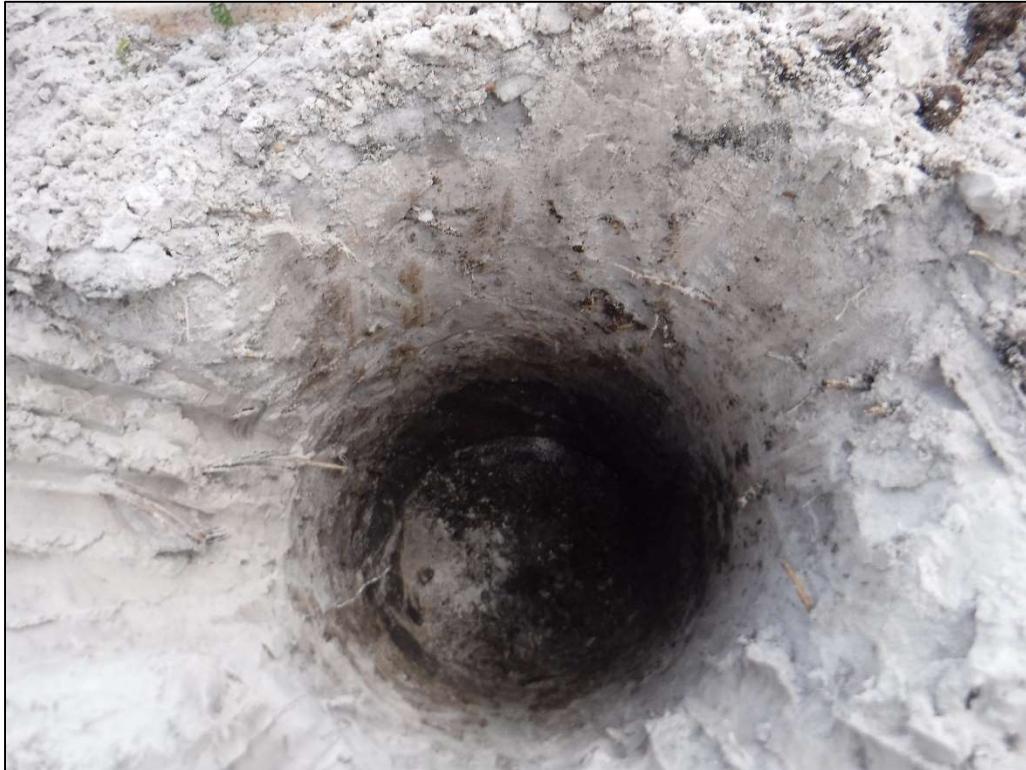
Figure 10-1 Stratigraphic Profile of ST No. 8 Within the Pond 1A Drainage Outfall, facing North

ST No. (Location)	Stratigraphic Profile	Results
ST No. 8 (Pond 1A Drainage Outfall)	Very light gray sand: 0-45 centimeters below the surface (cmbs) Gray sand: 45-72 cmbs Dark brown sand: 72-81 cmbs Brown compact sand: 81-94 cmbs Dense compact sand: 94 cmbs	No artifacts recovered.
ST No. 9 (Pond 1A Drainage Outfall)	Dark gray sand: 0-16 cmbs Gray sand: 16-32 cmbs Pale gray sand: 32-56 cmbs Pale gray sand mottled with grayish brown sand: 56-67 cmbs Compact clay at 67 cmbs	No artifacts recovered.
ST No. 10 (Pond 2B)	Gray sand with heavy roots: 0-20 cmbs Dark gray sand with heavy roots: 20-40 cmbs Pale gray sand: 40-105 cmbs	No artifacts recovered.
ST No. 11 (Pond 3AB)	Dark gray brownish sand: 0-21 cmbs Gray sand: 21-45 cmbs Pale gray sand: 45-68 Very dark brown hardpan: 68-76 cmbs Dense hardpan: 76 cmbs	No artifacts recovered.

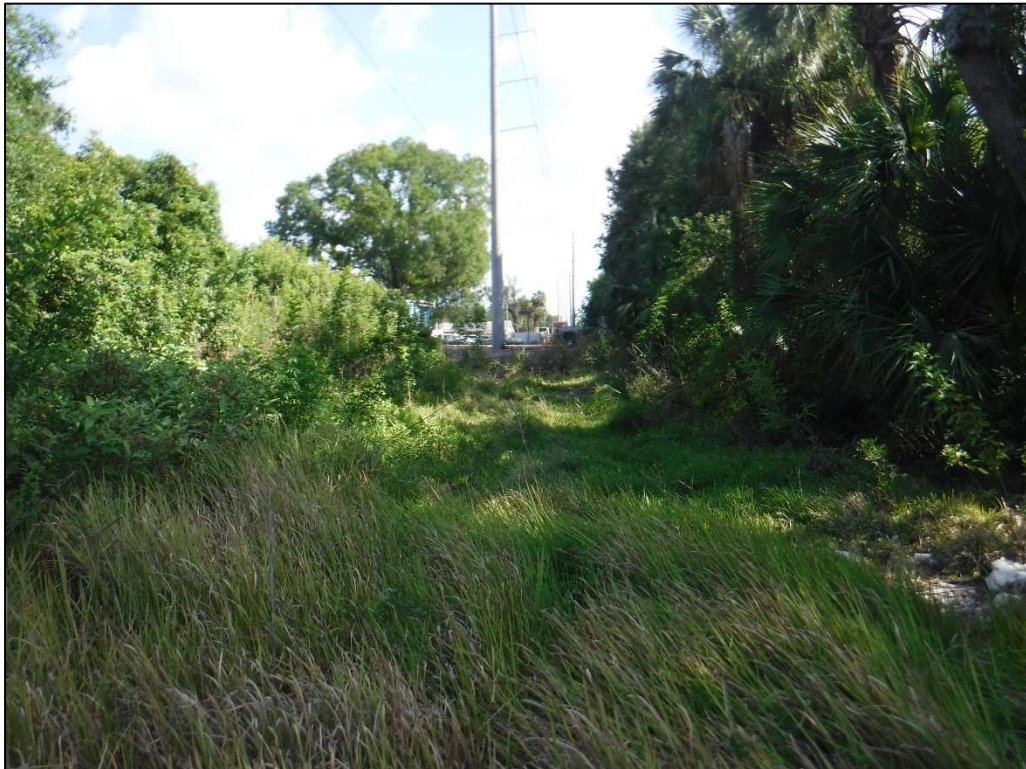
Figure 10-2 Representative View of the Pond 1A Drainage Outfall, facing North

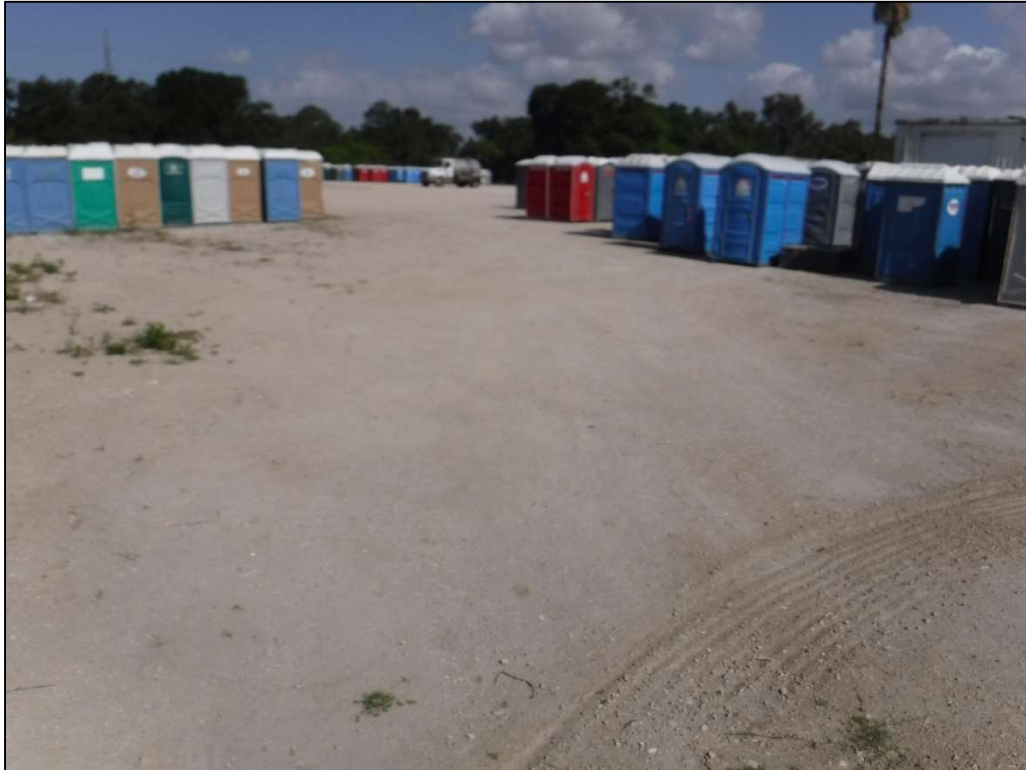
Figure 10-3 Representative View of the Modified Condition of Pond 1A, facing Northwest

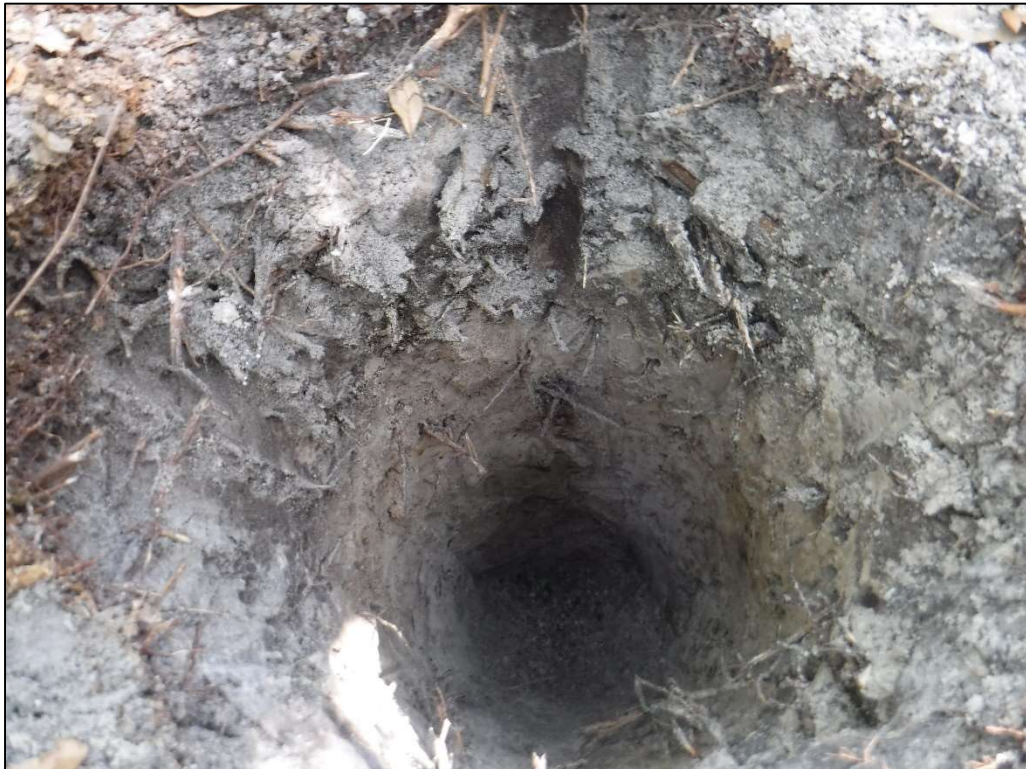
Figure 10-4 Stratigraphic Profile of ST No. 10 within Pond 2B, facing East

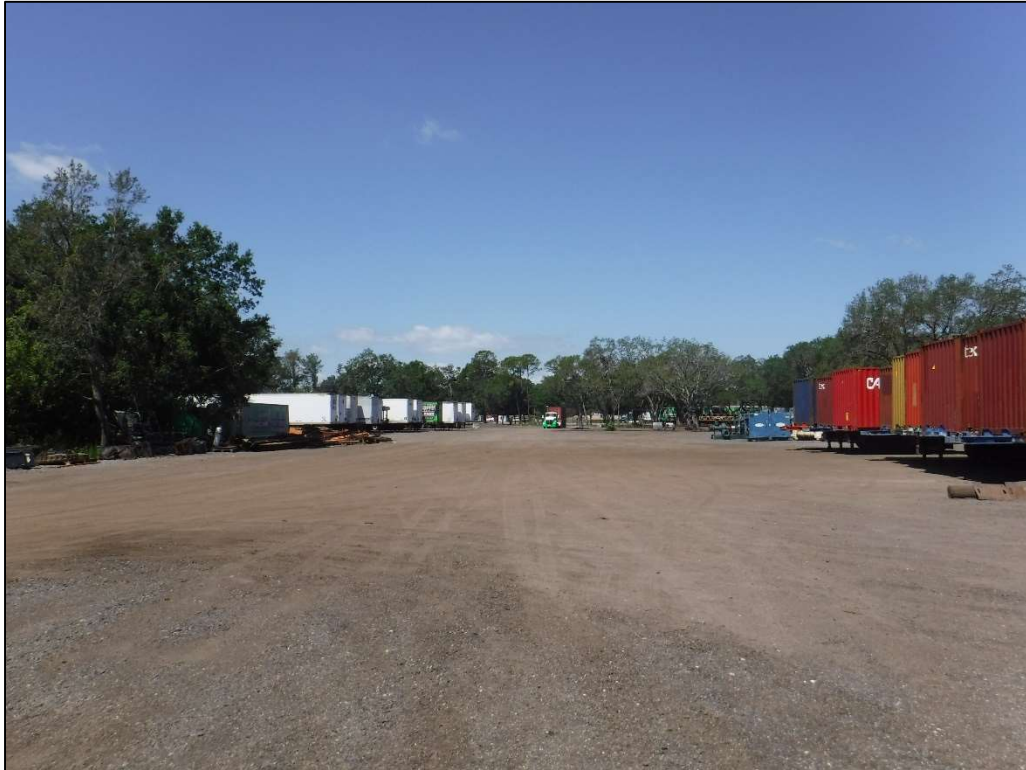
Figure 10-5 Representative View of the Modified Condition of Pond 2B, facing West

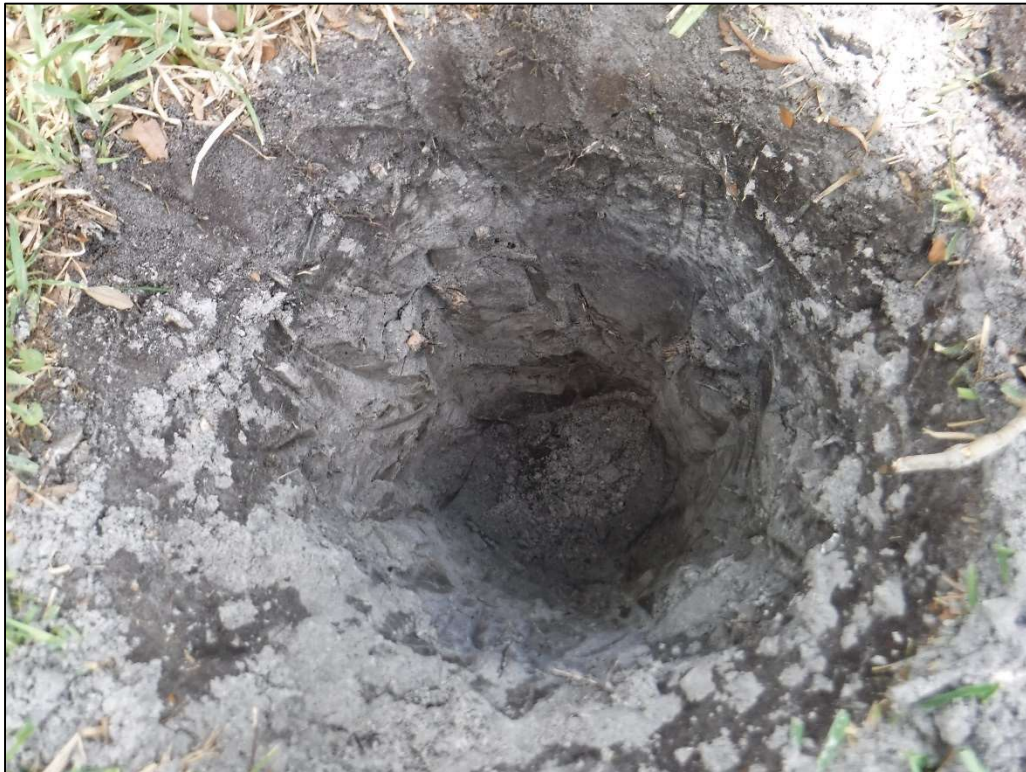
Figure 10-6 Stratigraphic Profile of ST No. 10 within Pond 3AB, facing East

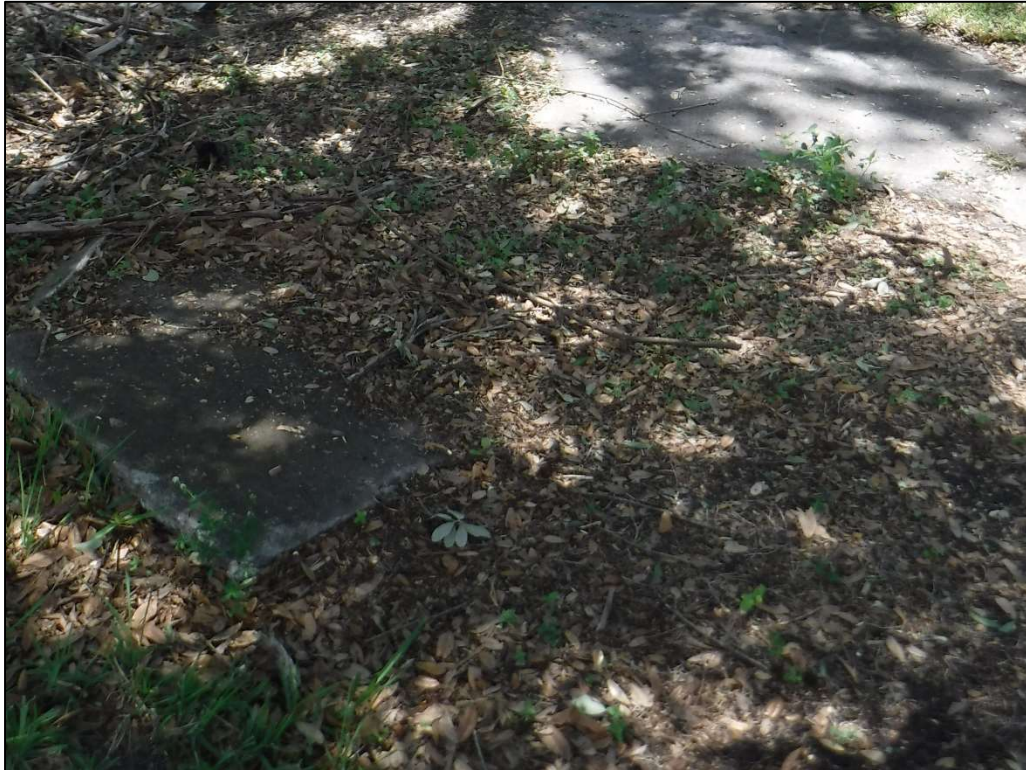
Figure 10-7 Representative View of Concrete Slab and Hardscape within Pond 3AB, facing Southeast
