Contamination Screening Evaluation Report – Ponds

US 41/SR 45 AT CSX GRADE SEPARATION
FROM S OF SR 676 TO N OF SR 676

Project Development & Environment (PD&E) Study
Design Change Reevaluation

February 2023

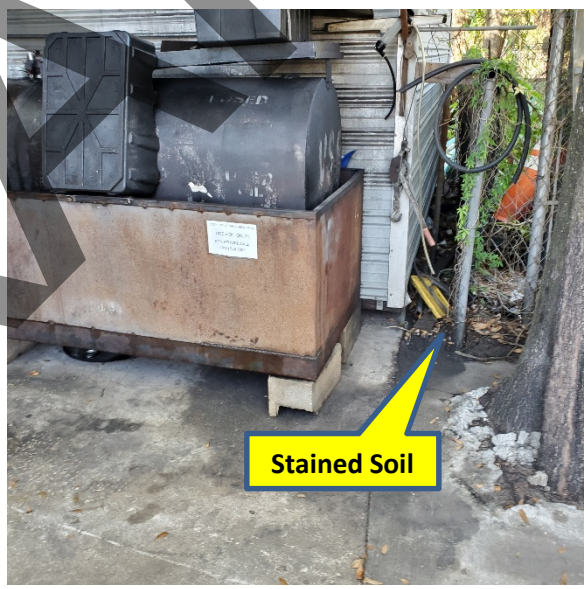
POND 3B – Cabellero Auto (West parcel)
South of waste oil AST looking north

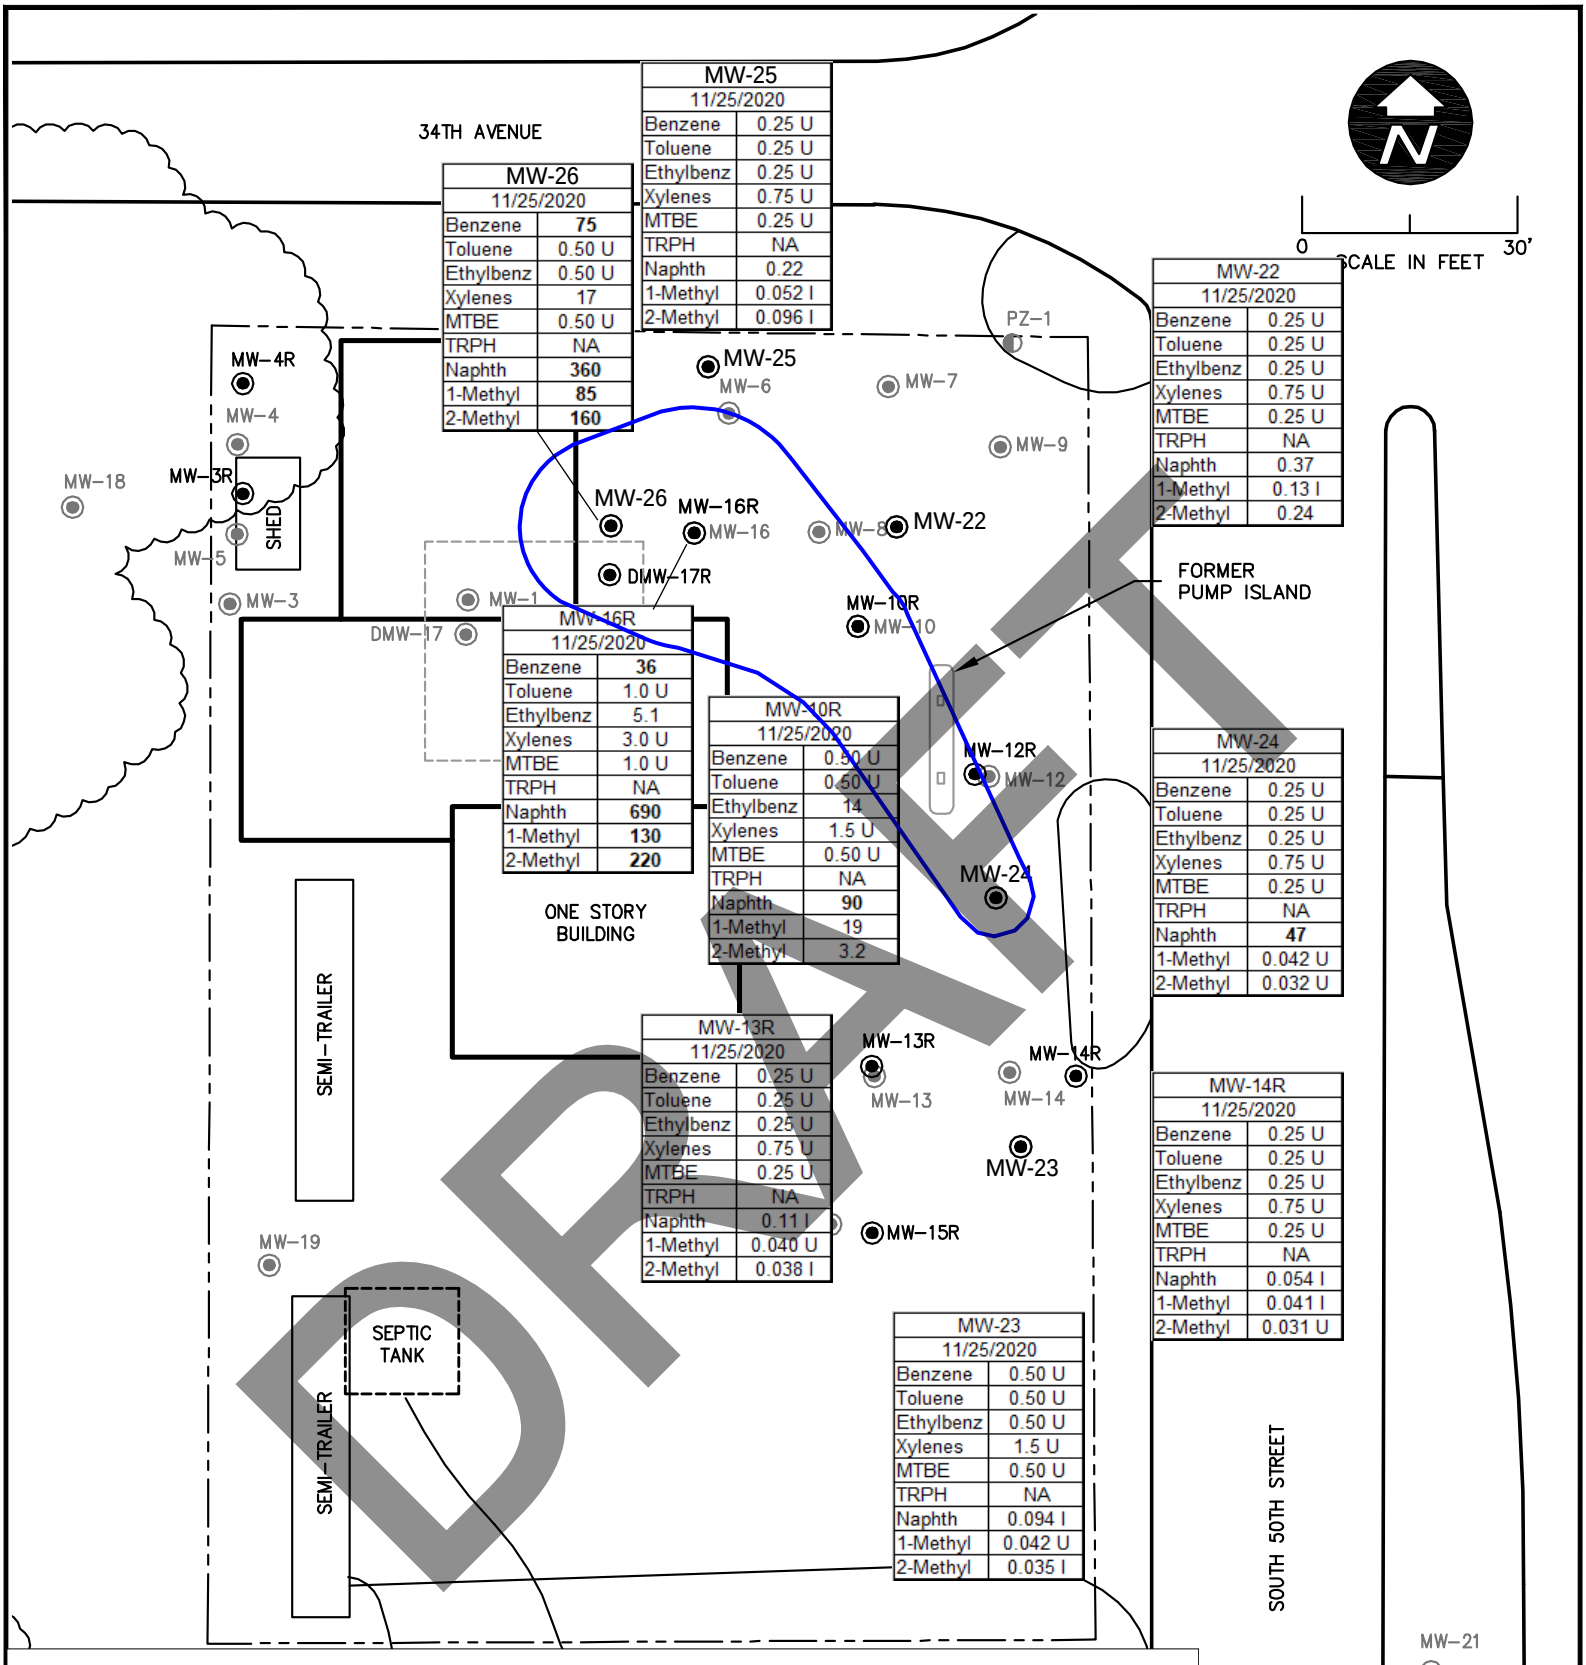
FIGURE 3
GROUNDWATER PLUME MAP
(11/25/20)

Groundwater analytical results from the most recent sampling event are summarized in **Table 1A** and **Table 1B along** with historical groundwater analytical data for the site. Groundwater contaminant concentrations are depicted on **Figure 3** for the November 25, 2020 sampling event. Field sampling logs and field notes for the sampling event are included in **Attachment** B for reference. Certificates of chemical analysis and chain of custody documentation for the November

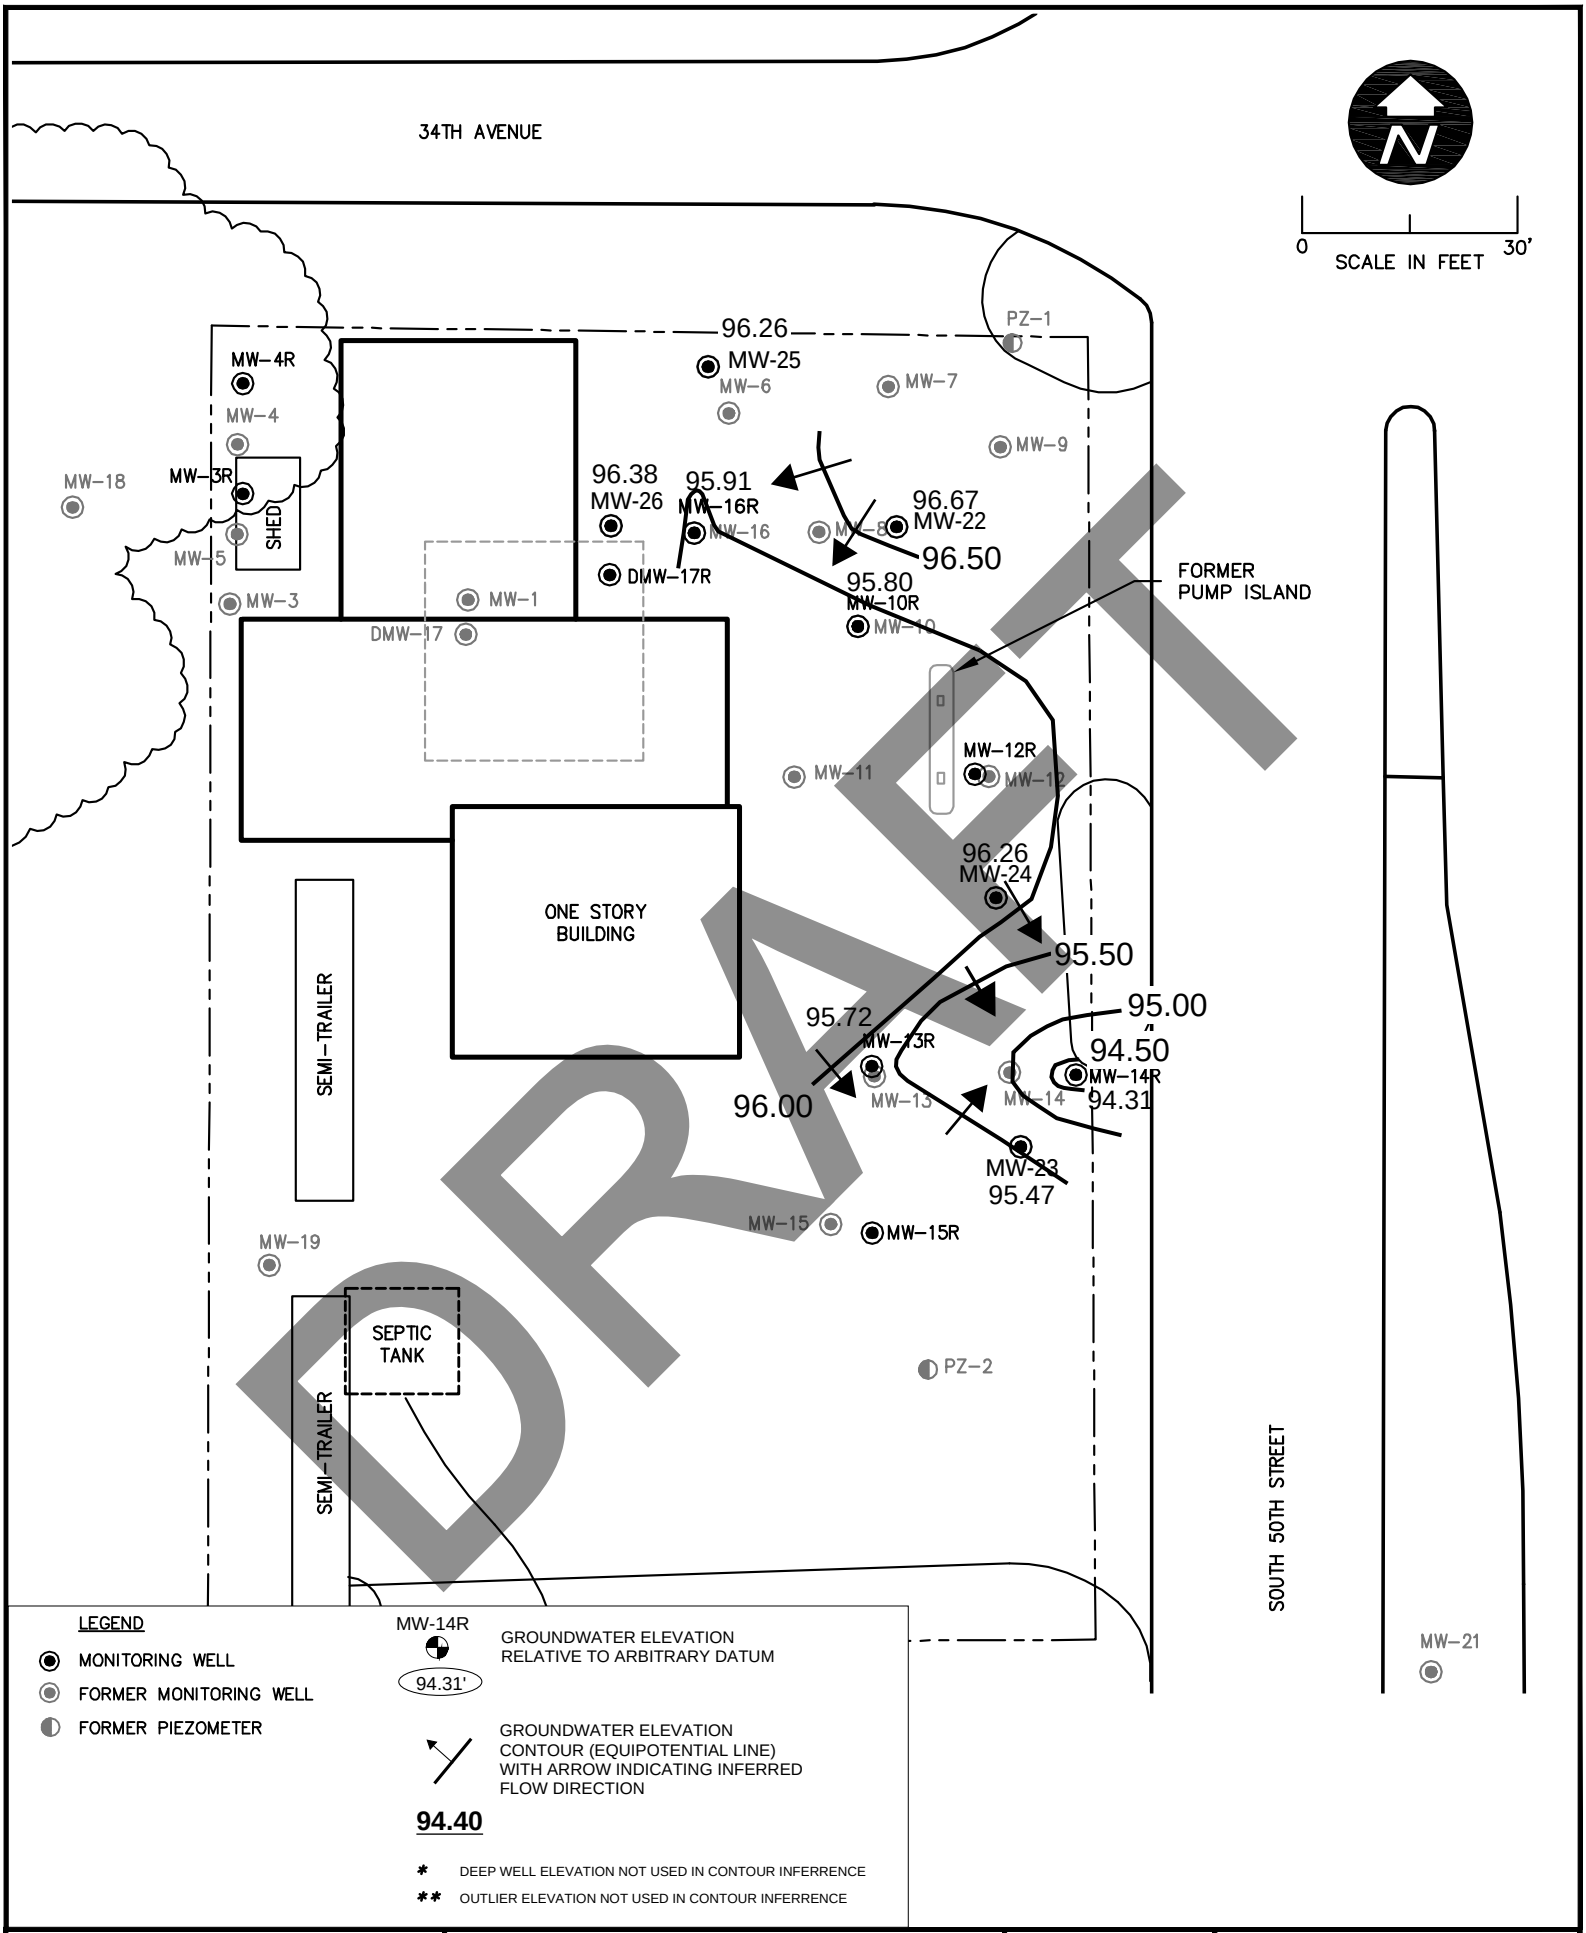
FIGURE 4
GROUNDWATER CONTOUR MAP
(11/24/20)

The latest depth to water measurements were recorded for monitoring wells MW-10R, MW-13R, MW-14R, MW-16R, MW-22, MW-23, MW-24, MW-25 and MW-26 during the November 25, 2020, sampling event. Depths to water ranged from 1.89 to 3.25 feet below the top of casing (fbtoc); the average of the measurements is 2.86 fbtoc. The groundwater flow direction was inferred to be generally southwestward from groundwater elevation data. The direction of groundwater flow has historically been inferred to be flowing southward. Historical groundwater elevation data is tabulated in **Table 2**. A groundwater elevation contour map is provided as **Figure 4**.

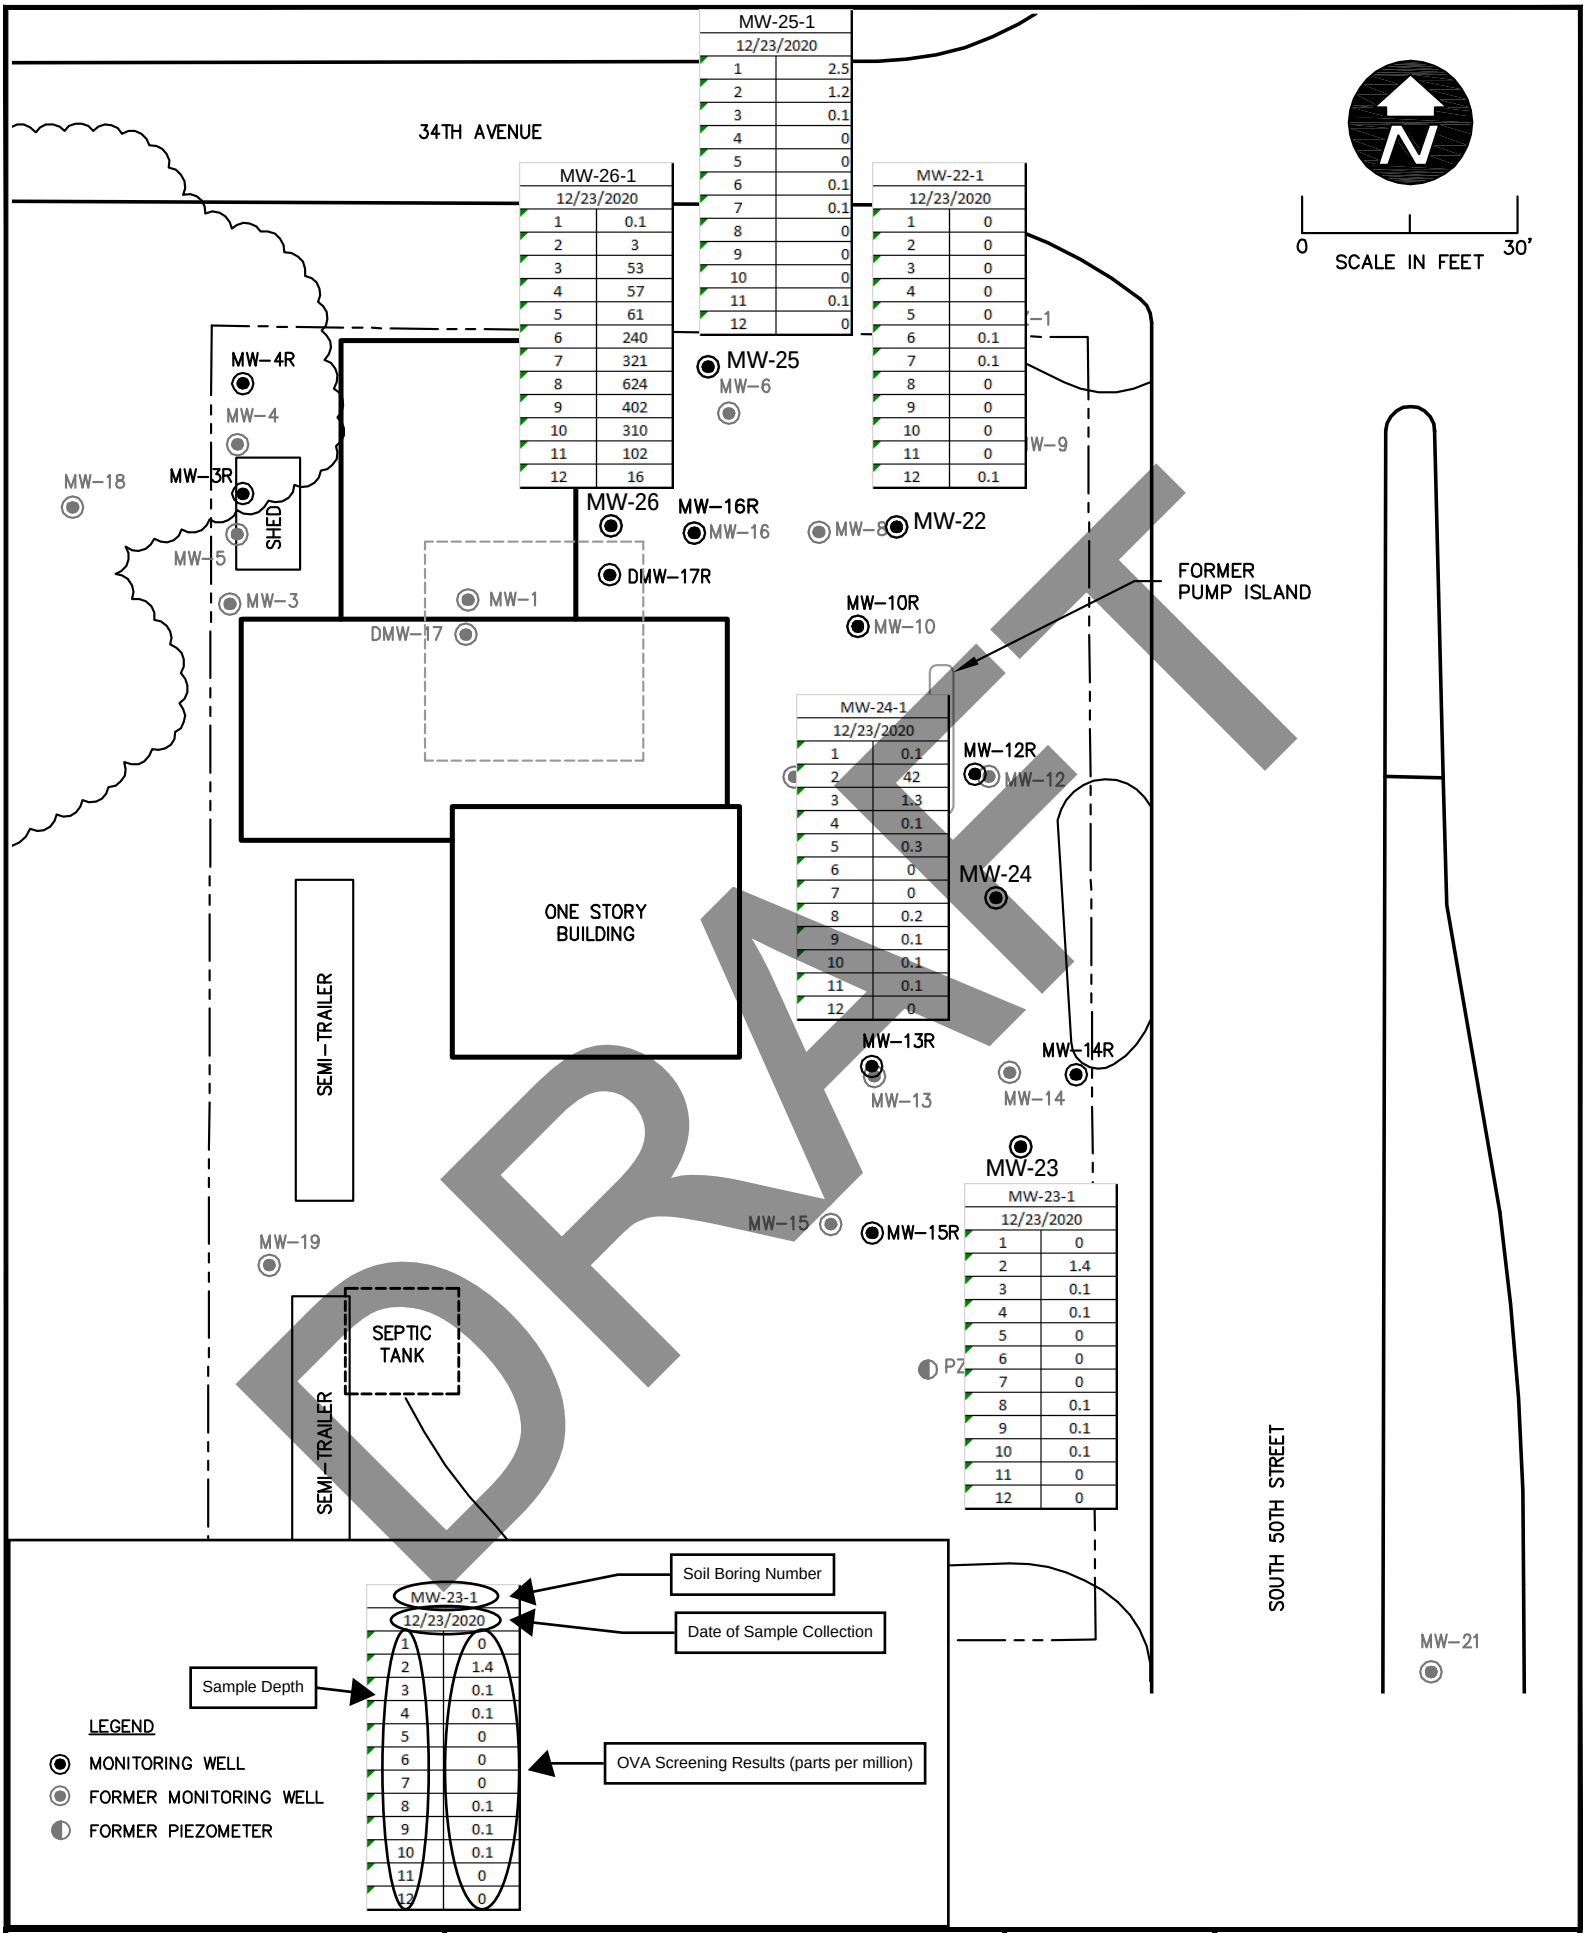
FIGURE 5
OVA SCREENING RESULTS
(11/23/20)

Soil screening on soil borings was last performed on April 1, 2013, reported on May 15, 2013, in a SCS Report by ARCADIS. The OVA results for these soil borings are presented in **Table 3**. The most recent OVA soil screening was performed during monitoring well installations on December 23-24, 2020, as reported by EEJV and can be found in **Table 3**, along with other historic OVA results. The most recent soil analysis is from a soil sample taken during the installation of a deep monitoring well on July 1, 2020, as reported by FER. The results of this analysis, as well as other historic sampling events, can be found in **Table 4**. An OVA Screening Results map for the most recent OVA results is provided as **Figure 5**. A Soil Analytical Results map for the most recent soil results is provided as **Figure 6**.

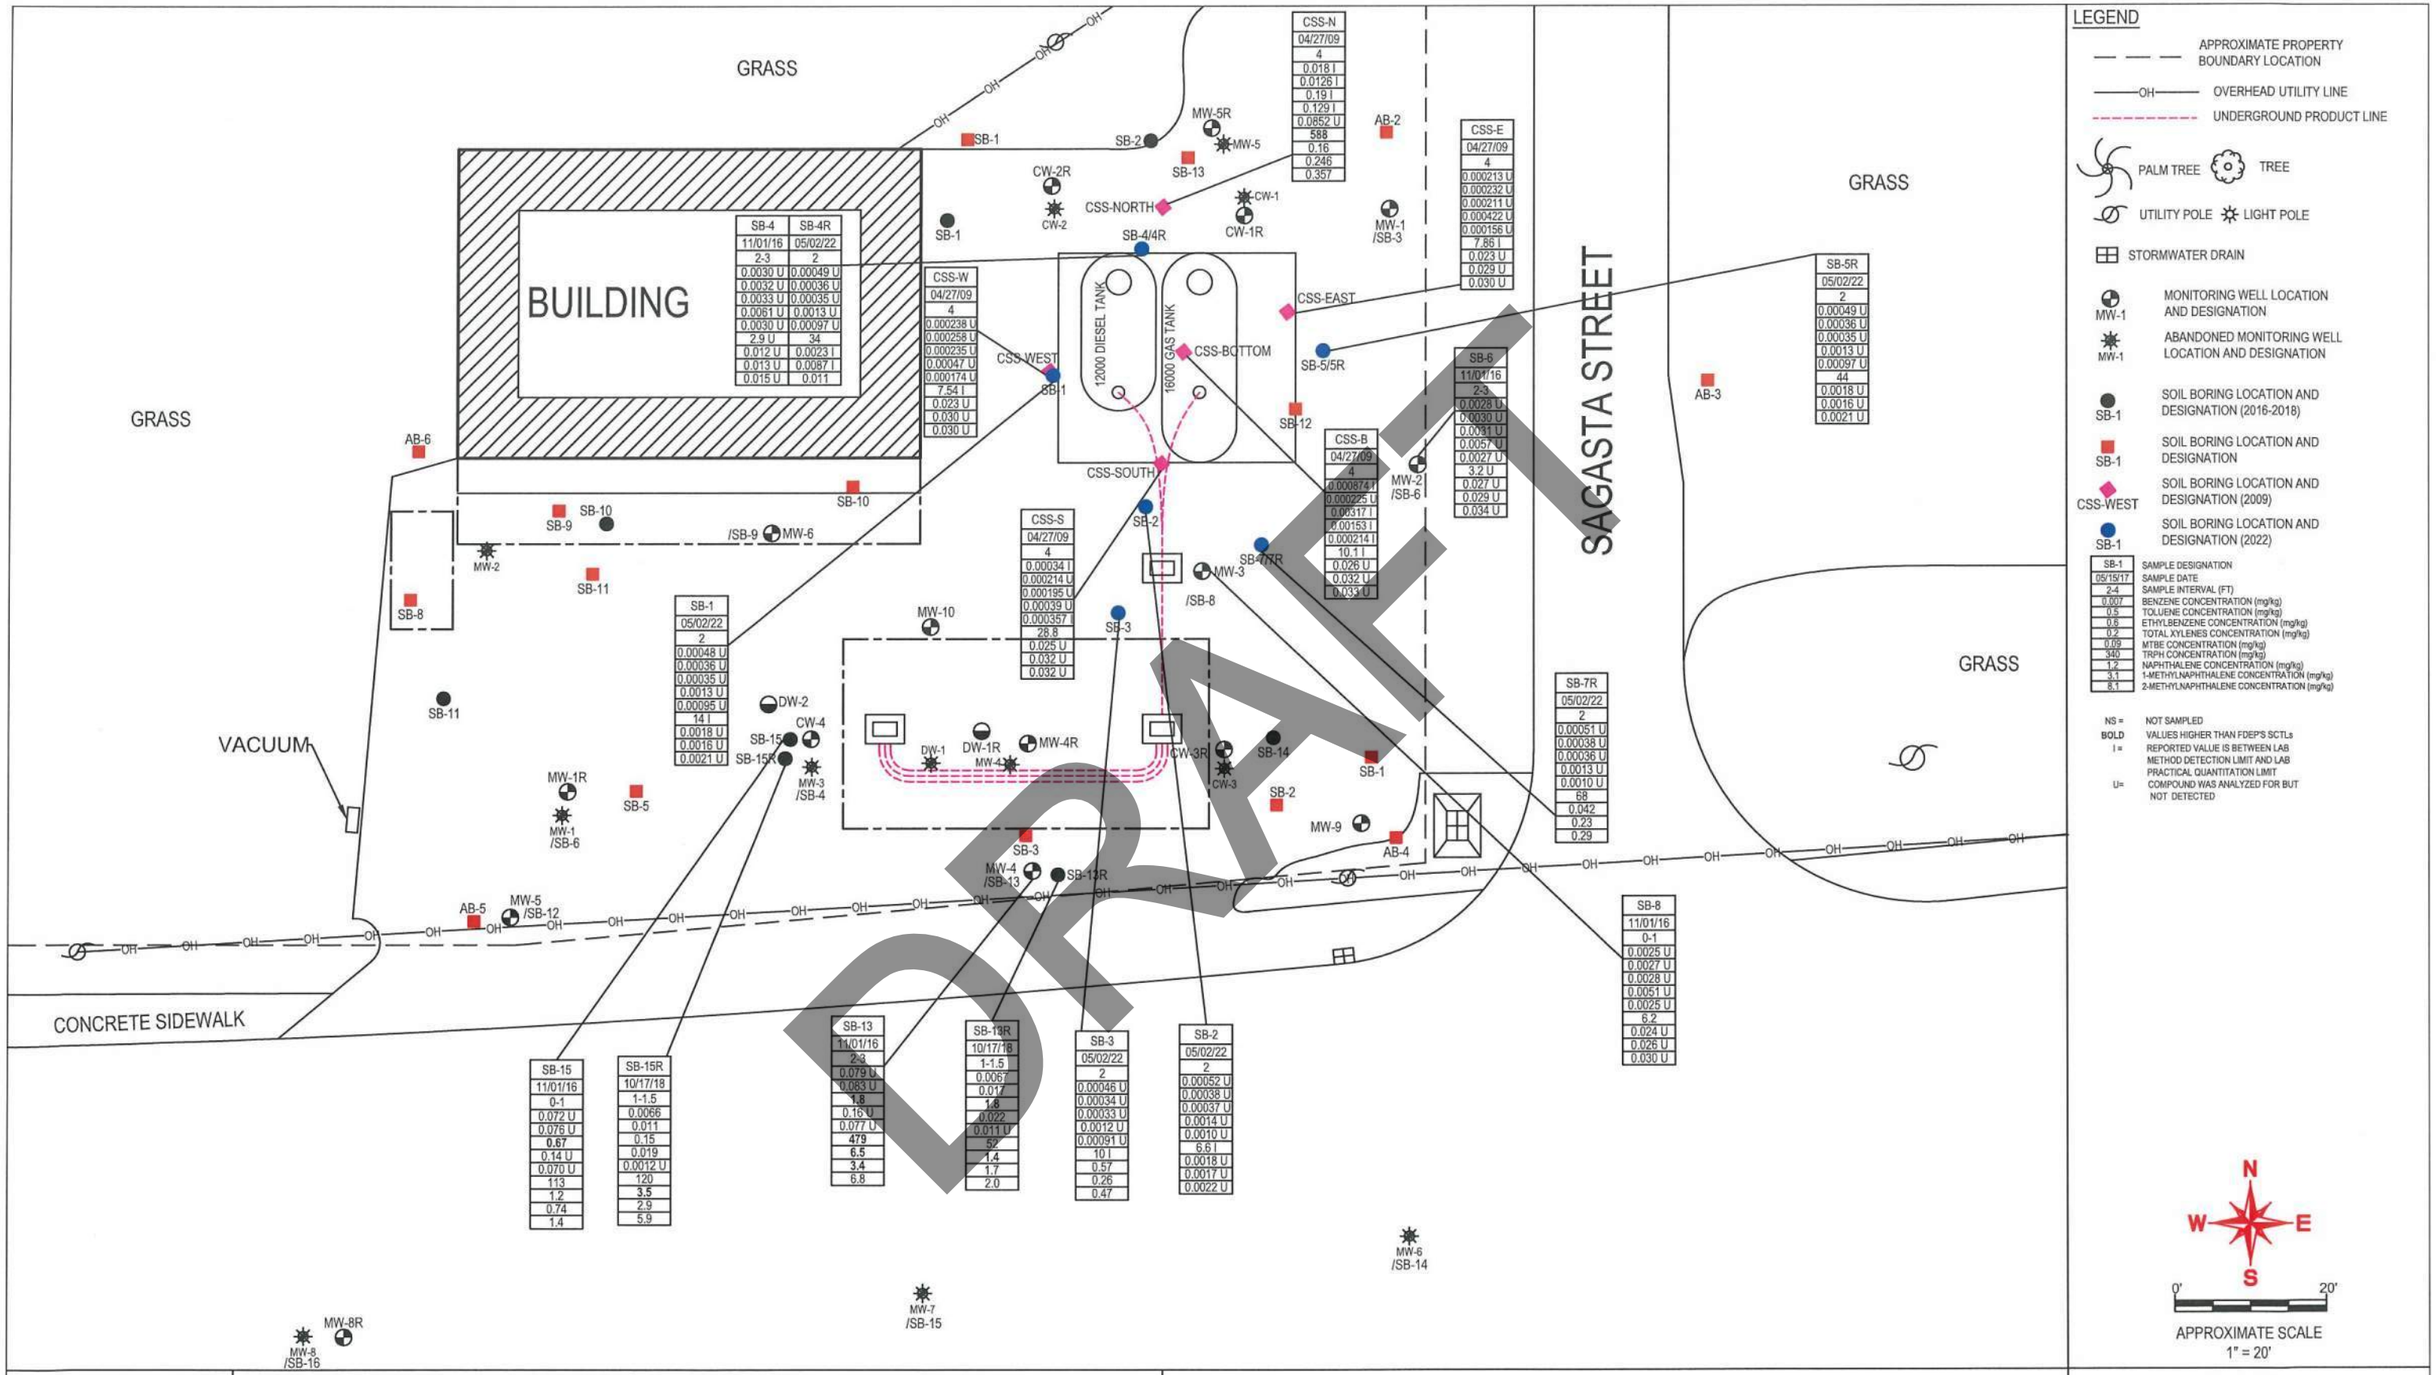
SOIL ANALYTICAL SUMMARY MAP
(04/27/09, 11/01/16, 10/17/18 & 05/02/22)

A summary of the soil analytical results are provided in **Tables 2A** to **2C**, and the Benzo(a)Pyrene conversion tables are provided after **Table 2C**. The soil analytical results are depicted on **Figure 3**. A copy of the soil laboratory analytical report is provided in **Appendix E**.

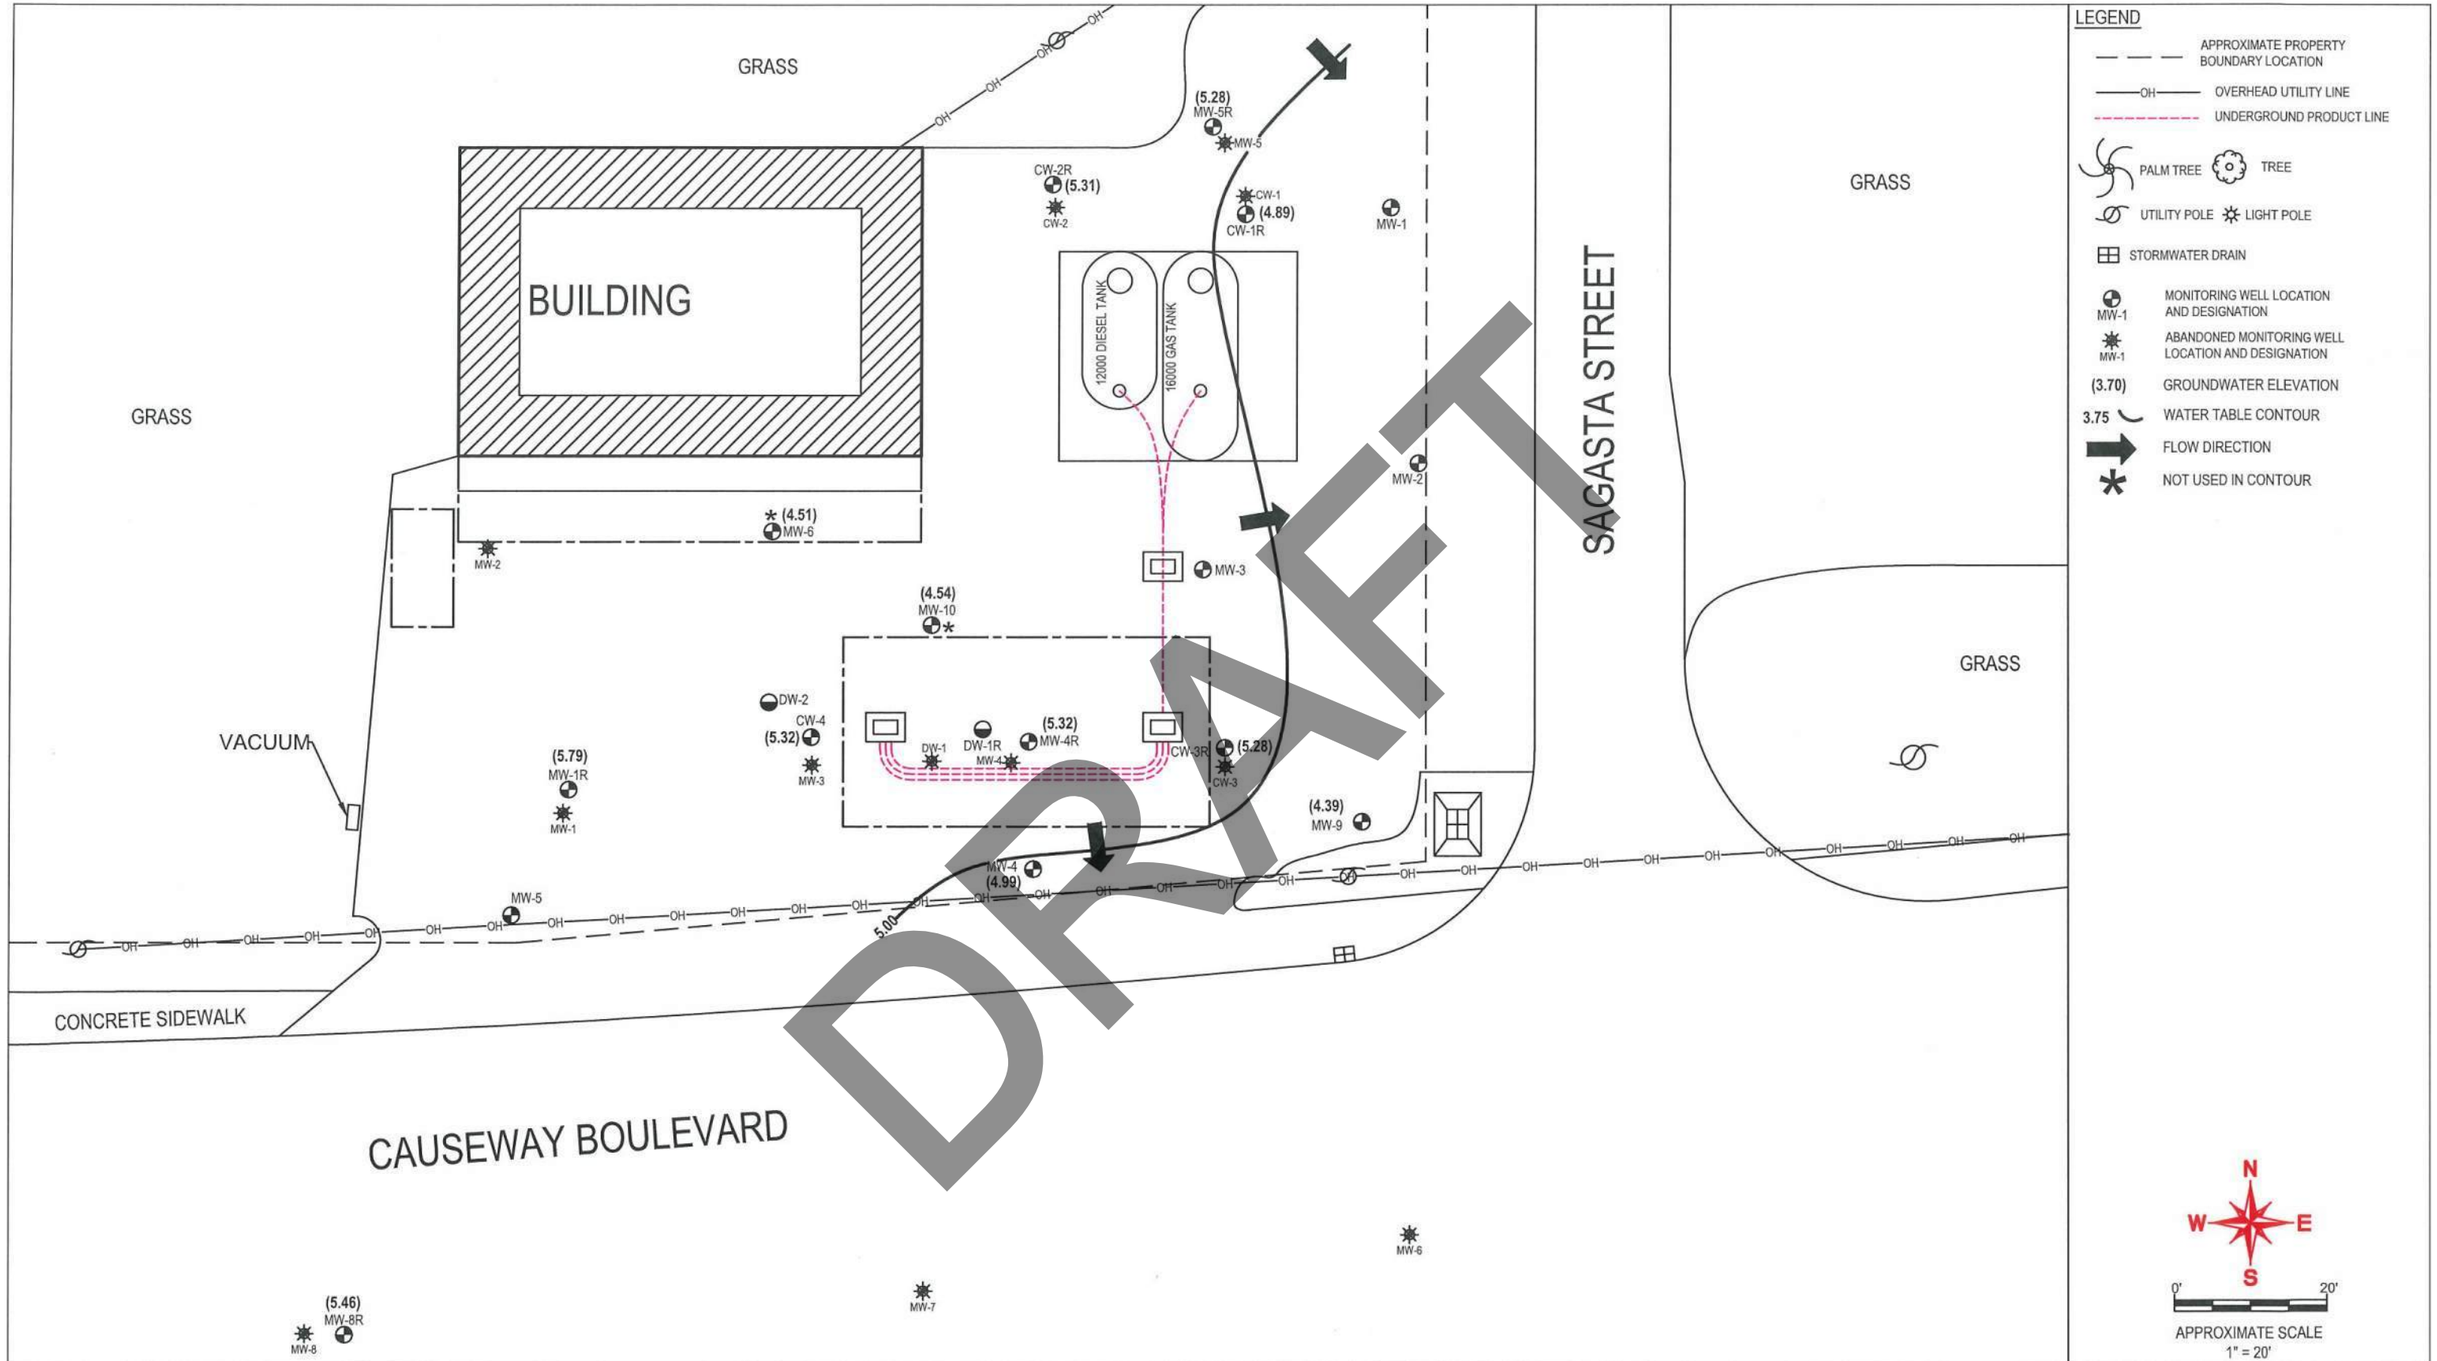
GROUNDWATER ELEVATION CONTOUR MAP (05/11/22)

Prior to sample collection, the monitoring wells were gauged for the depth to water. The calculated groundwater elevation data is summarized on **Table 3**. A groundwater elevation map for May 11, 2022 is presented in **Figure 4**. Excess groundwater generated during the purging activities was discharged directly onto the paved surface in the immediate vicinity of the monitoring wells and no disposal costs were incurred. To eliminate the risk of cross contamination, all wells were purged and sampled with dedicated tubing. The groundwater samples were packed in ice and submitted under proper chain of custody documentation to the certified laboratory for analysis.
