CONTAMINATION TECHNICAL MEMORANDUM

I-275 (SR 93) Design Change Re-evaluation

Project Development and Environment Study from south of 54th Avenue South to north of 4th Street North

Pinellas County, Florida

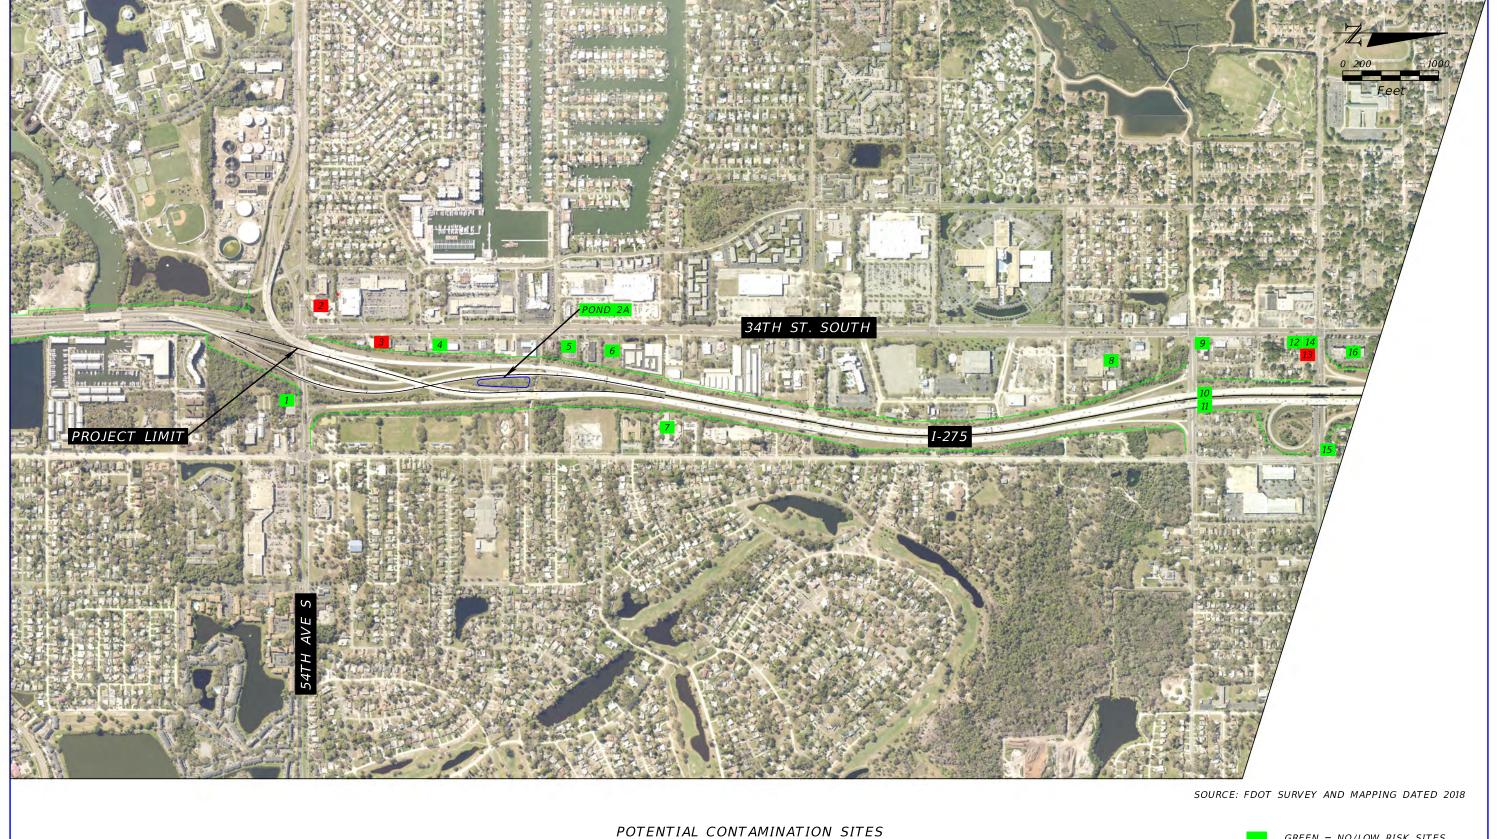
GREEN = NO/LOW RISK SITES

RED = HIGH/MEDIUM RISK SITES

Appendix A: Potential Contamination Sites Map

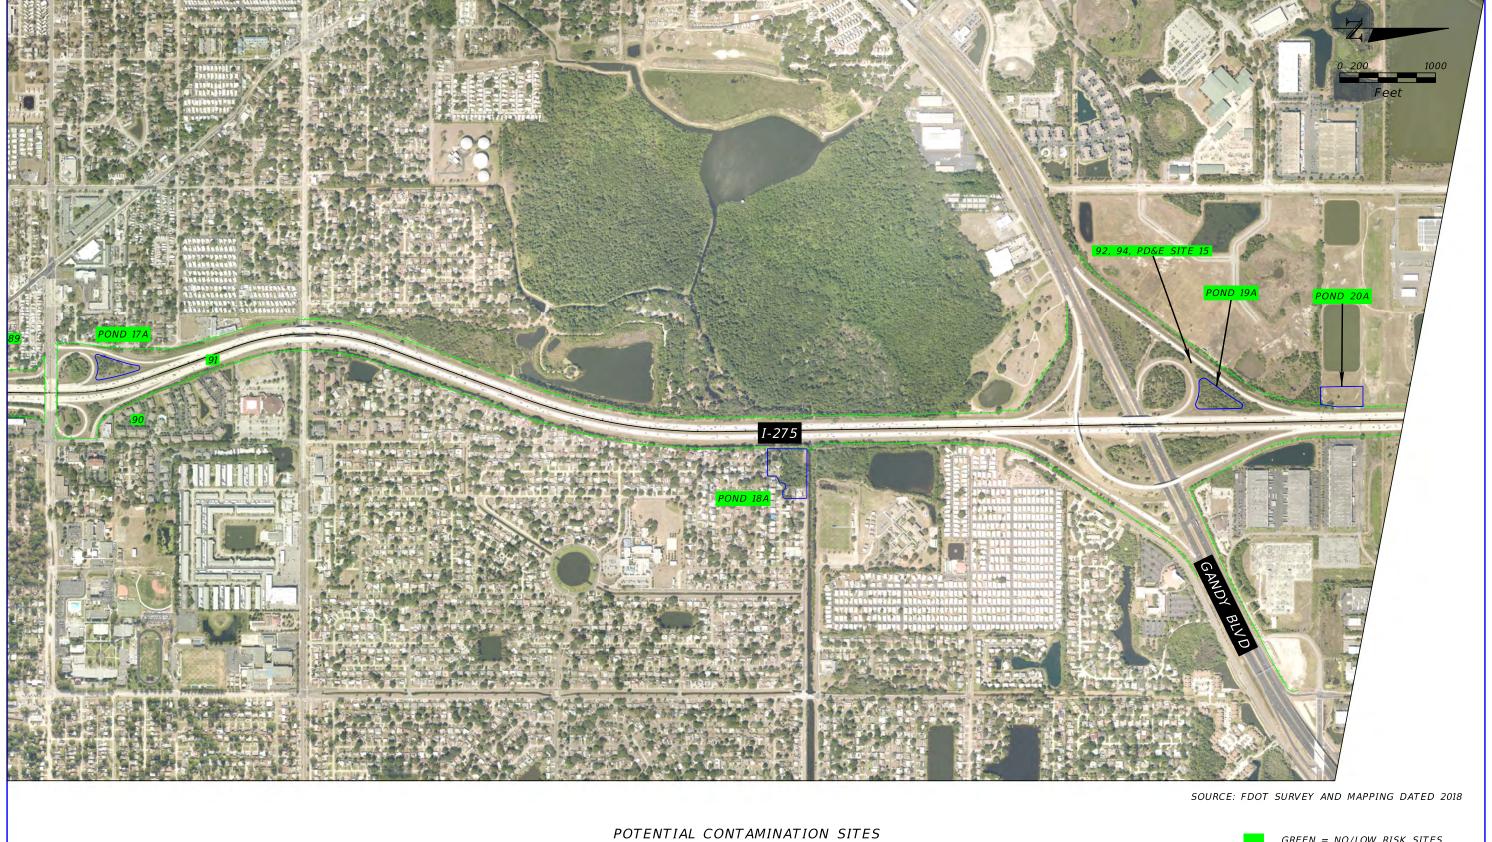
GREEN = NO/LOW RISK SITES

RED = HIGH/MEDIUM RISK SITES
